Table Cape Lighthouse

Heritage Management Plan

2022

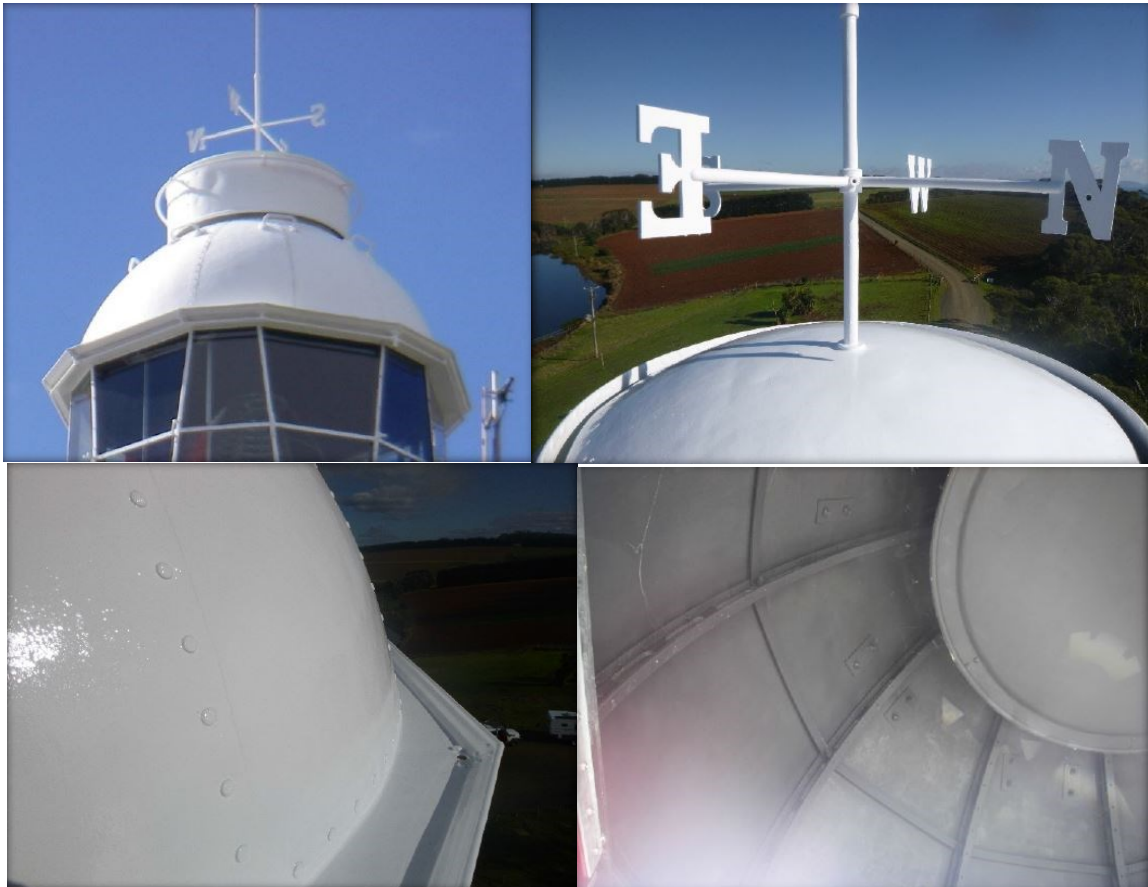
Lighthouse feature: Lantern roof

Finish:	Painted
Condition	Intact and sound
Integrity	High
Significance	High
Maintenance	Keep in service, prepare and repaint at normal intervals
Rectification works	None

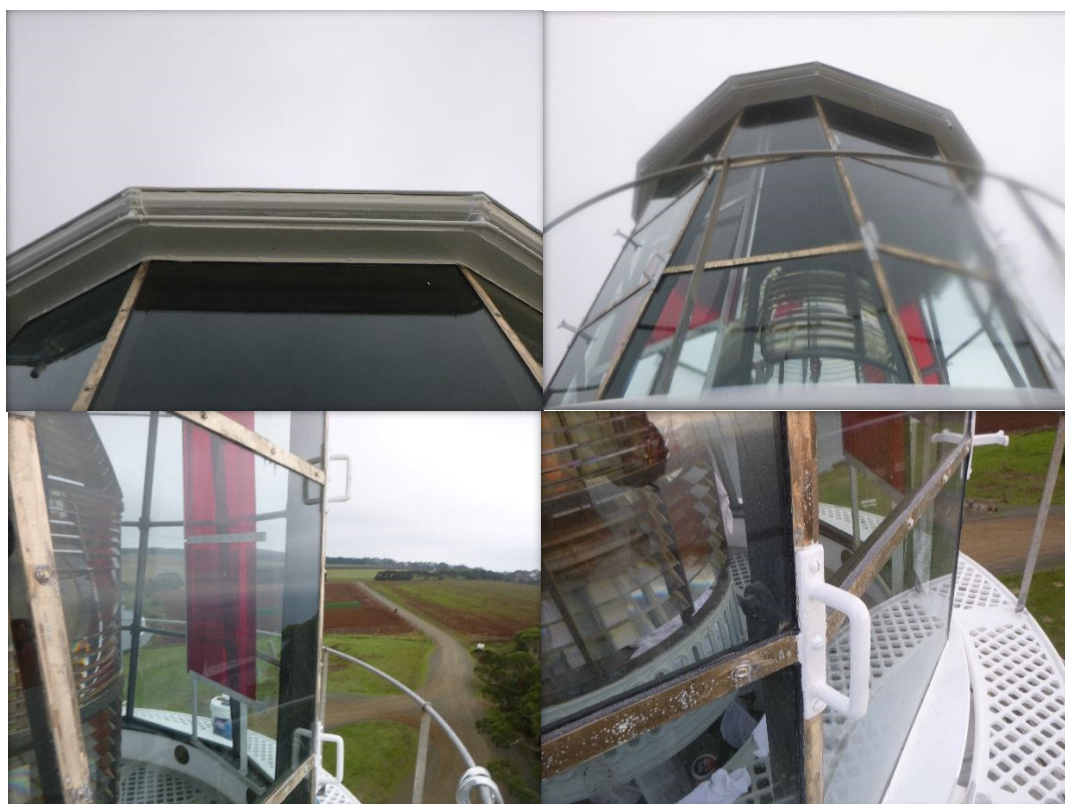
Lighthouse feature: Lantern glazing

Finish	astragals and glazing strips painted
Condition	intact and sound
Integrity	high
Significance	high
Maintenance	keep in service, reglaze as necessary prepare and repaint at normal intervals
Rectification works	none

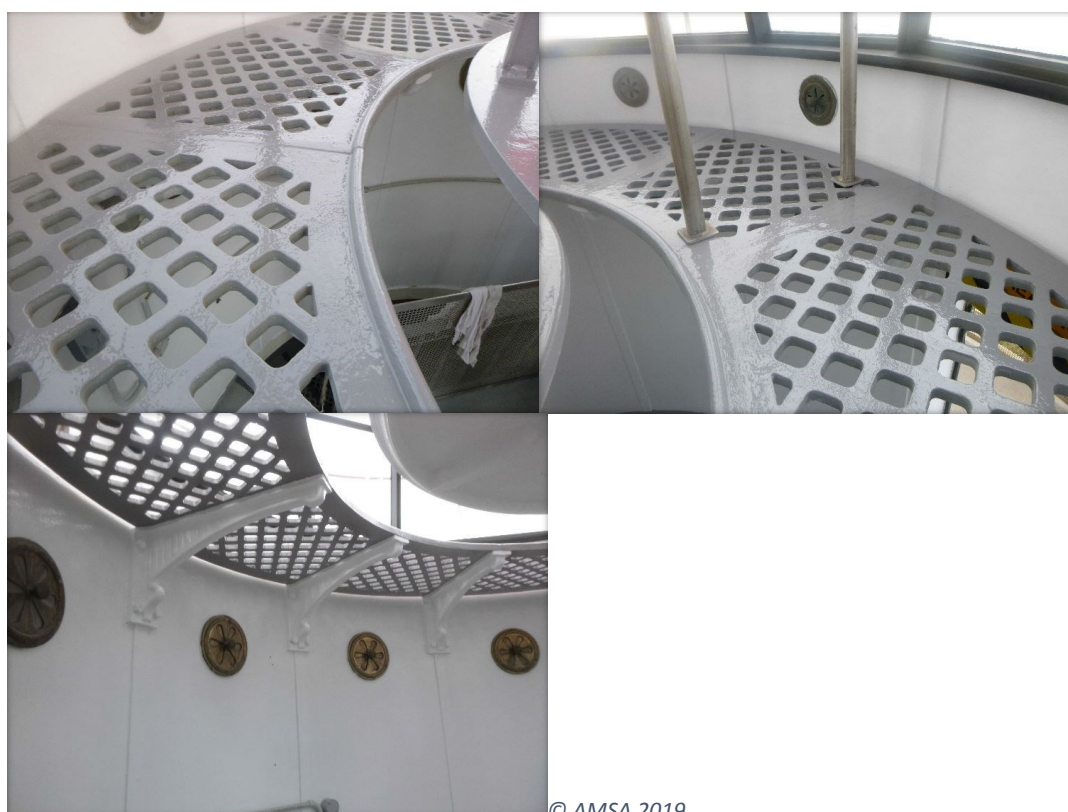
Lighthouse feature: Internal catwalk

Finish	painted
Condition	intact and sound
Integrity	high
Significance	high
Maintenance	keep in service, prepare and repaint at normal intervals
Rectification works	none

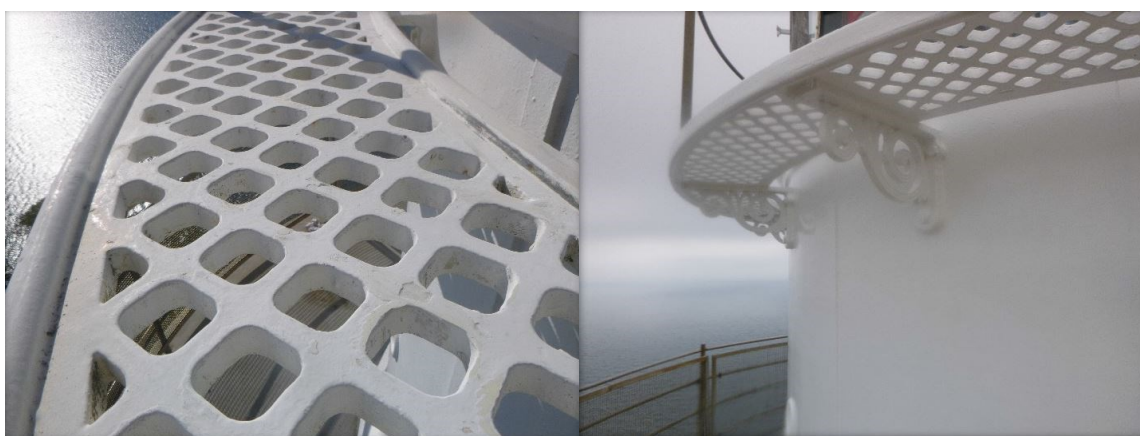
Lighthouse feature: External catwalk

- Handrail – recent stainless steel tubular handrail on rectangular section stanchions, bolted to floor panels.

Finish	handrail and stanchions bare: stainless steel other parts: painted
Condition	intact and sound
Integrity	high
Significance	high
Maintenance	keep in service, prepare and repaint at normal intervals
Rectification works	none

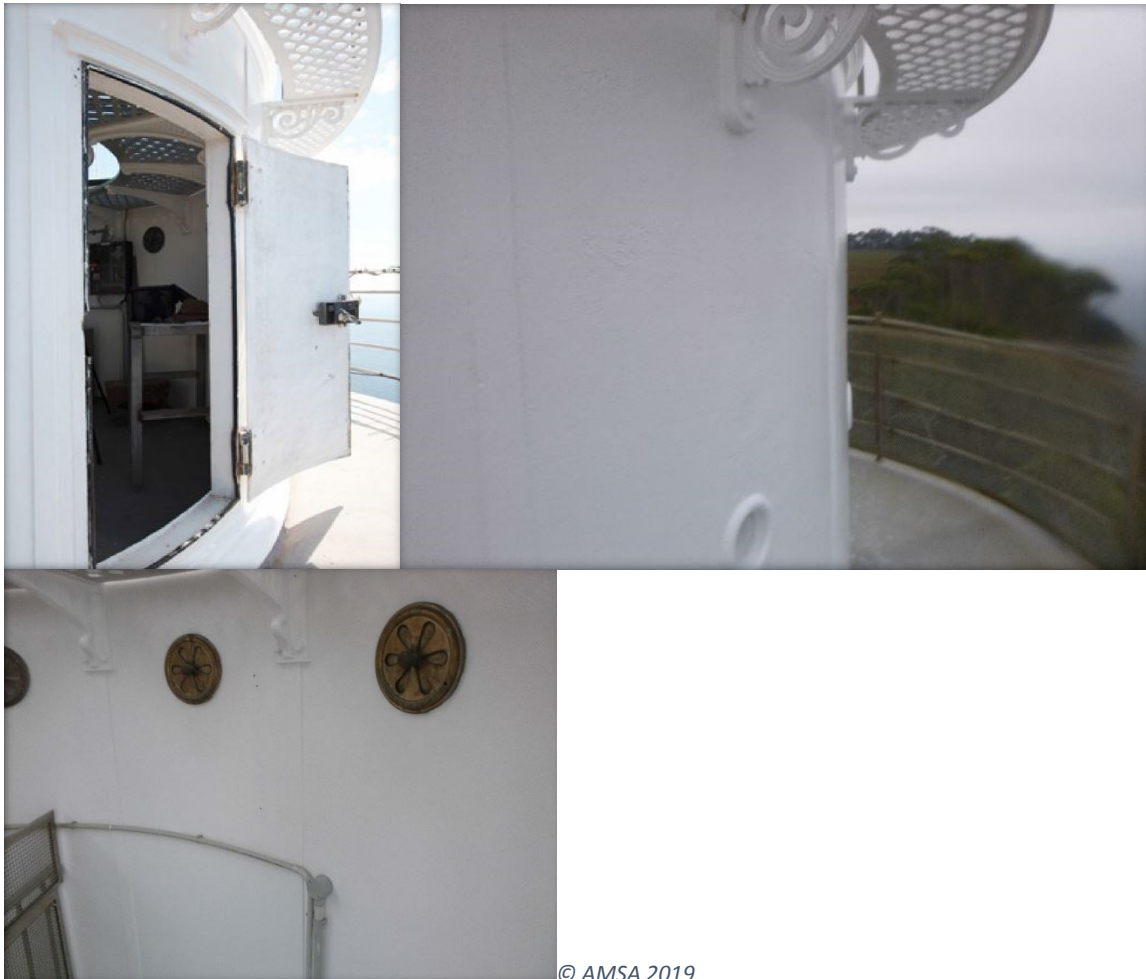
Lighthouse feature: Lantern base

Finish	painted
Condition	intact and sound
Integrity	high
Significance	high
Maintenance	keep in service, prepare and repaint at normal intervals
Rectification works	none

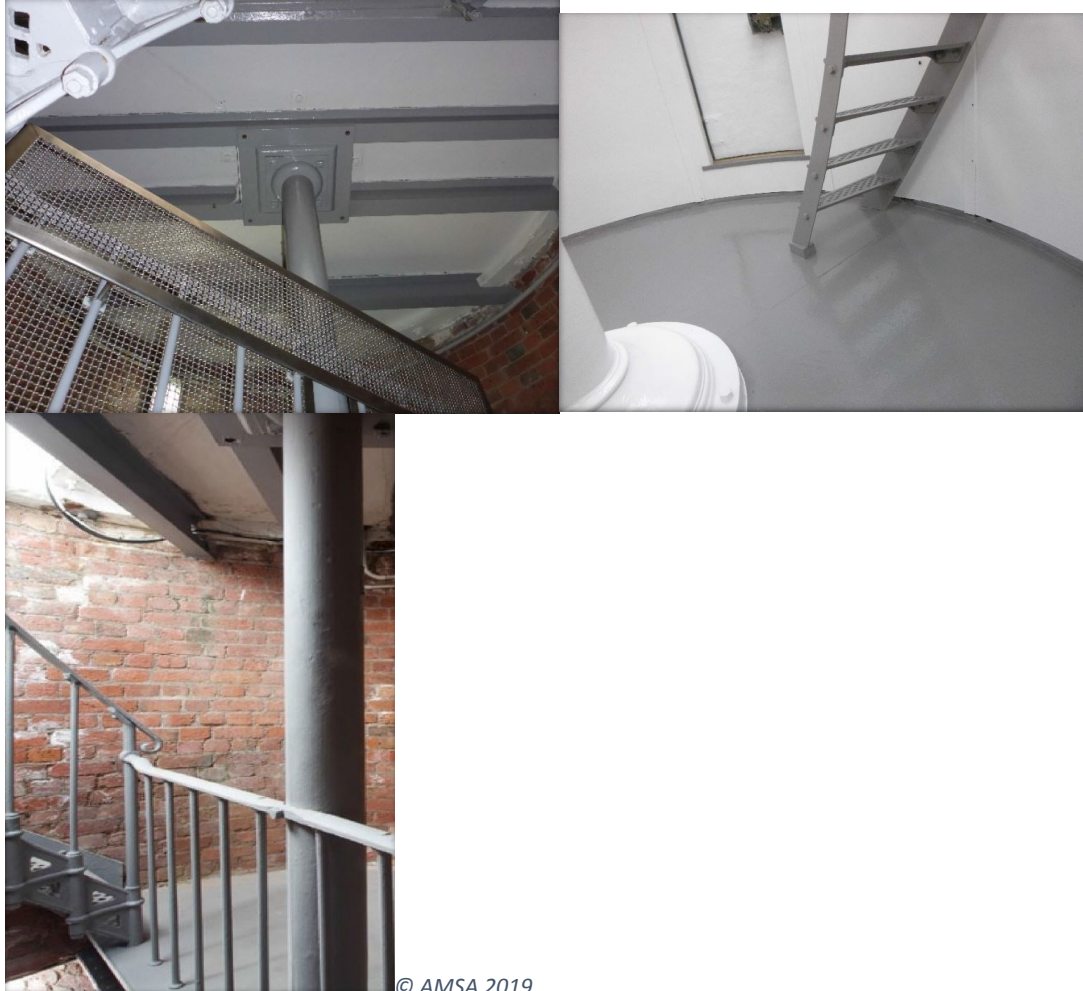
Lighthouse feature: Lantern floor

Slate slab floor, continues with balcony floor, supported on the top of the tower walls and on rolled iron beams.

Finish	painted
Condition	intact and sound
Integrity	high
Significance	high
Maintenance	keep in service, prepare and repaint at normal intervals
Rectification works	none

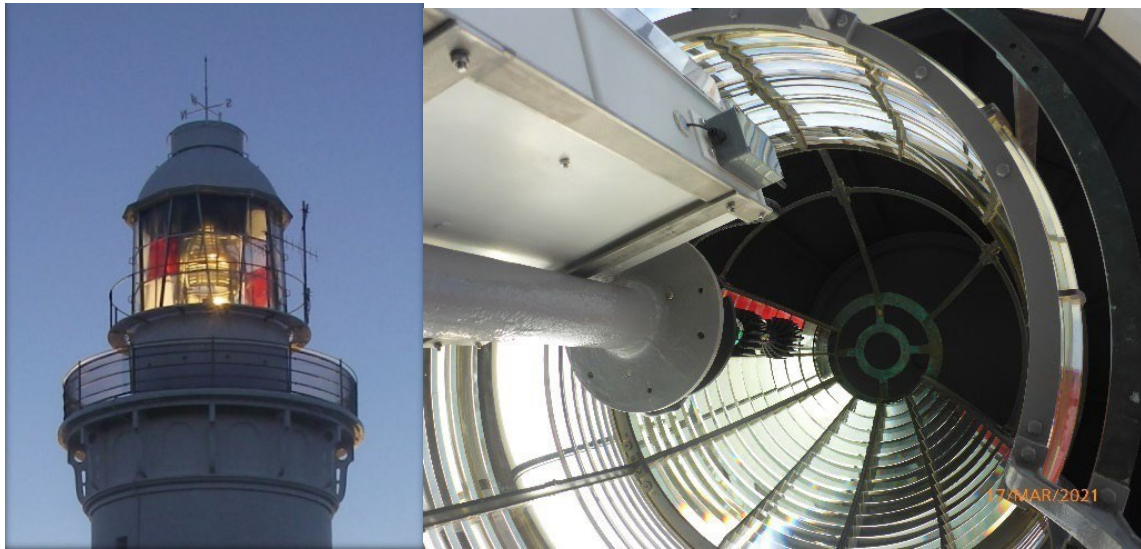
Lighthouse feature: Lens assembly

Condition	intact and sound
Integrity	high
Significance	high
Maintenance	keep in service, clean at normal intervals
Rectification works	none

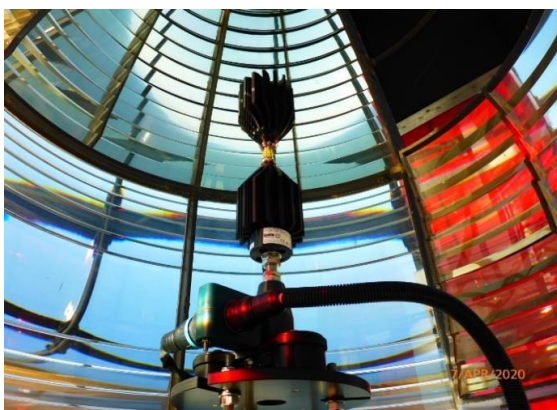
Lighthouse feature: Light source

Condition	intact and sound
Significance	low
Maintenance	keep in service
Rectification works	none

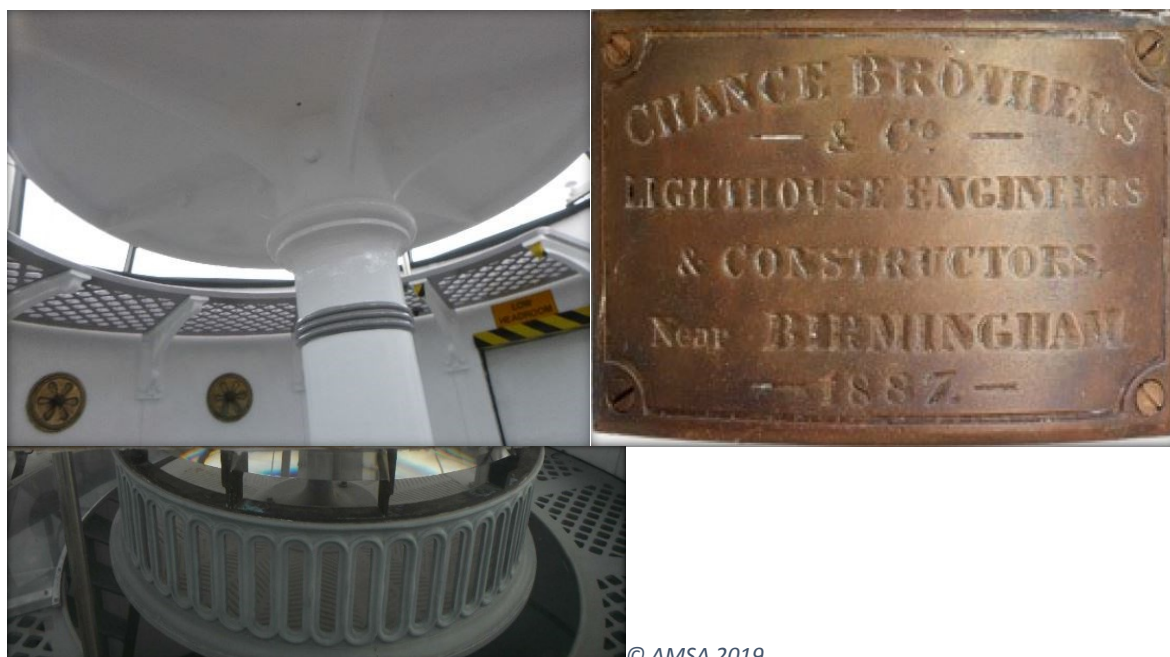
Lighthouse feature: Pedestal

Finish	painted
Condition	intact and sound
Integrity	high
Significance	high
Maintenance	keep in service, prepare and repaint pedestal at normal intervals
Rectification works	none

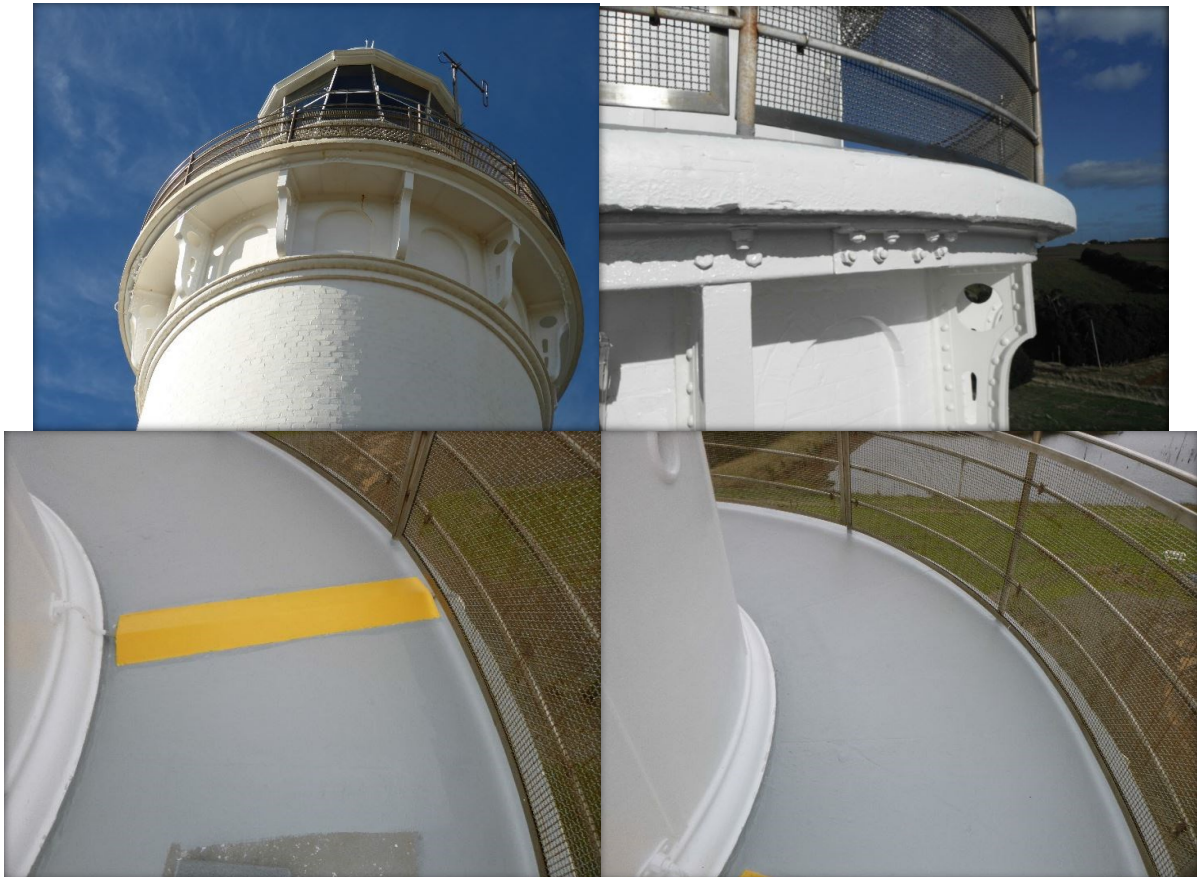
Lighthouse feature: Balcony floor

Finish	Painted
Condition	Intact and sound
Integrity	High
Significance	High
Maintenance	Keep in service, maintain joint seals Prepare and repaint at normal intervals
Rectification works	None

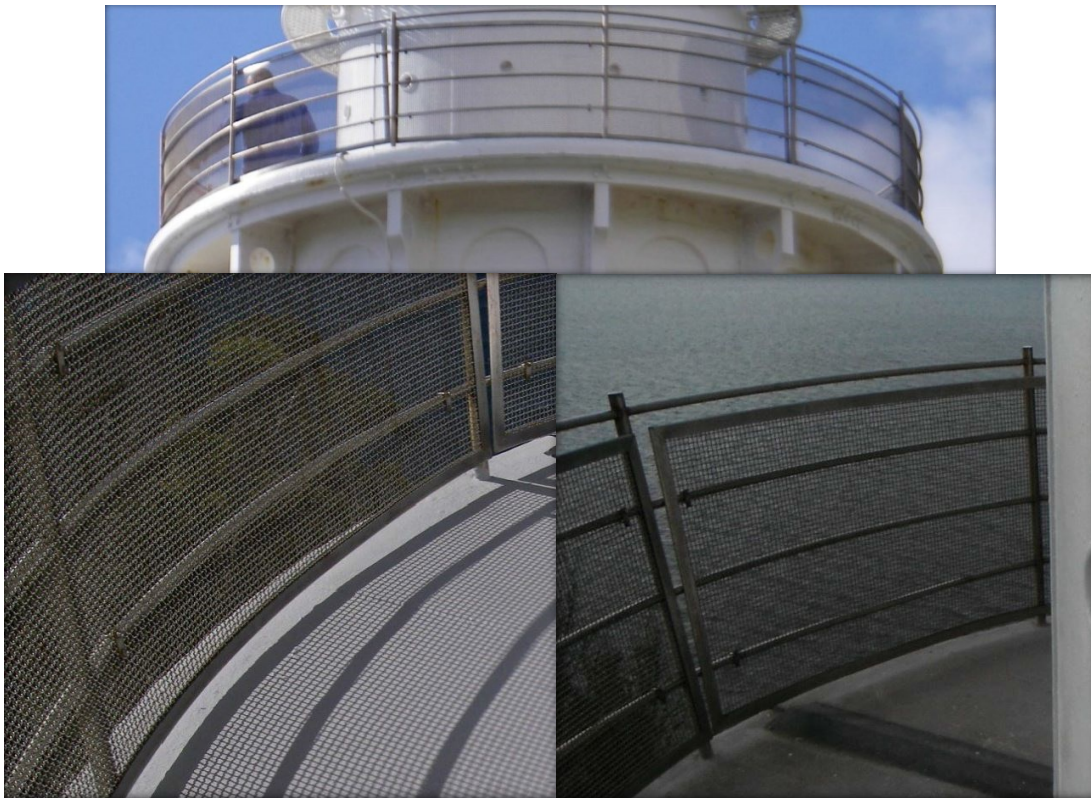
Lighthouse feature: Balcony balustrade

Recent stainless steel balustrade with four tubular rails welded to tubular stanchions. Recent stainless steel mesh and frame attached to balustrade for public safety.

Finish	bare stainless steel
Condition	intact and sound
Integrity	high
Significance	high
Maintenance	keep in service, monitor condition
Rectification works	none

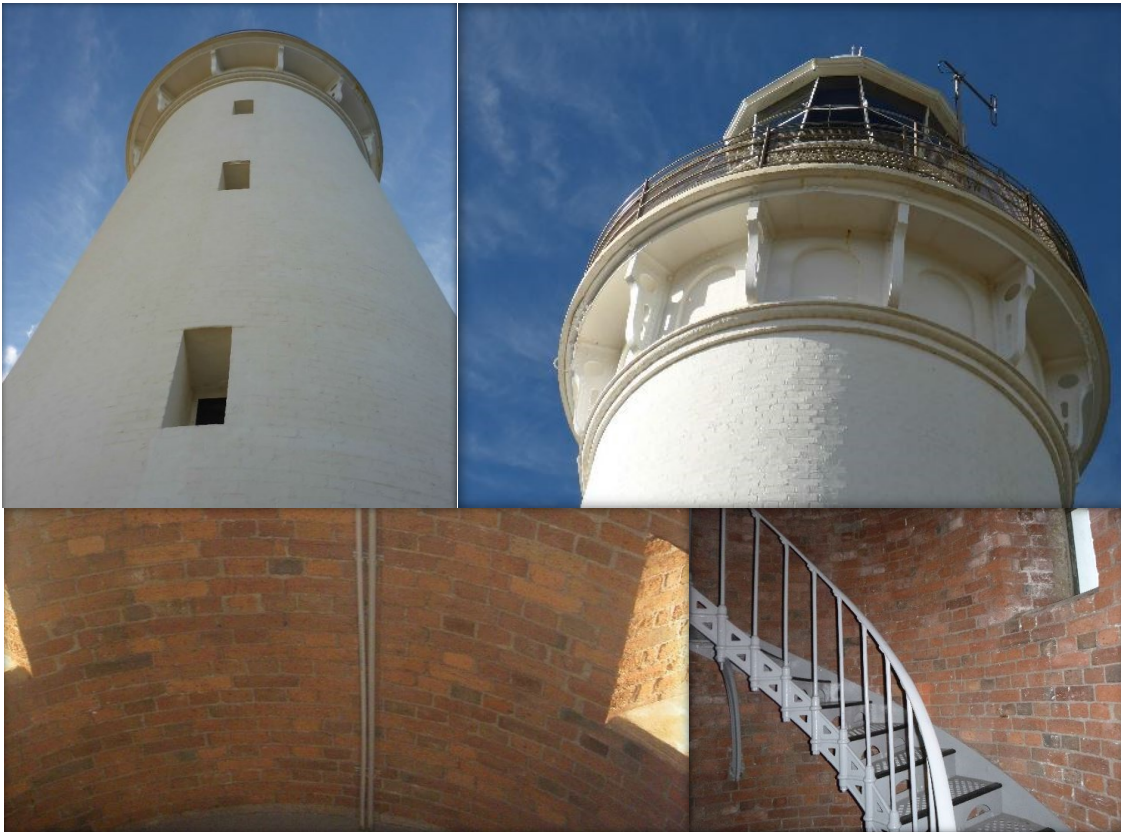
Lighthouse feature: Walls

Finish	external: painted internal: most paintwork removed by abrasive blasting
Condition	minor erosion of internal surface by abrasive blasting otherwise intact and sound
Integrity	high
Significance	high
Maintenance	keep in service, prepare and paint at normal intervals monitor condition of pointing and brickwork
Rectification works	none

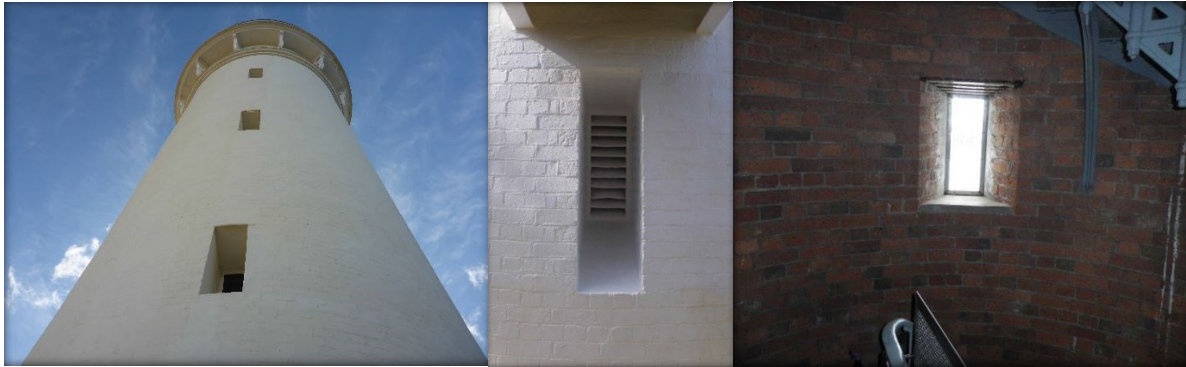
Lighthouse feature: Windows

Original window openings with recent stainless steel frames built into brickwork, with fixed glazing.

Finish	frames: painted outside, bare metal inside glass: clear
Condition	intact and sound
Integrity	high
Significance	moderate
Maintenance	keep in service, prepare and repaint at normal intervals
Rectification works	none

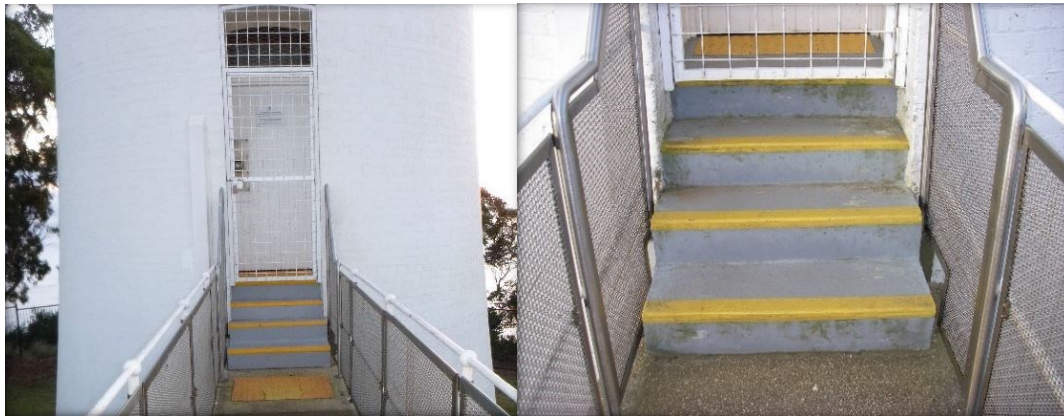
Lighthouse feature: Door

- Inner door – recent timber framed, braced and sheeted door, hung in timber door frame with fixed glass fanlight. Recent cylinder dead locking rimlock. Three recent heavy strap hinges. Stainless steel plate around keyhole.
- Outer door – welded steel grille door, with welded mesh infill, hung in welded steel frame with fixed grille above transom. Secured with pad bolt.
- Entry steps – three concrete entry steps. Steps and landing were demolished and reconstructed in 2011 as previous steps had varying height risers and were not suitable for tourist access.

Finish	Painted
Condition	Sound
Integrity	High
Significance	High
Maintenance	Keep in service, prepare and repaint at normal intervals
Rectification works	None

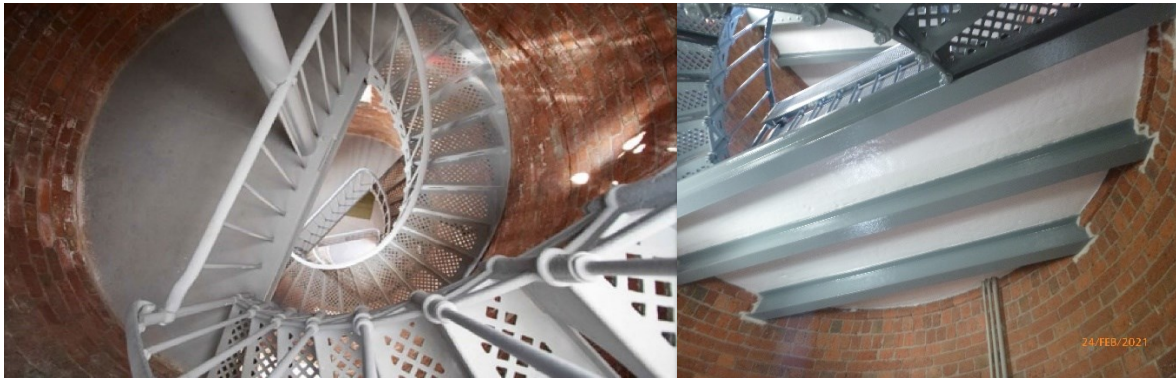
Lighthouse feature: Intermediate floors

Finish	Painted
Condition	Intact and sound
Integrity	High
Significance	High
Maintenance	Keep in service, prepare and repaint at normal intervals
Rectification works	None

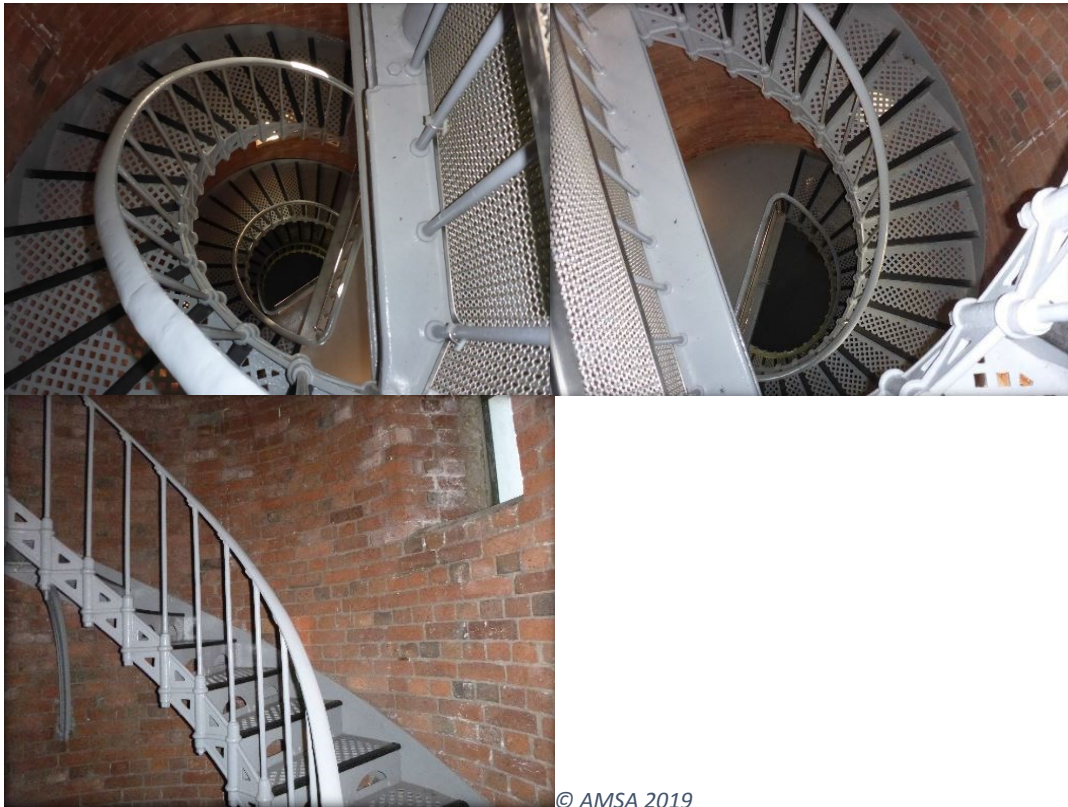
Lighthouse feature: Stairs

1888 geometric stair with cast iron treads/risers attached to curved iron plate fixed to the tower wall, and wrought iron handrail and stanchions. Curved iron supported set into the tower walls support each flight at mid span.

Finish	Painted
Condition	intact and sound
Integrity	high
Significance	high
Maintenance	keep in service, prepare and repaint at normal intervals
Rectification works	none

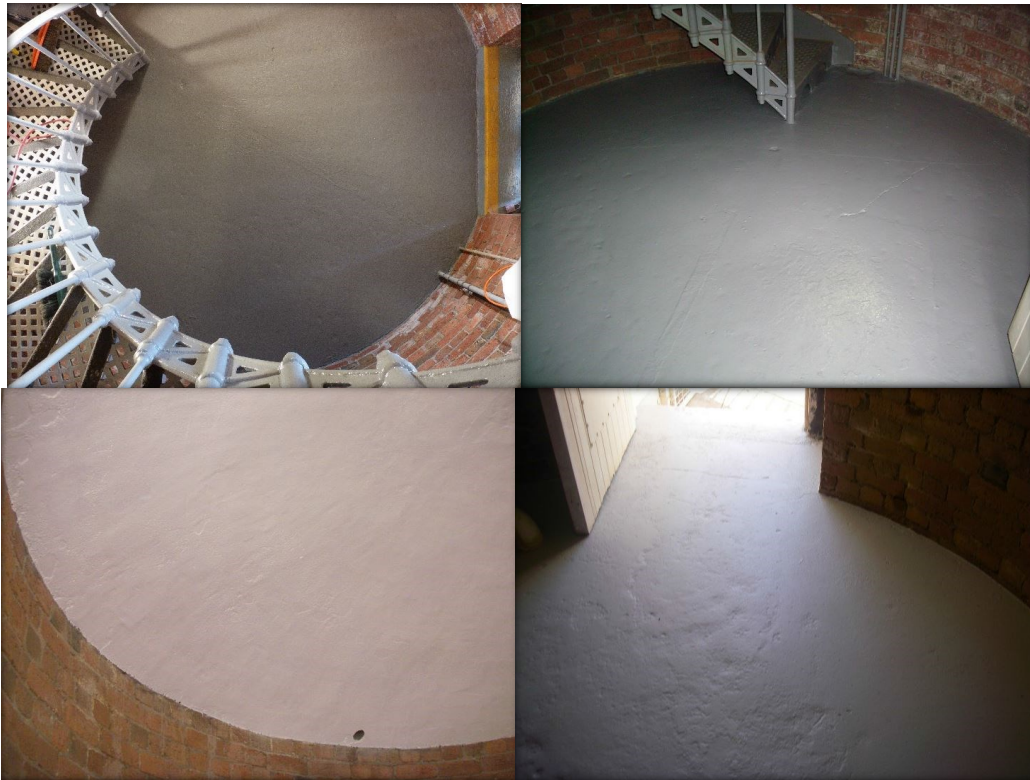
Lighthouse feature: Ground floor

Finish	bare concrete
Condition	intact and sound
Integrity	high
Significance	high
Maintenance	keep in service, clean at normal intervals
Rectification works	none

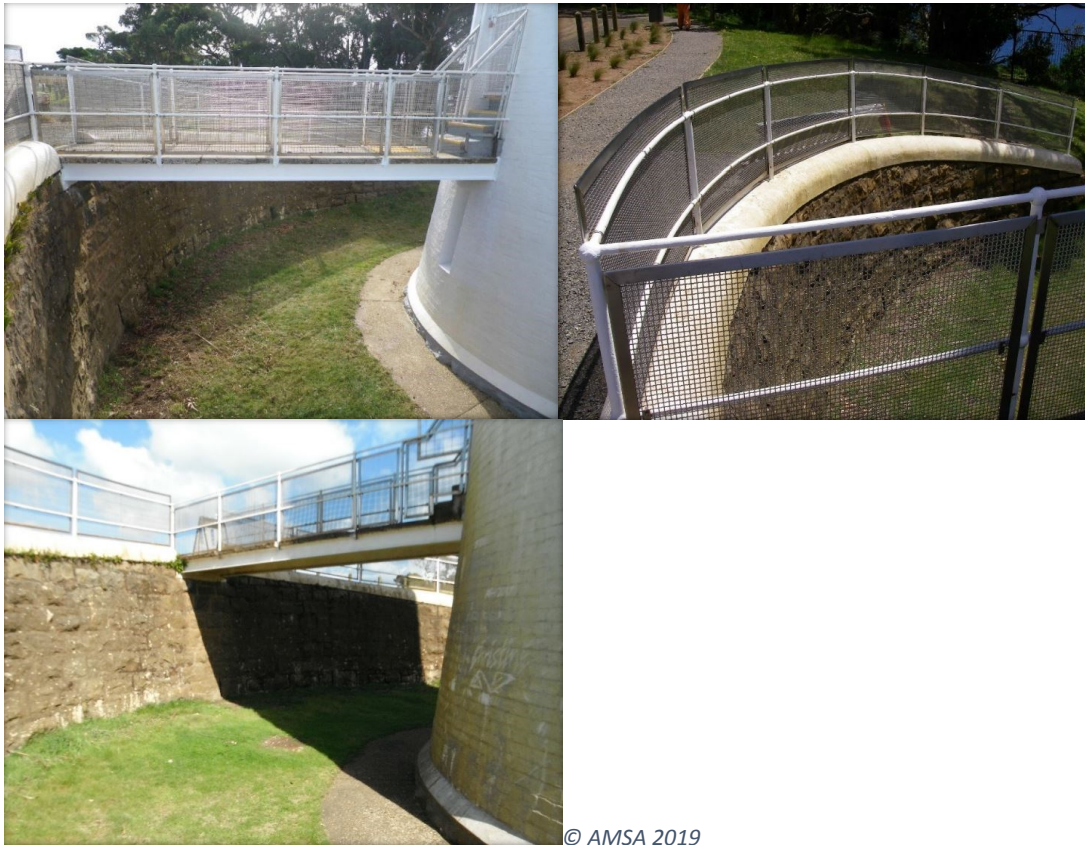
Lighthouse feature: Retaining wall

1888 semi-circular wall of rock-faced stone. Rendered and painted coping course. Balustrade of iron pipe rails and stanchions, painted. Recent stainless steel mesh and frame
