Gabo Island Lighthouse

Heritage Management Plan

Heritage Management Plan 2023

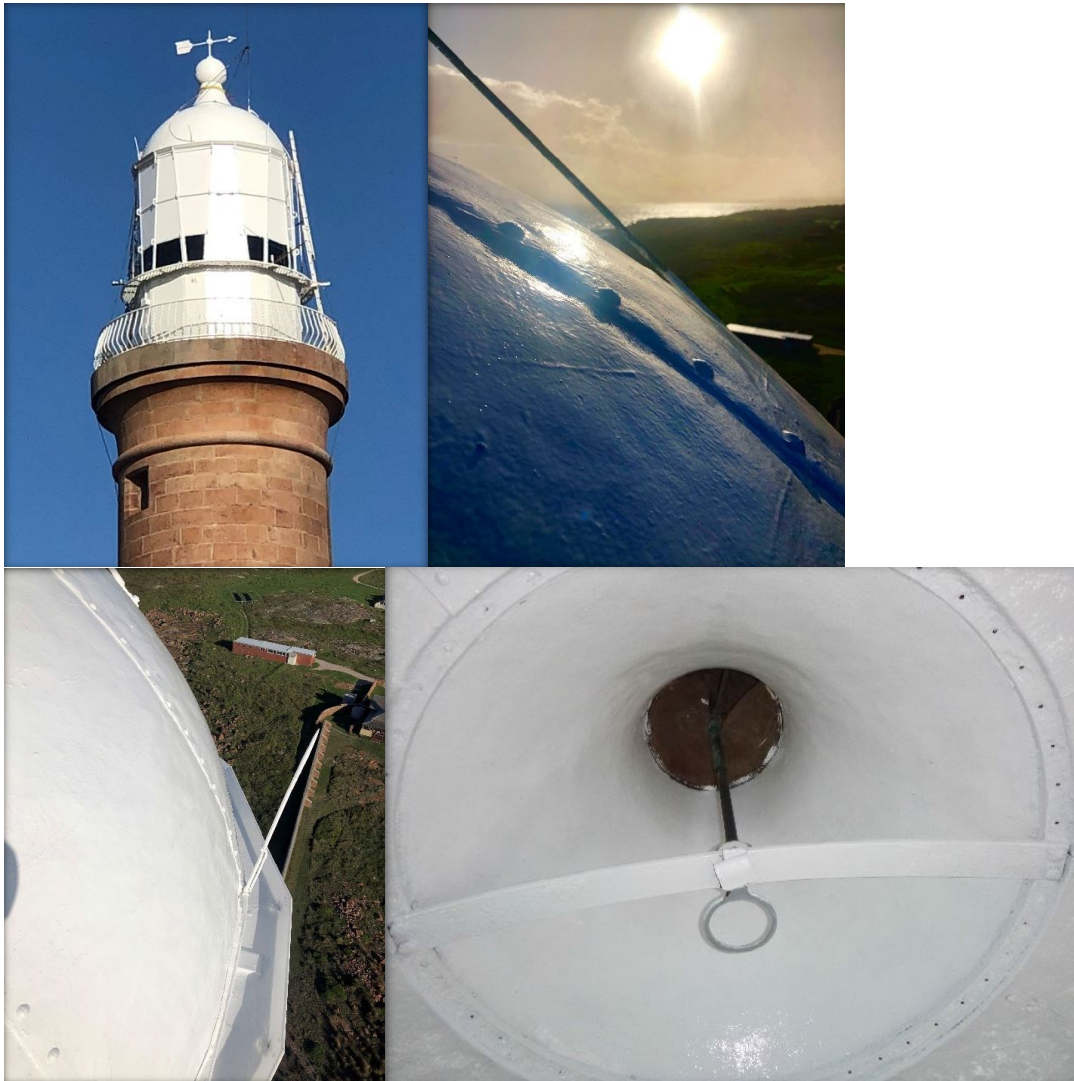
Lighthouse feature: Lantern roof

Finish	painted
Condition	intact and sound
Significance	high
Integrity	high
Maintenance	keep in service, prepare and repaint at normal intervals
Rectification works	none

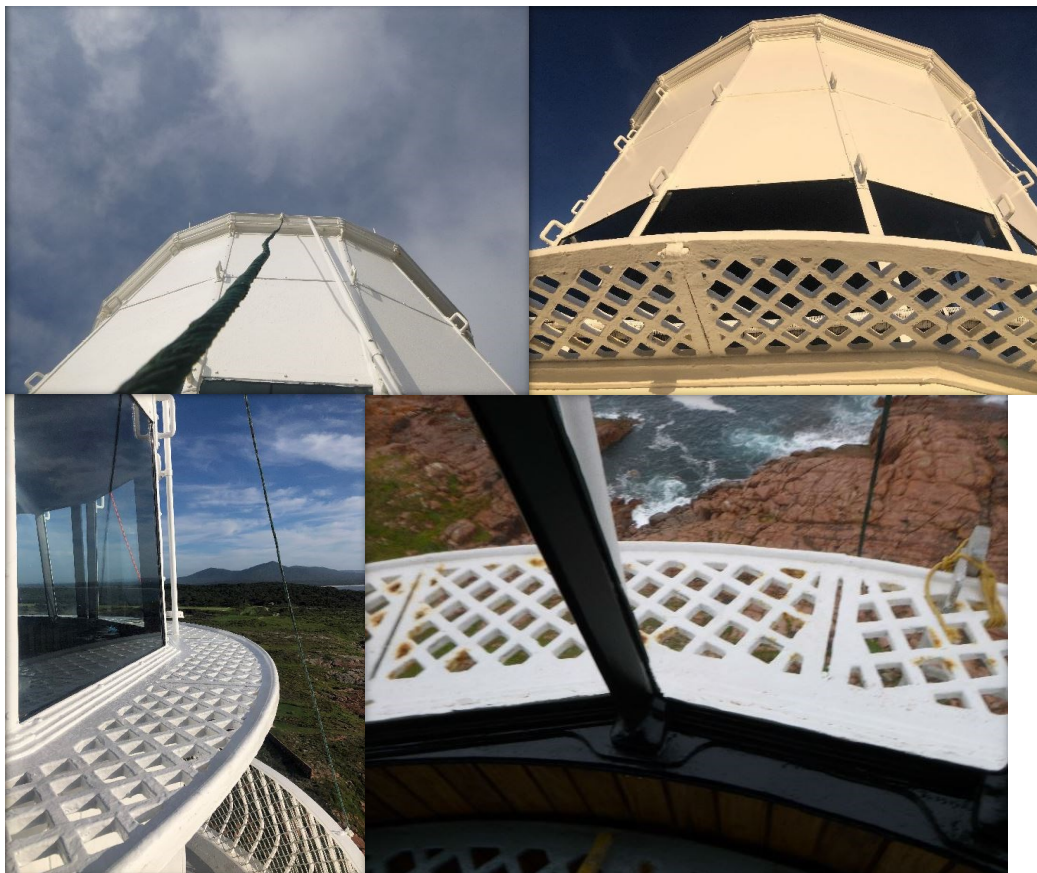
Lighthouse feature: Lantern glazing

Finish	astragals and glazing strips: painted
Condition	intact and sound
Significance	high
Integrity	high
Maintenance	keep in service, reglaze as necessary, prepare and repaint at normal intervals
Rectification works	none

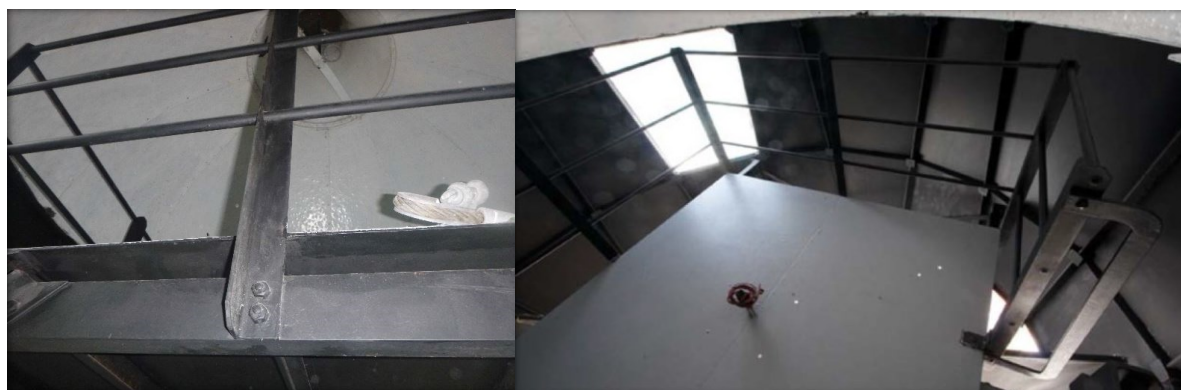
Lighthouse feature: Auxiliary light platform

Finish	painted
Condition	intact and sound
Significance	moderate

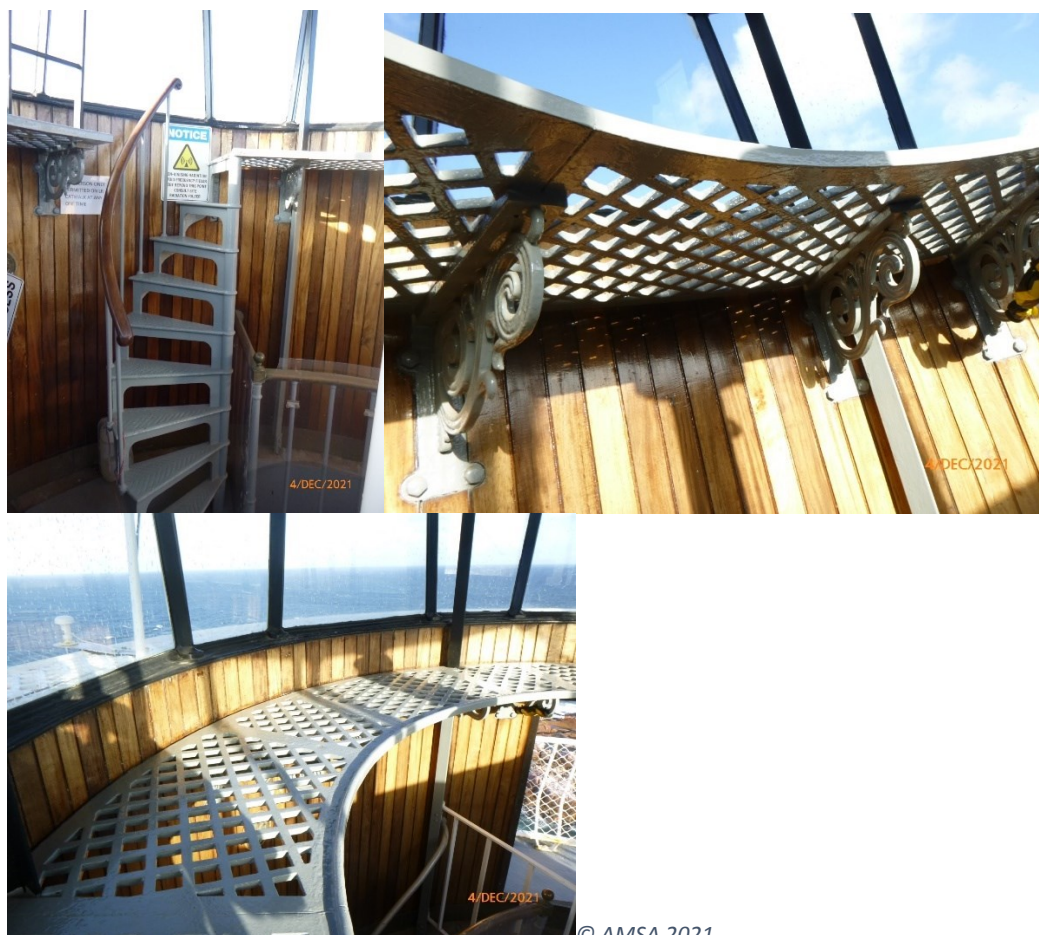
Lighthouse feature: Internal catwalk

Finish	ladder handrail: varnished other parts: painted
Condition	sound
Significance	high
Integrity	high
Maintenance	keep in service, prepare and repaint at normal intervals
Rectification works	none

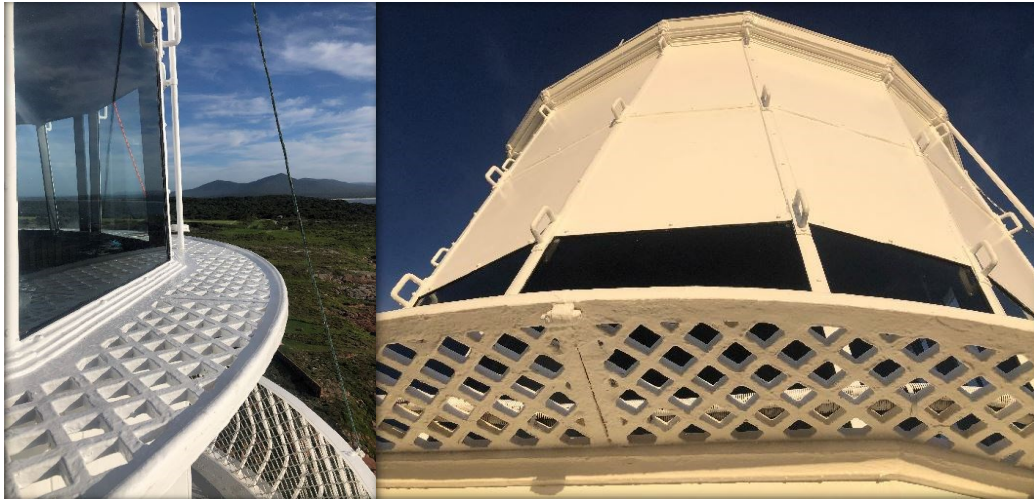
Lighthouse feature: External catwalk

Finish	Painted
Condition	Intact and sound
Significance	High
Integrity	High
Maintenance	Keep in service, prepare and repaint at normal intervals
Rectification works	None

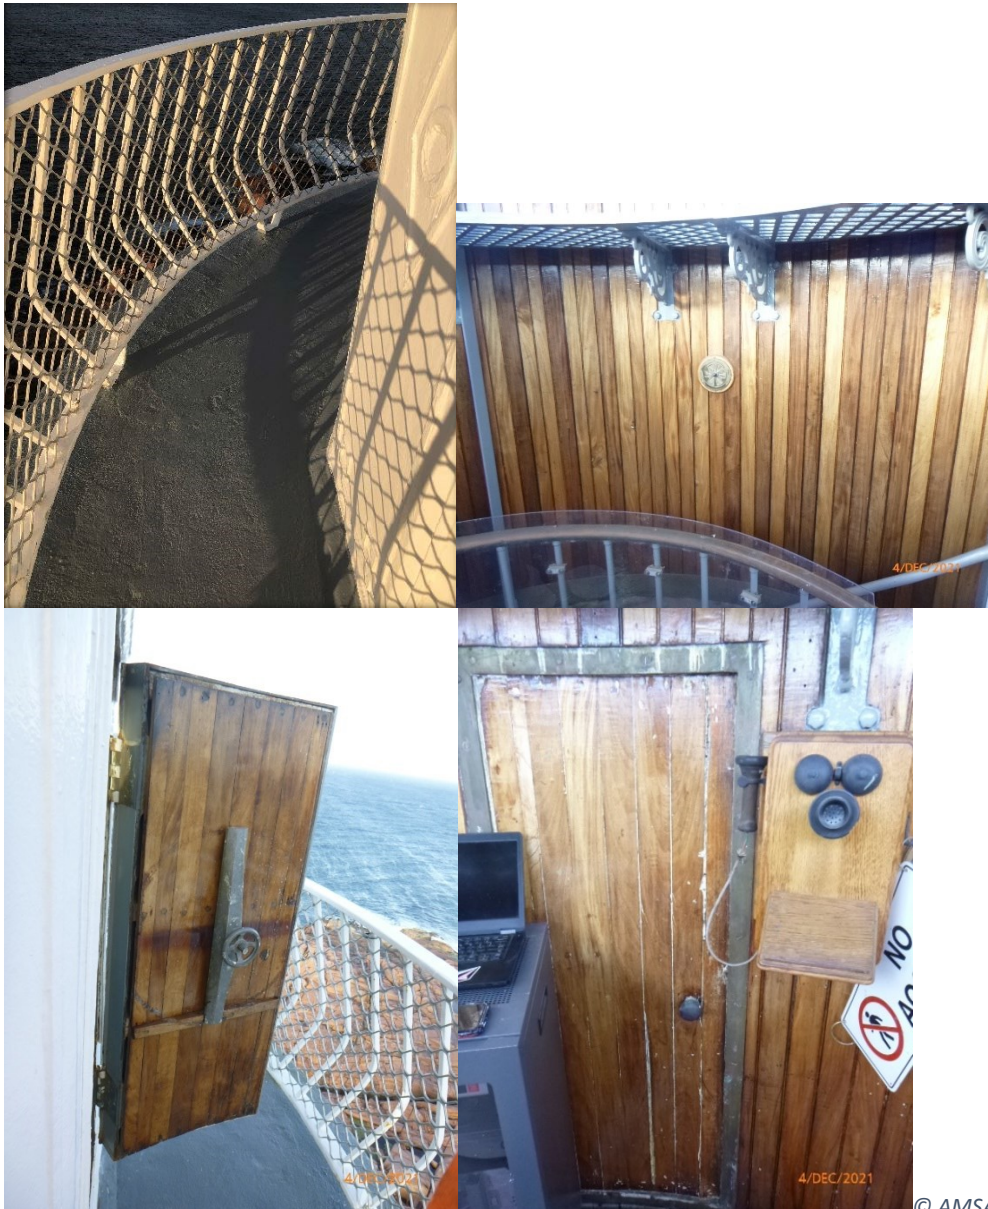
Lighthouse feature: Lantern base

Finish	internal timber lining: varnished other parts: painted
Condition	intact and sound
Significance	high
Integrity	high
Maintenance	keep in service, prepare and repaint at normal intervals
Rectification works	none

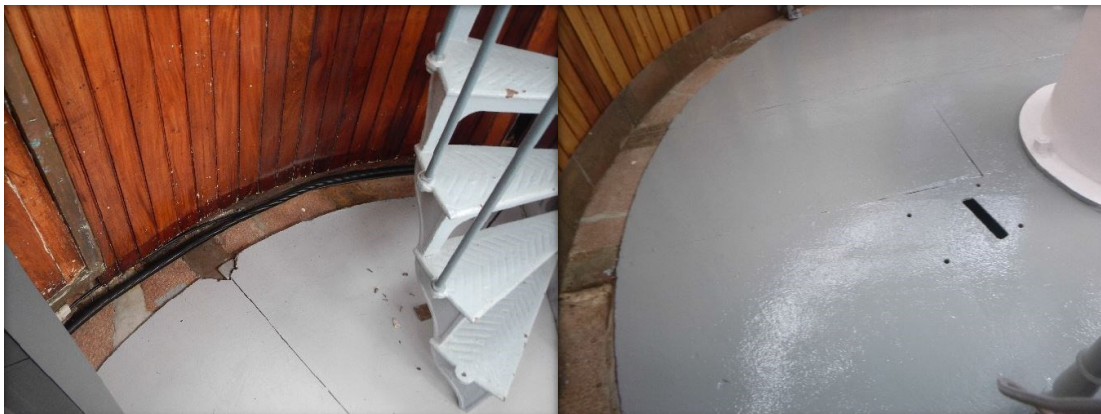
Lighthouse feature: Lantern floor

Finish	painted
Condition	intact and sound
Significance	high
Integrity	high
Maintenance	keep in service, prepare and repaint at normal intervals
Rectification works	none

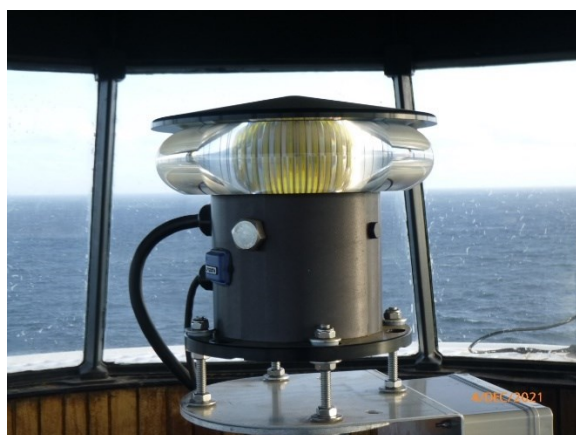
Lighthouse feature: Beacon

Condition	intact and sound
Significance	low
Integrity	high
Maintenance	keep in service
Rectification works	none

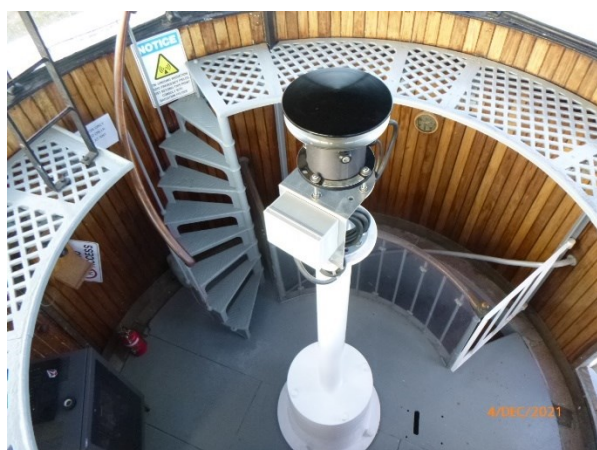
Lighthouse feature: Pedestal

Condition	intact and sound
Significance	moderate
Integrity	medium
Maintenance	keep in service, prepare and repaint pedestal at normal intervals
Rectification works	none

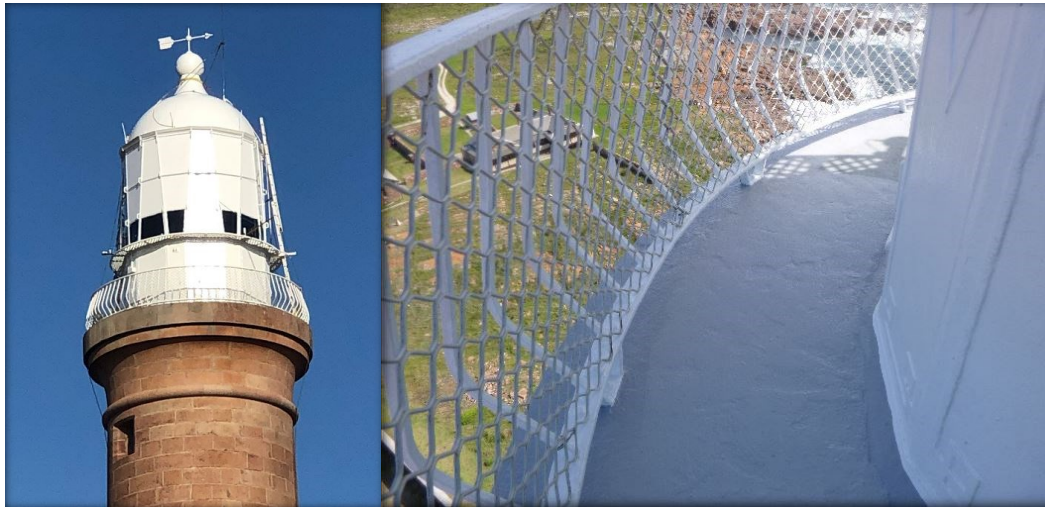
Lighthouse feature: Balcony floor

Finish	Painted
Condition	Intact and sound
Significance	Balcony floor: high Racon: low
Integrity	High
Maintenance	Keep in service, maintenance joint seals, prepare and repaint at normal intervals
Rectification works	None

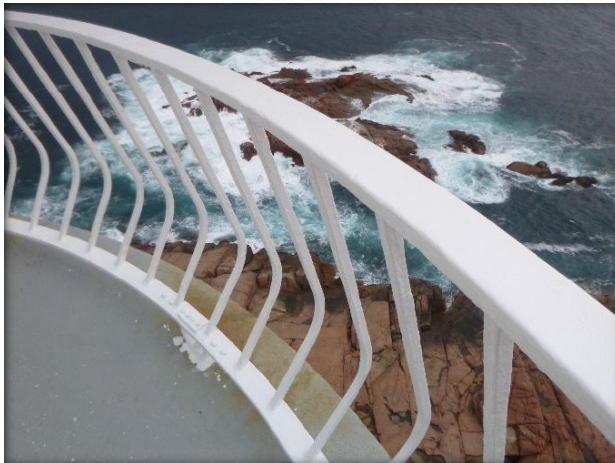
Lighthouse feature: Balcony balustrade

Finish	aluminium mesh: bare anodised other parts: painted
Condition	intact and sound
Significance	moderate
Integrity	high
Maintenance	keep in service, prepare and repaint at normal intervals
Rectification works	none

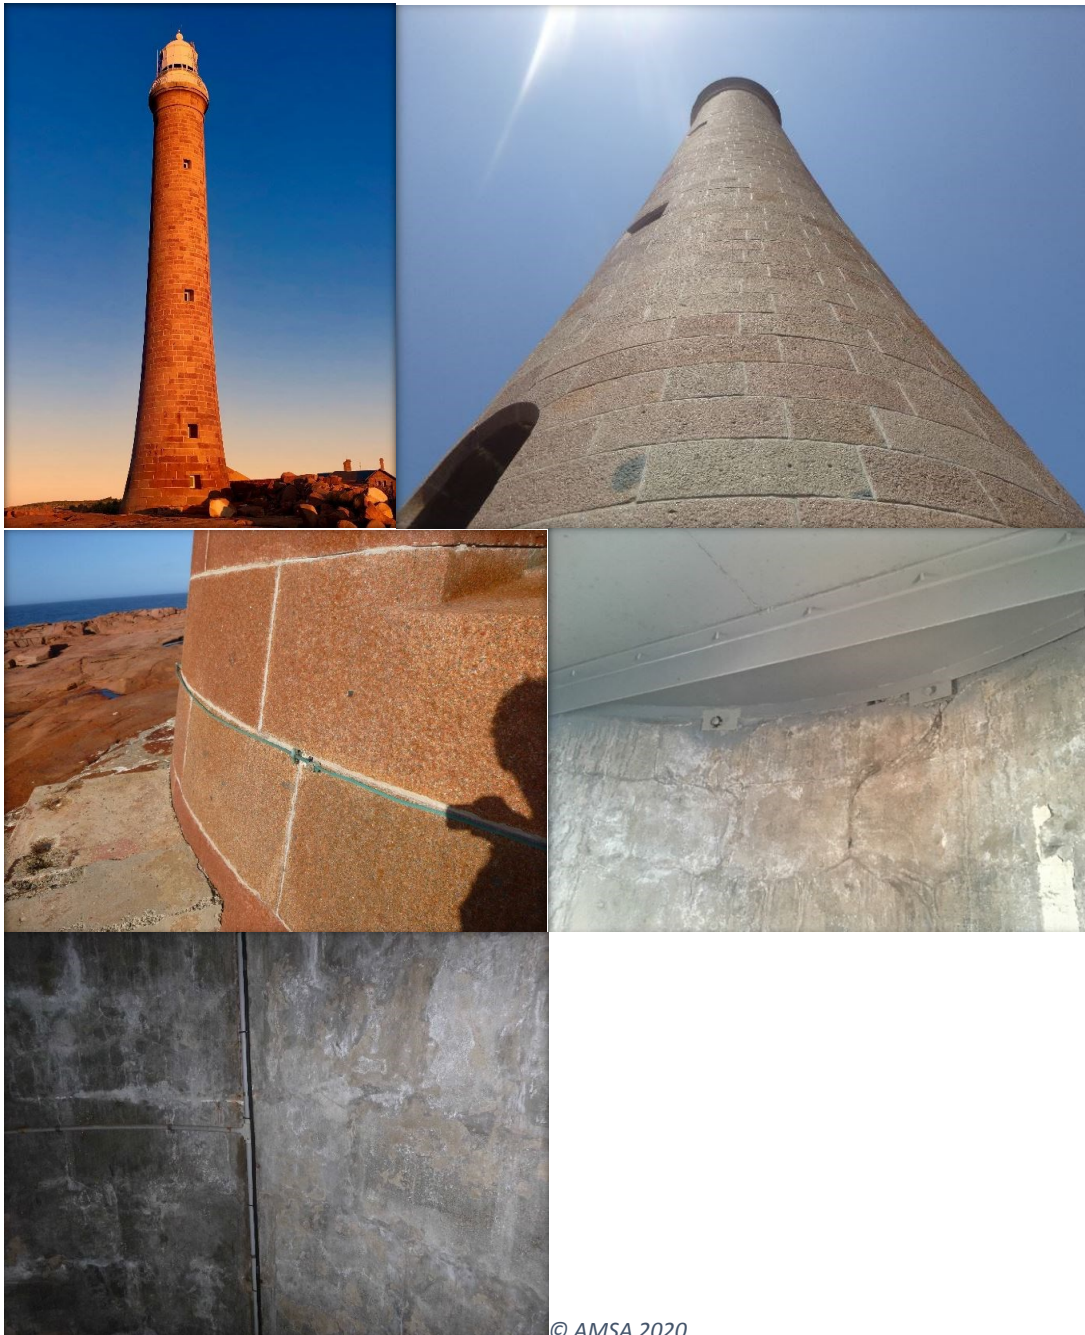
Lighthouse feature: Walls

Finish	exterior surface: bare stone interior surface: cement rendered and unpainted
Condition	intact and sound
Significance	high
Integrity	high
Maintenance	keep in service, monitor condition of pointing and stonework
Rectification works	none

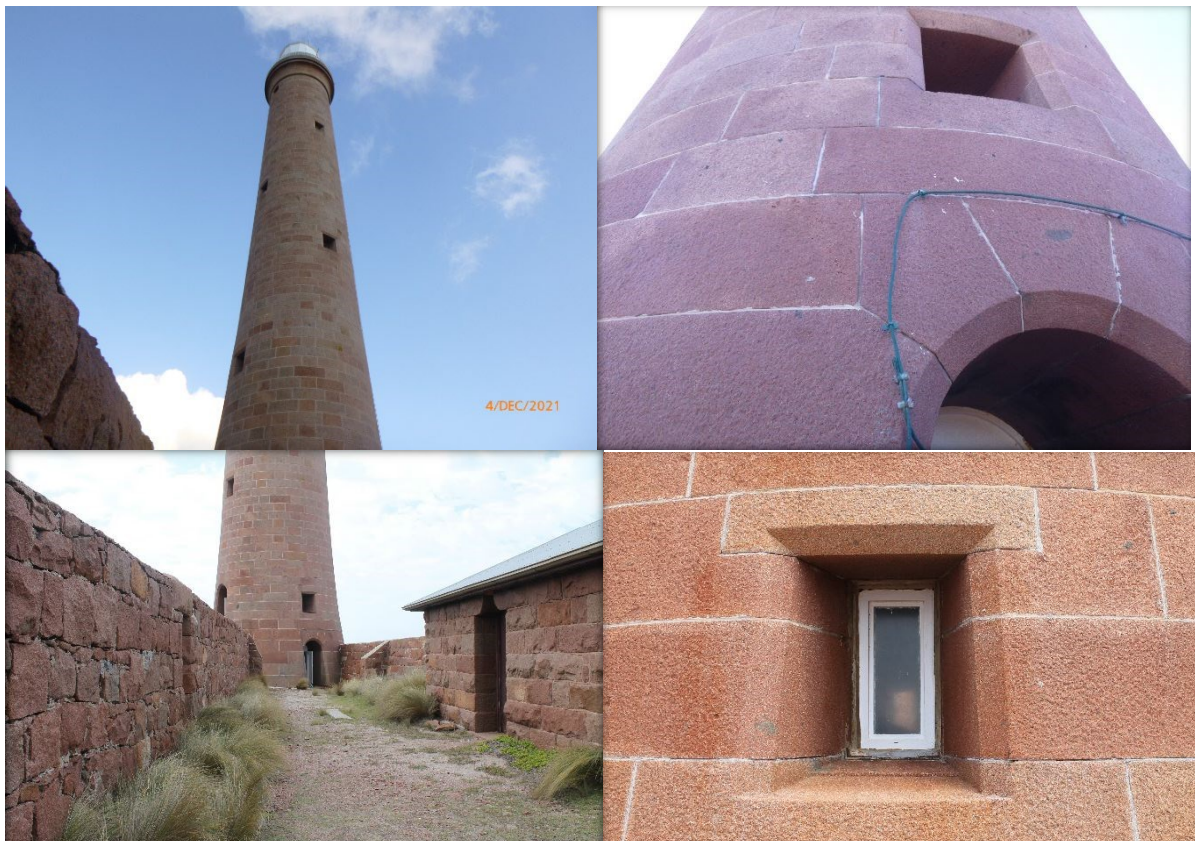
Lighthouse feature: Windows

Finish	frames and sashes: painted glass: clear
Condition	intact and sound
Significance	high
Integrity	high
Maintenance	keep in service, prepare and repaint at normal intervals
Rectification works	none

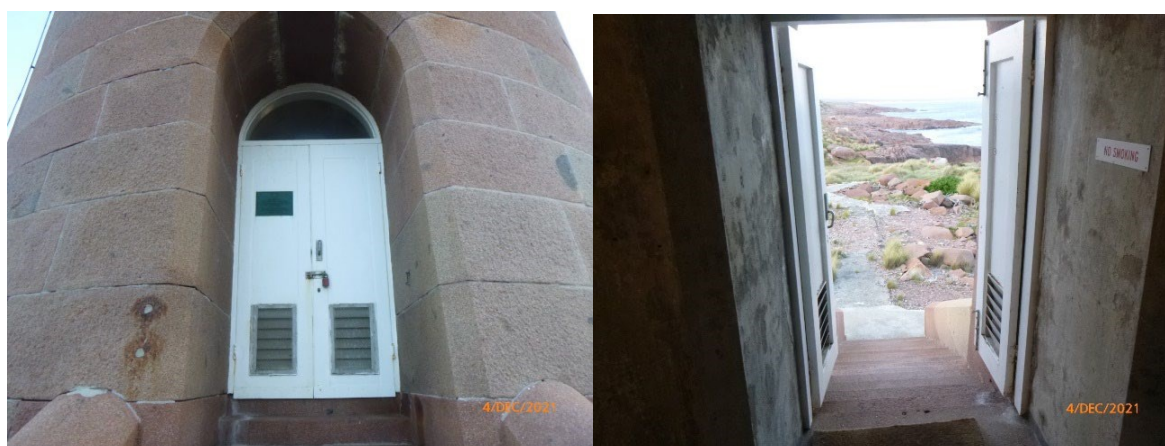
Lighthouse feature: Door

Finish	painted
Condition	intact and sound
Significance	moderate
Integrity	high
Maintenance	keep in service, prepare and repaint at normal intervals
Rectification works	none

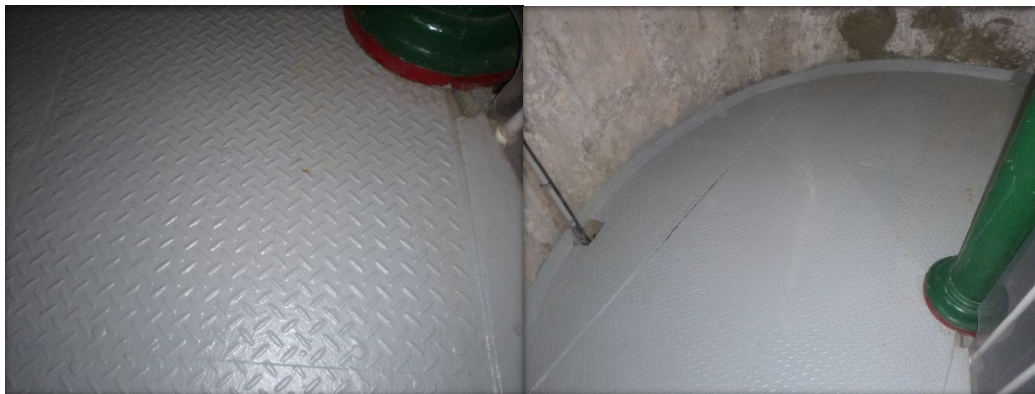
Lighthouse feature: Intermediate floors

Finish	Painted
Condition	one of the upper landings has a crack across near the stair other locations: some corrosion along wall with some gaps otherwise intact and sound
Significance	high
Integrity	high
Maintenance	keep in service, prepare and repaint at normal intervals
Rectification works	Investigate and perform repair to stabilize cracked landing

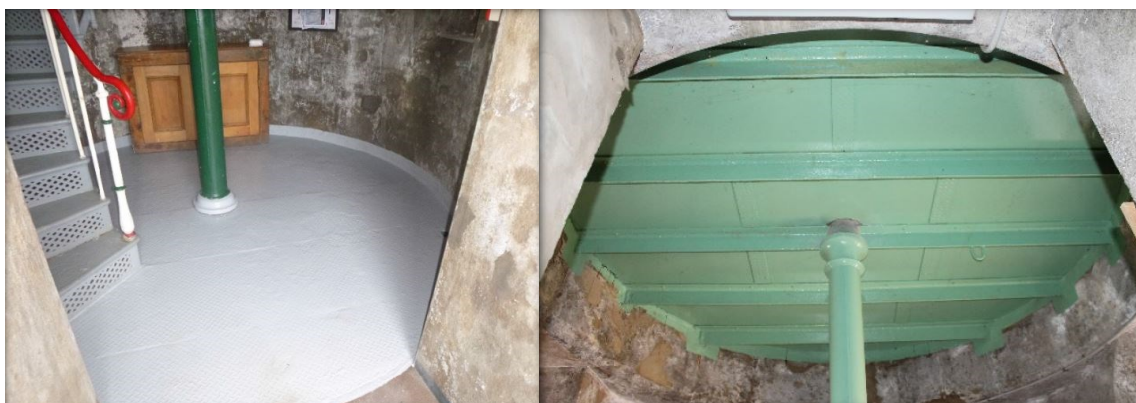
Lighthouse feature: Upper entrance floor

Finish	Painted
Condition	Intact and sound
Significance	High
Integrity	High
Maintenance	Keep in service, prepare and repaint at normal intervals
Rectification works	None

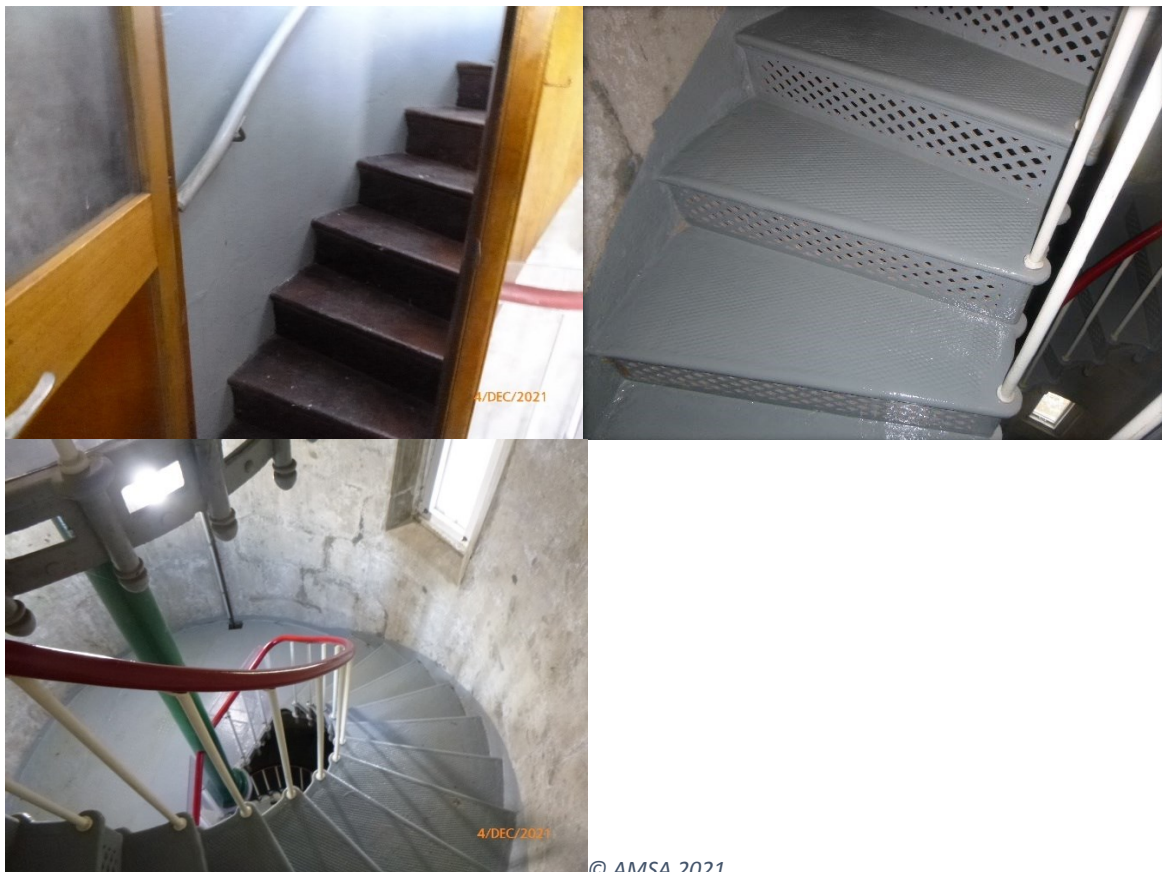
Lighthouse feature: Stairs

1978-1988 reconstruction of 1862 geometric stair with cast iron treads and risers bolted to the tower wall, with original handrails. Each flight is broken in the middle by a short landing carried on a cast iron bracket bolted to the tower wall.

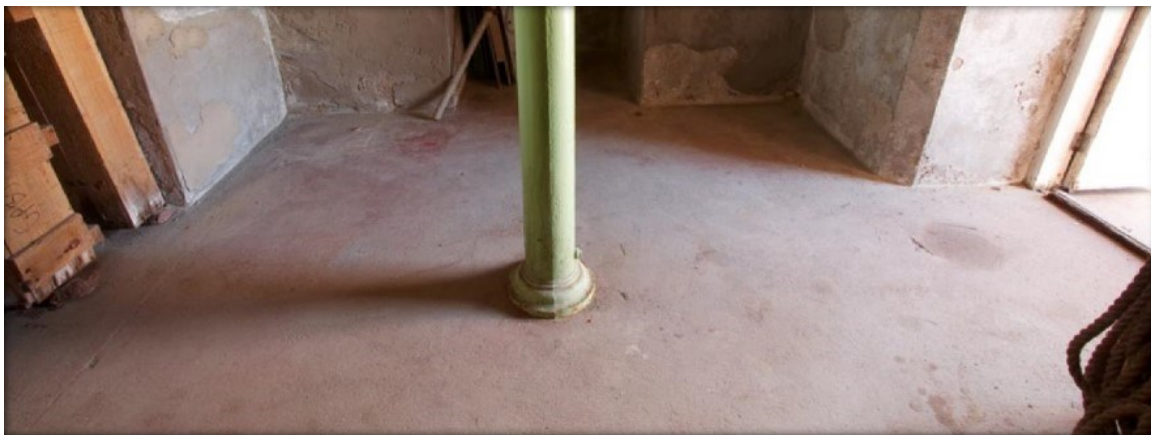
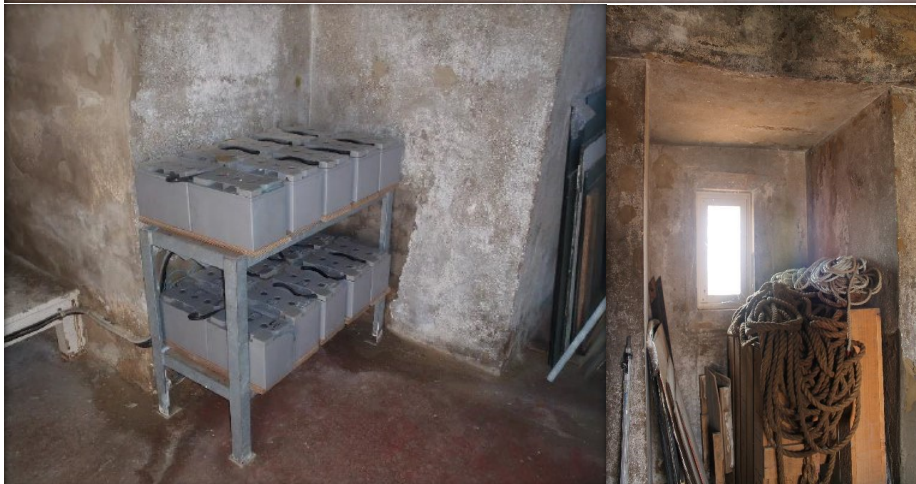
Lighthouse feature: Basement entrance floor

Finish	bare concrete
Condition	intact and sound
Significance	high
Integrity	high
Maintenance	none
Rectification works	none

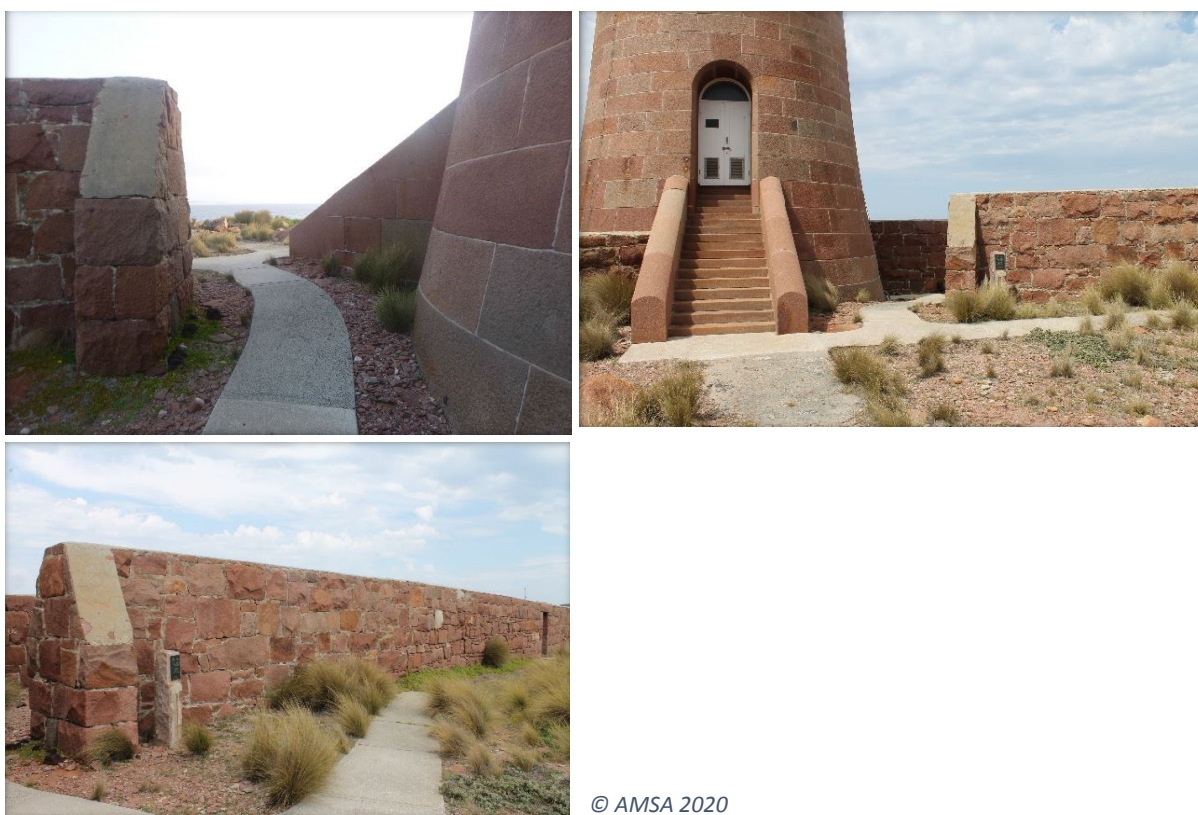
Lighthouse feature: Paths

Recent concrete path leading to the store door and the bottom of the entrance stair.
