Cape Leeuwin Lighthouse

Heritage Management Plan

2022

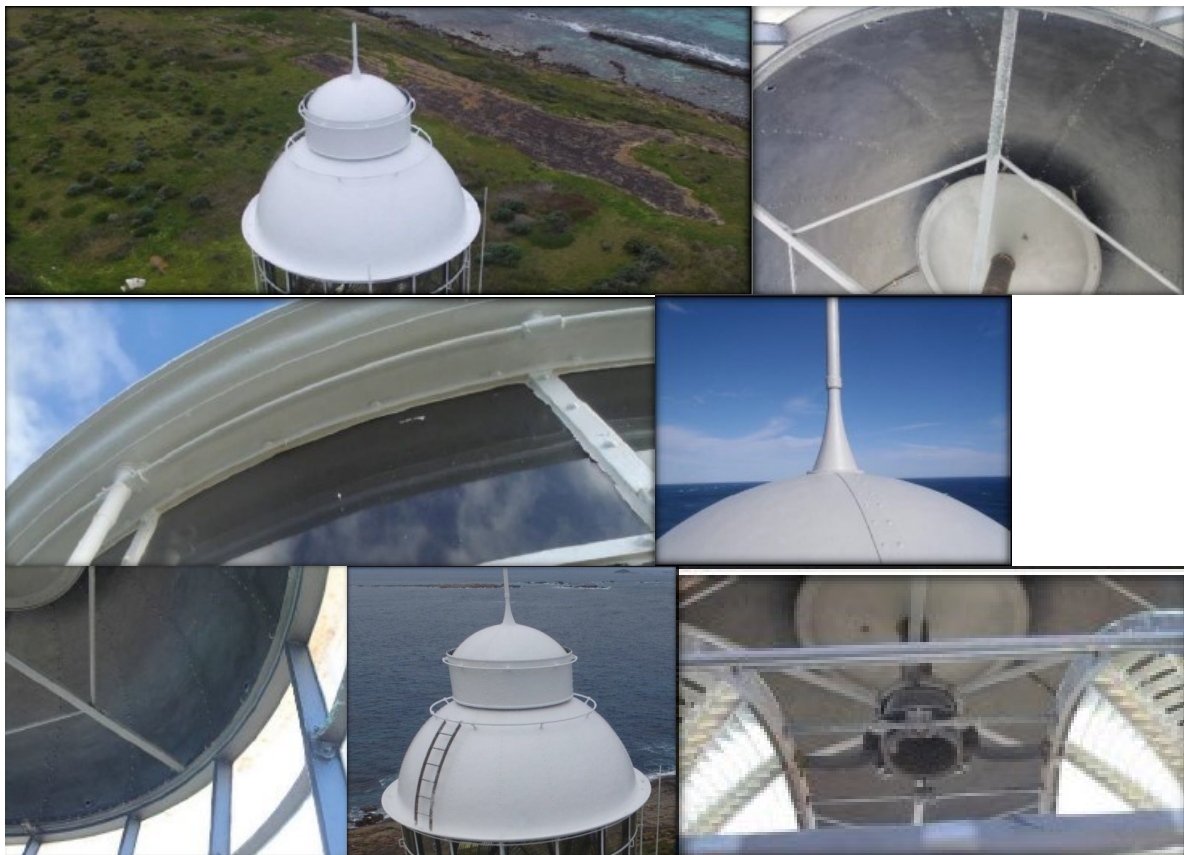
Lighthouse Feature: Lantern roof

Finish	Painted
Condition	Intact and sound
Integrity	High
Significance	High
Maintenance	Keep in service Prepare and repaint at normal intervals
Rectification works	None

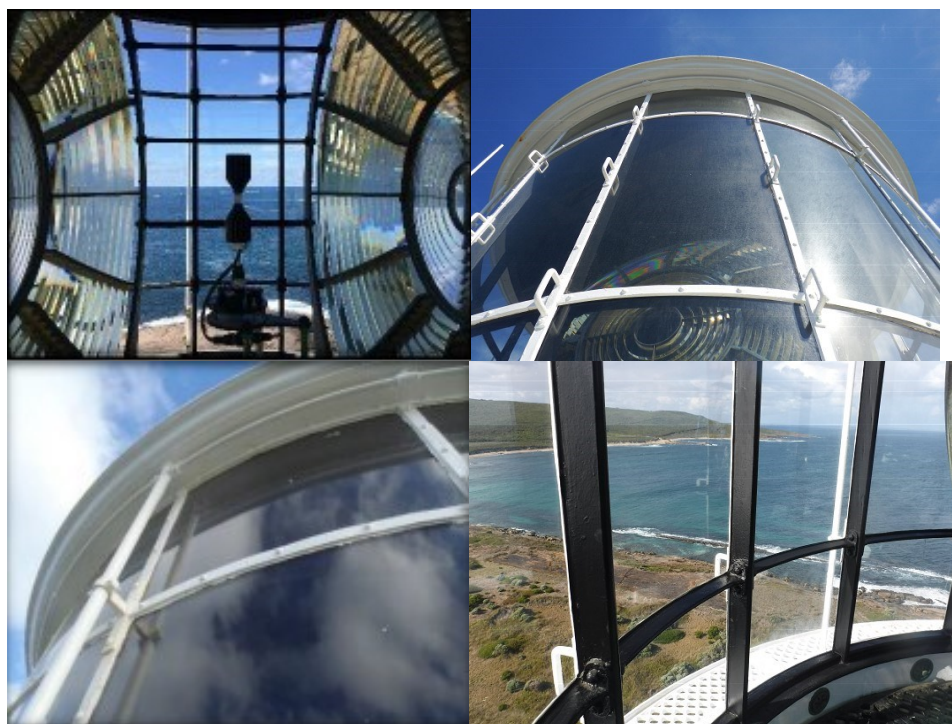
Lighthouse Feature: Lantern glazing

Finish	astragals and glazing strips painted
Condition	intact and sound
Integrity	high
Significance	high
Maintenance	keep in service, reglaze as necessary, prepare and repaint at normal intervals
Rectification works	none

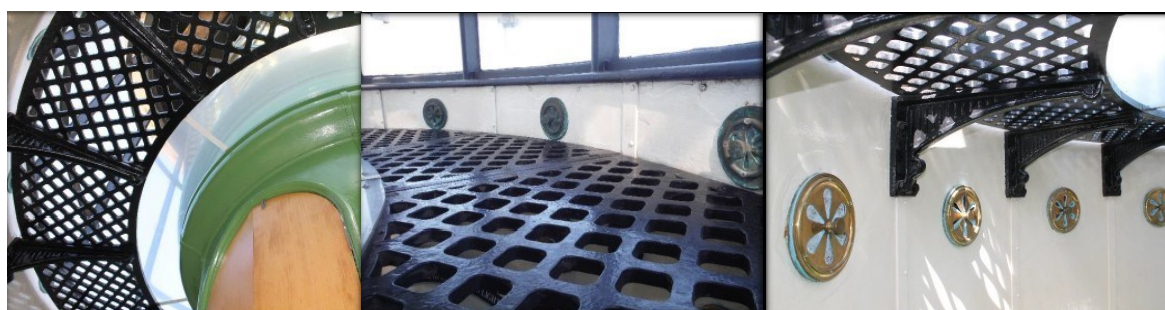
Lighthouse feature: Internal catwalk

Finish	painted
Condition	intact and sound
Integrity	high
Significance	high
Maintenance	keep in service prepare and repaint at normal intervals
Rectification works	none

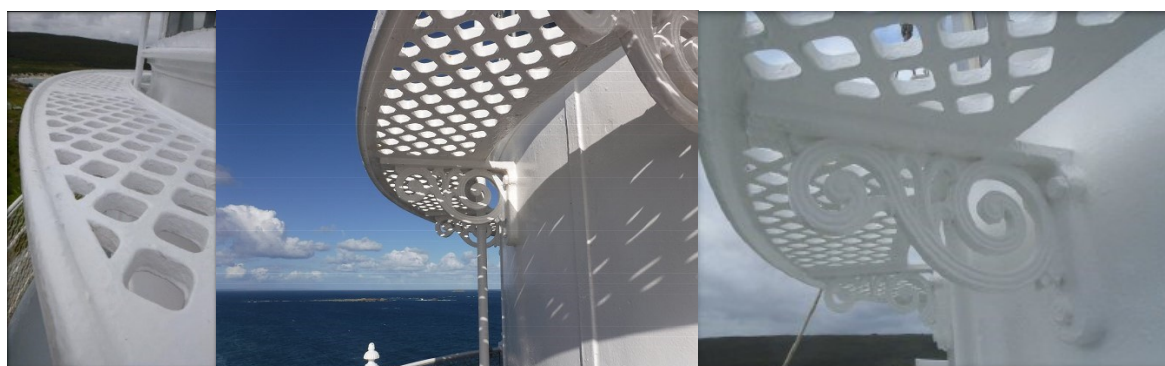
Lighthouse feature: External catwalk

Finish	Painted
Condition	intact and sound
Integrity	high
Significance	high
Maintenance	keep in service prepare and repaint at normal intervals
Rectification works	none

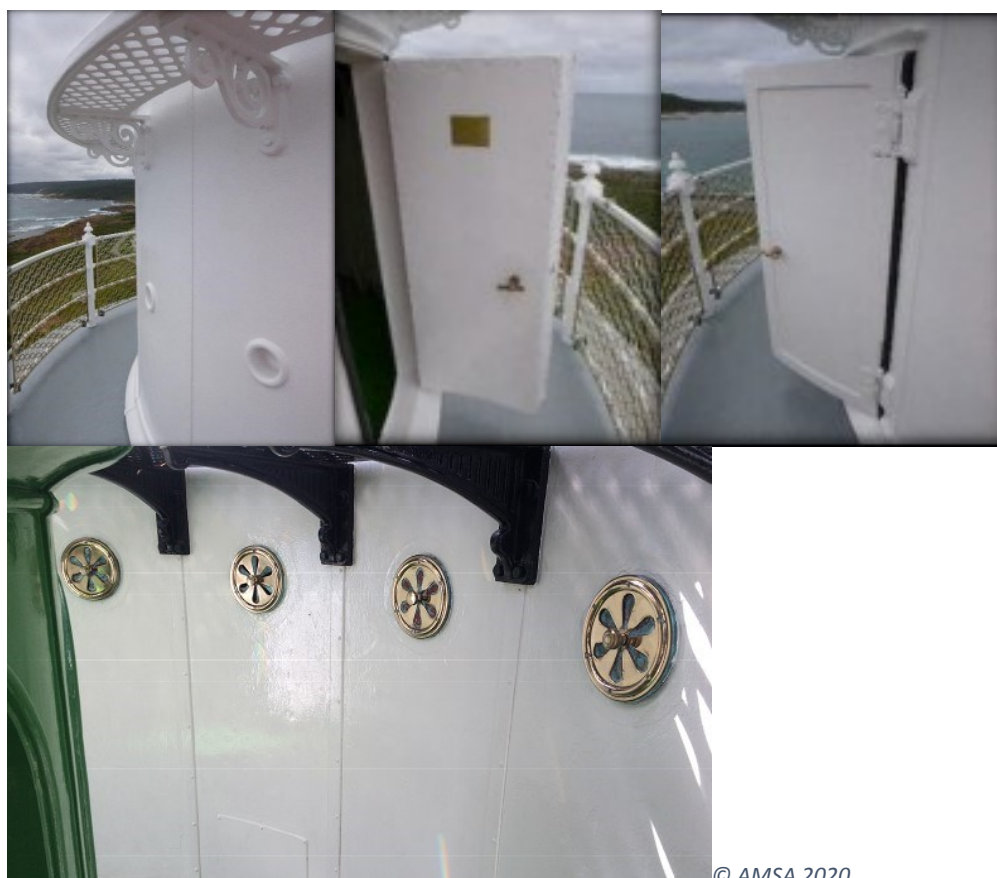
Lighthouse feature: Lantern base

Finish	painted
Condition	intact and sound
Integrity	high
Significance	high
Maintenance	keep in service prepare and repaint at normal intervals
Rectification works	none

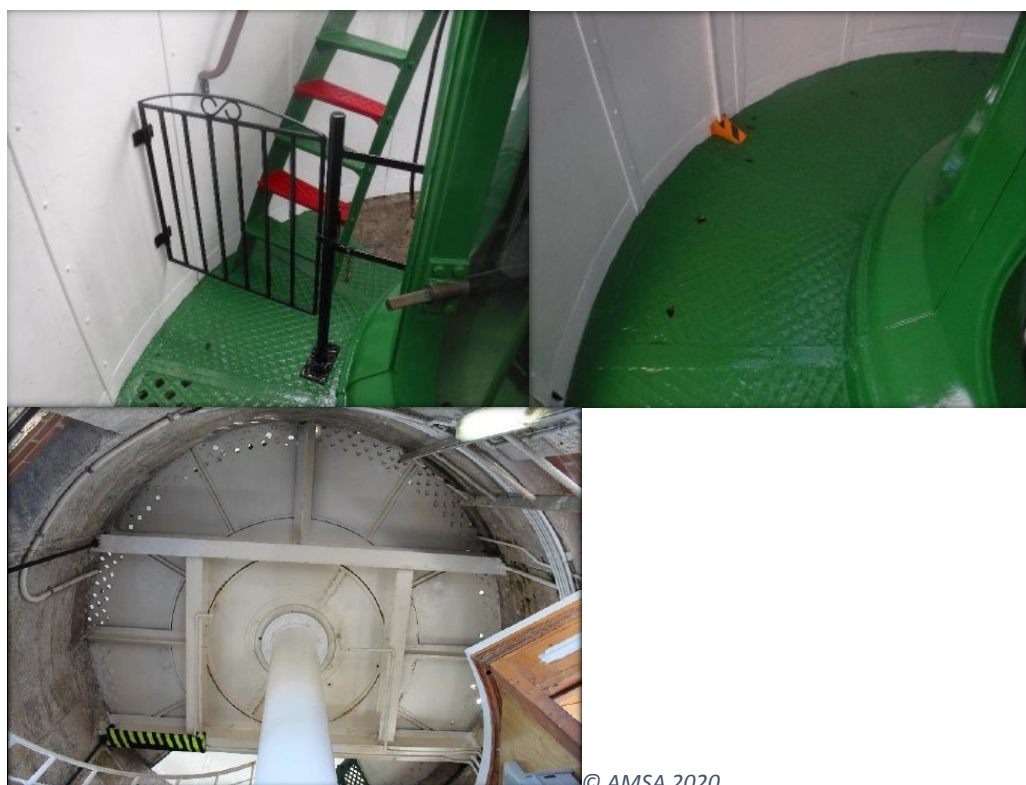
Lighthouse feature: Lantern floor

Finish	Painted
Condition	intact and sound
Integrity	high
Significance	high
Maintenance	keep in service prepare and repaint at normal intervals
Rectification works	none

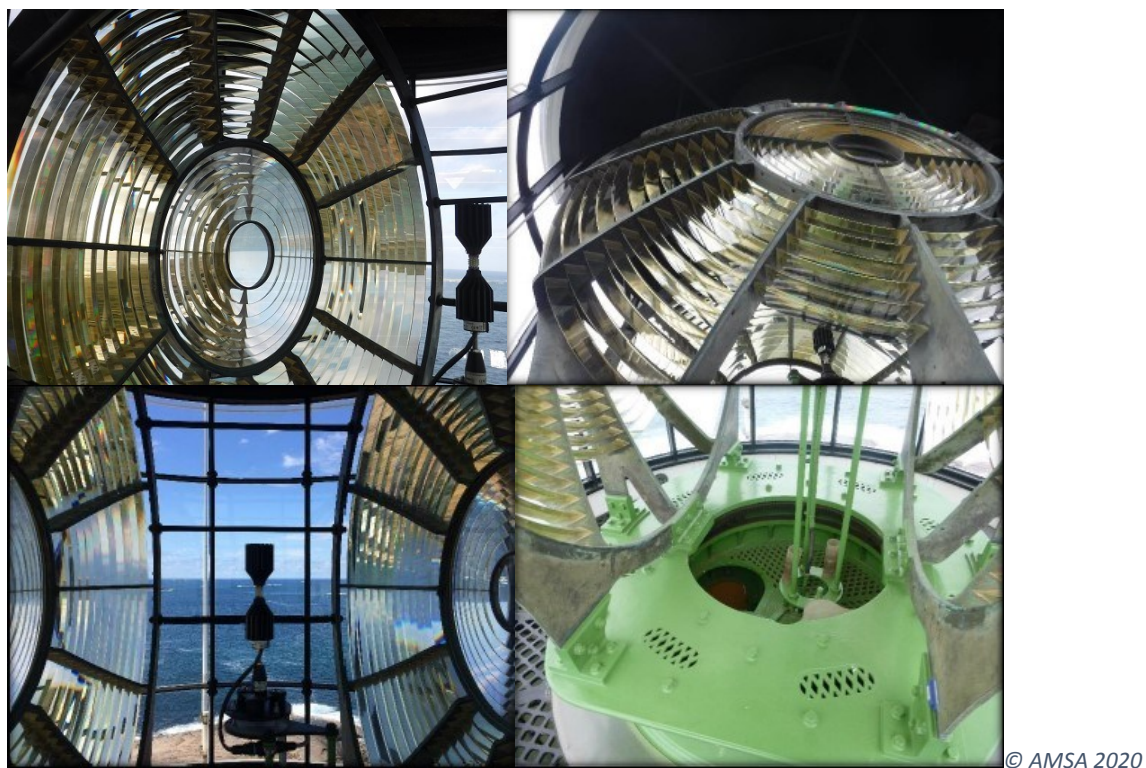
Lighthouse feature: Lens assembly

Finish	Painted
Condition	Intact and sound
Integrity	High
Significance	High
Maintenance	Keep in service Prepare and repaint at normal intervals
Rectification works	None

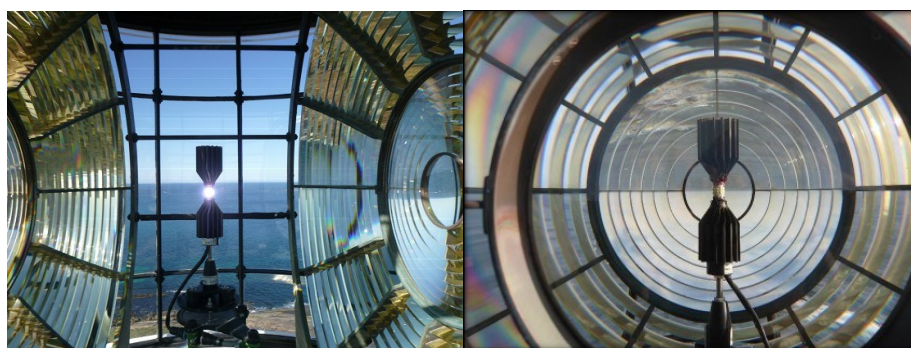
Lighthouse feature: Light source

Condition	intact and sound
Significance	low
Maintenance	keep in service
Rectification works	none

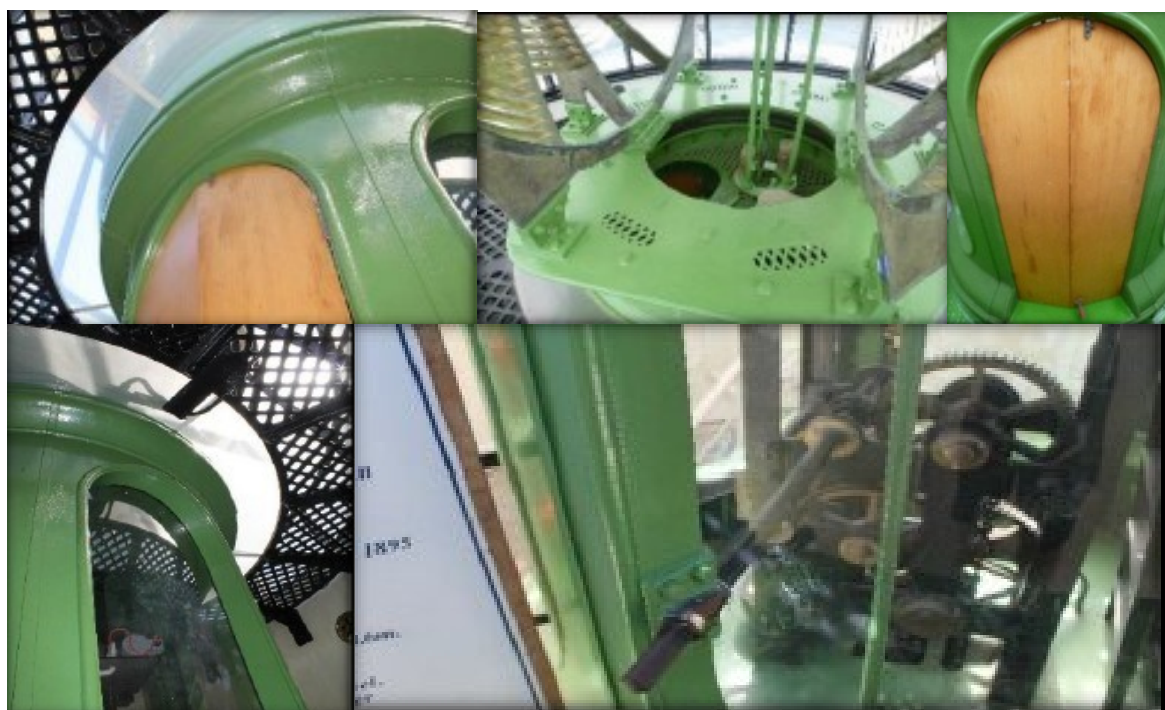
Lighthouse feature: Pedestal

Finish	Painted
Condition	intact and sound
Integrity	high
Significance	high
Maintenance	keep in service prepare and repaint at normal intervals
Rectification works	none

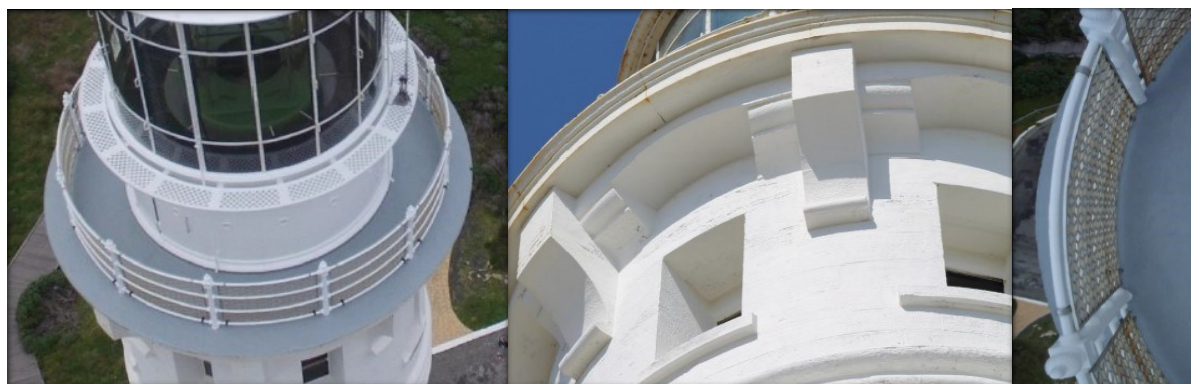
Lighthouse feature: Balcony floor

Finish	Painted with resilient grey coating
Condition	intact and sound
Integrity	high
Significance	high
Maintenance	keep in service maintain seal joints prepare and repaint at normal intervals
Rectification works	none

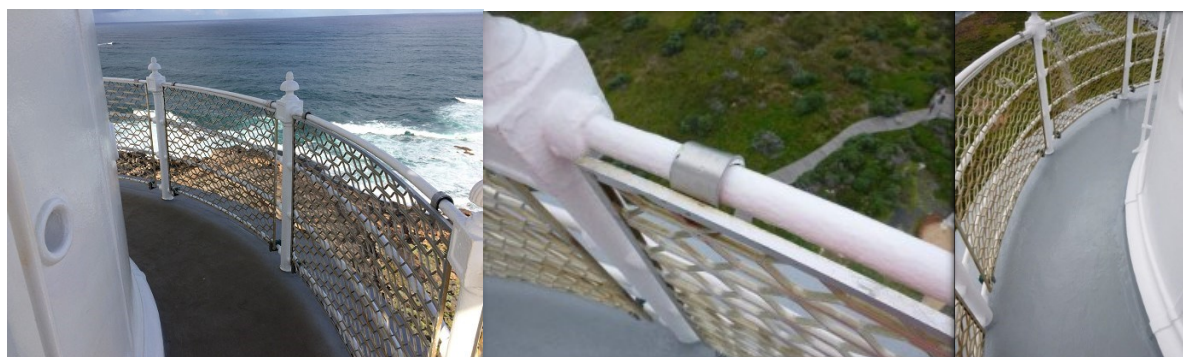
Lighthouse feature: Balcony balustrade

Finish	iron parts: painted aluminium: unpainted
Condition	intact and sound
Integrity	high
Significance	recent mesh grille: low all other fabric: high
Maintenance	keep in service prepare at normal intervals
Rectification works	none

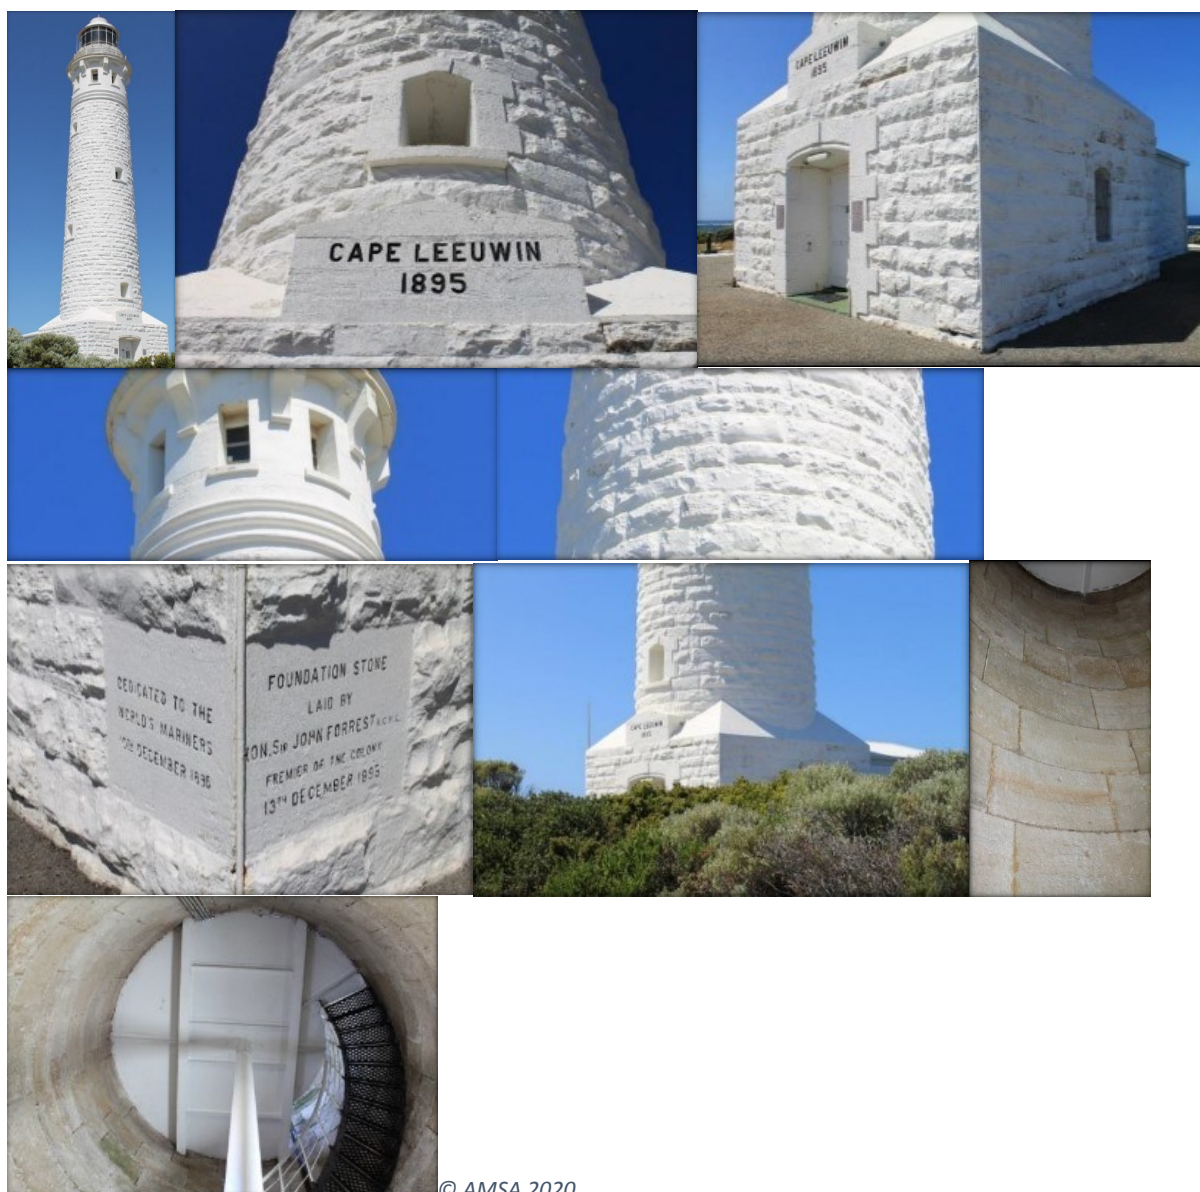
Lighthouse feature: Walls

Finish	external: painted internal: bare stone
Condition	Heavy mould on internal walls in upper part of tower, some mould on external walls, pointing deteriorating in some internal locations. Otherwise intact and sound.
Integrity	high
Significance	high
Maintenance	Keep in service, monitor condition of pointing and stonework repair pointing as required. Prepare and repaint external surfaces at regular intervals. Treat mould on internal walls
Rectification works	implement moisture controls

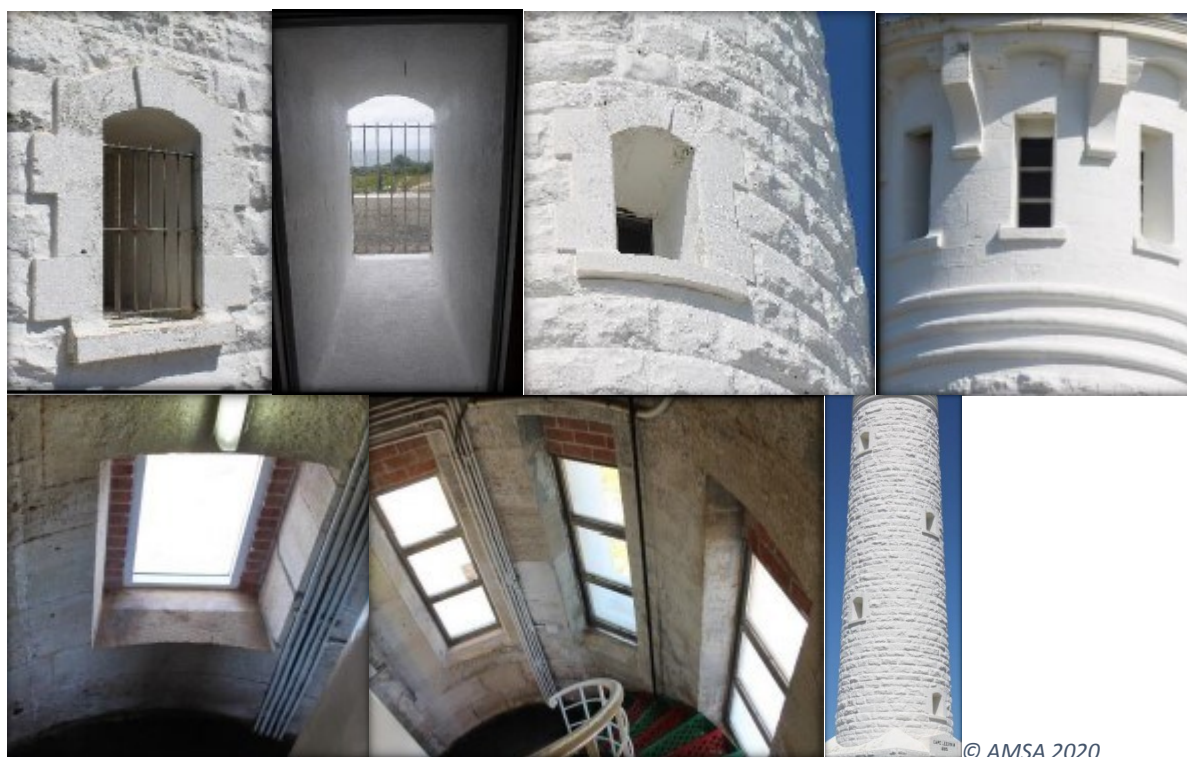
Lighthouse feature: Windows

Finish	unpainted
Condition	sound
Integrity	high
Significance	original openings: high recent stainless steel and glass: low
Maintenance	keep in service
Rectification works	none

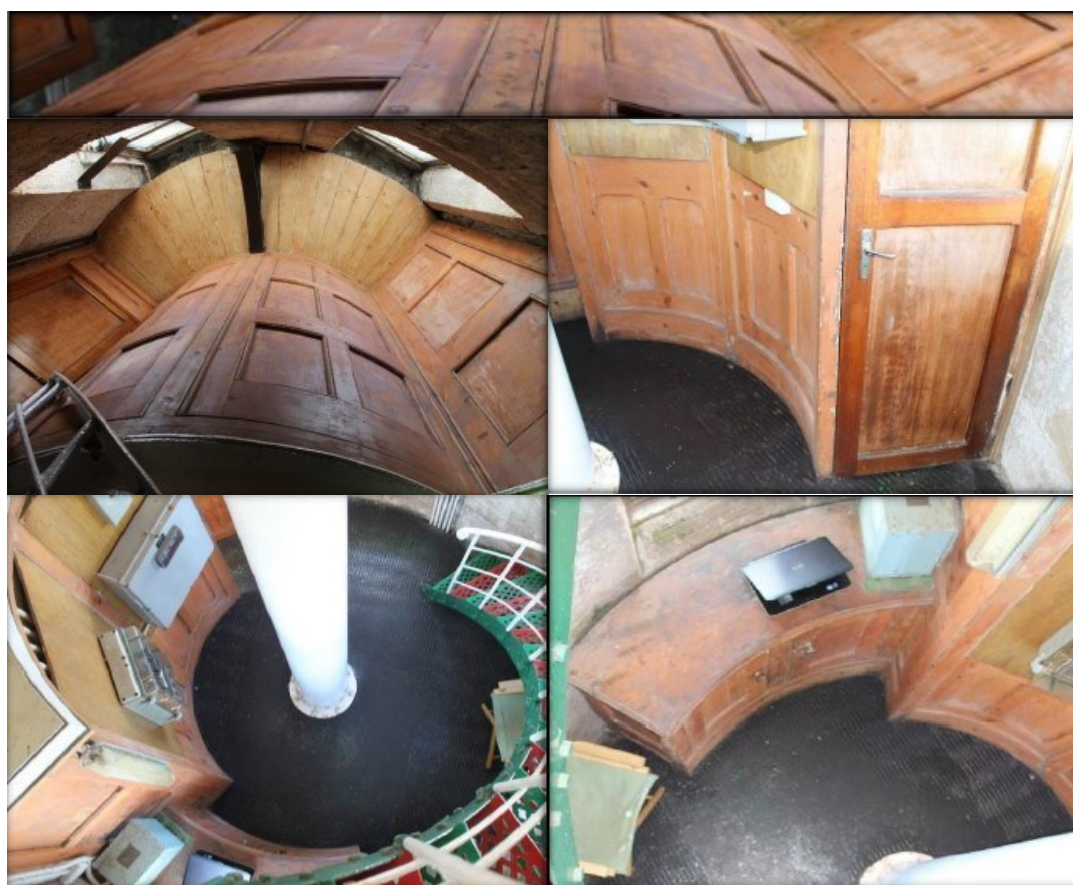
Lighthouse feature: Staircase screen and cupboard

Finish	stained/varnished
Condition	intact and sound
Integrity	high
Significance	high
Maintenance	keep in service prepare and repaint at normal intervals
Rectification works	none

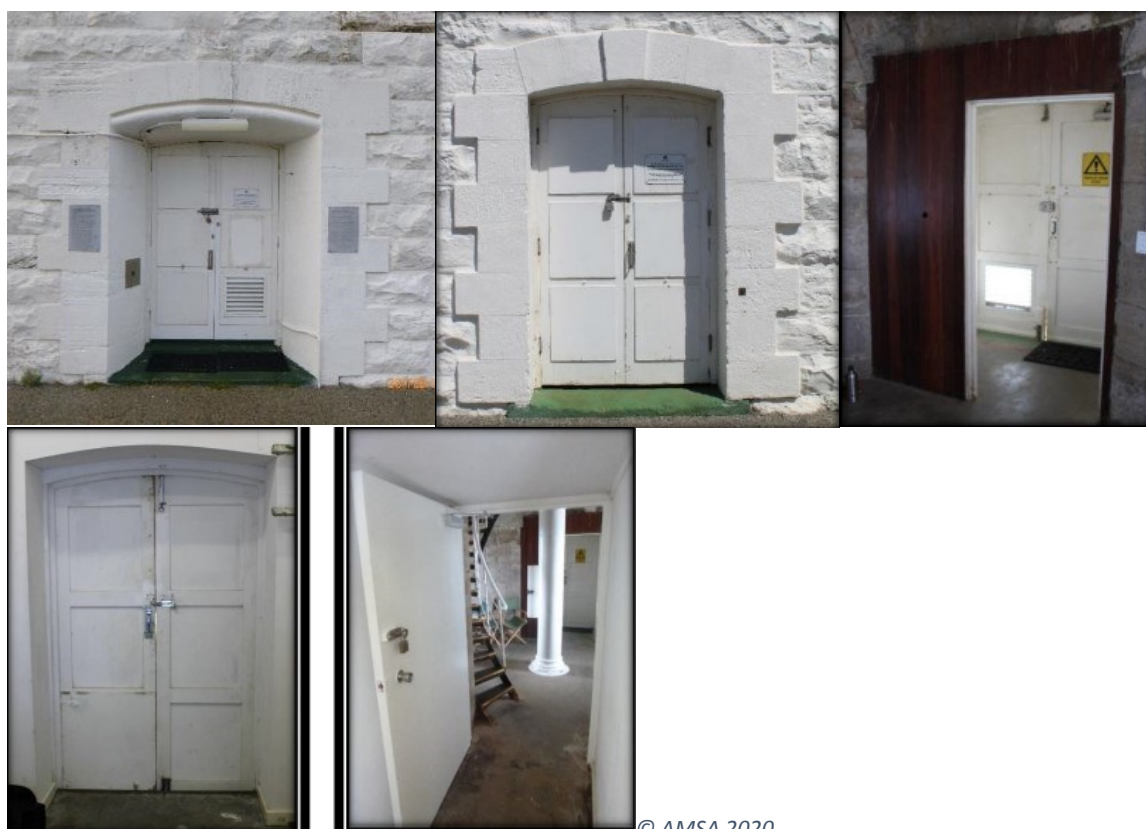
Lighthouse feature: Doors

Finish	Painted
Condition	Intact and sound
Integrity	High
Significance	High
Maintenance	Keep in service Prepare and repaint at normal intervals
Rectification works	None

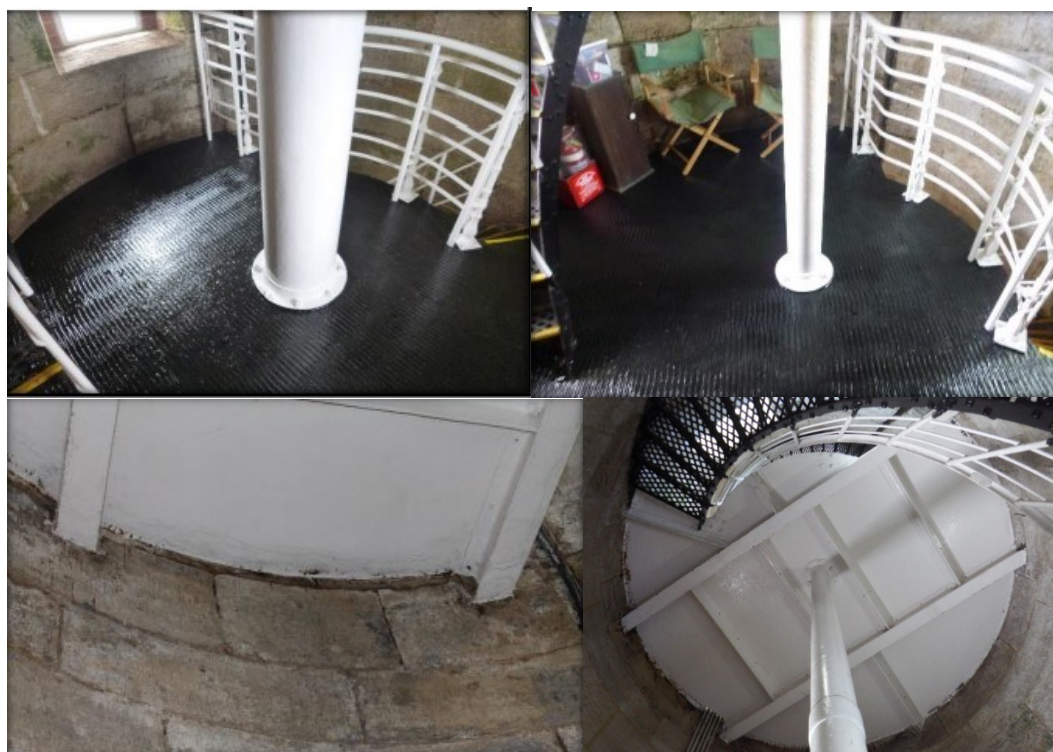
Lighthouse feature: Intermediate floors

Finish	Painted
Condition	Corrosion on edges of floor plates and supporting beams where they intersect with masonry wall. Otherwise intact and sound.
Integrity	high
Significance	extended balustrade: low other parts: high
Maintenance	keep in service treat corrosion prepare and repaint at normal intervals
Rectification works	none

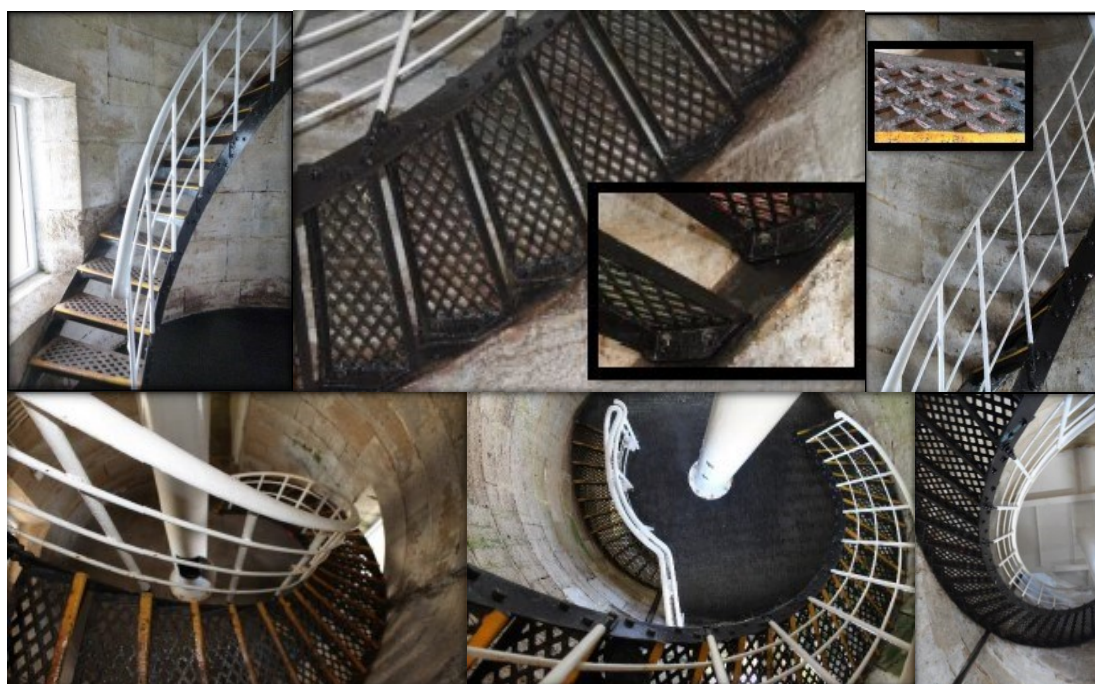
Lighthouse feature: Stairs

Finish	Painted
Condition	localised corrosion on external stair stringers and wall anchor bolts otherwise intact and sound
Integrity	high
Significance	high
Maintenance	keep in service prepare and repaint at normal intervals
Rectification works	none

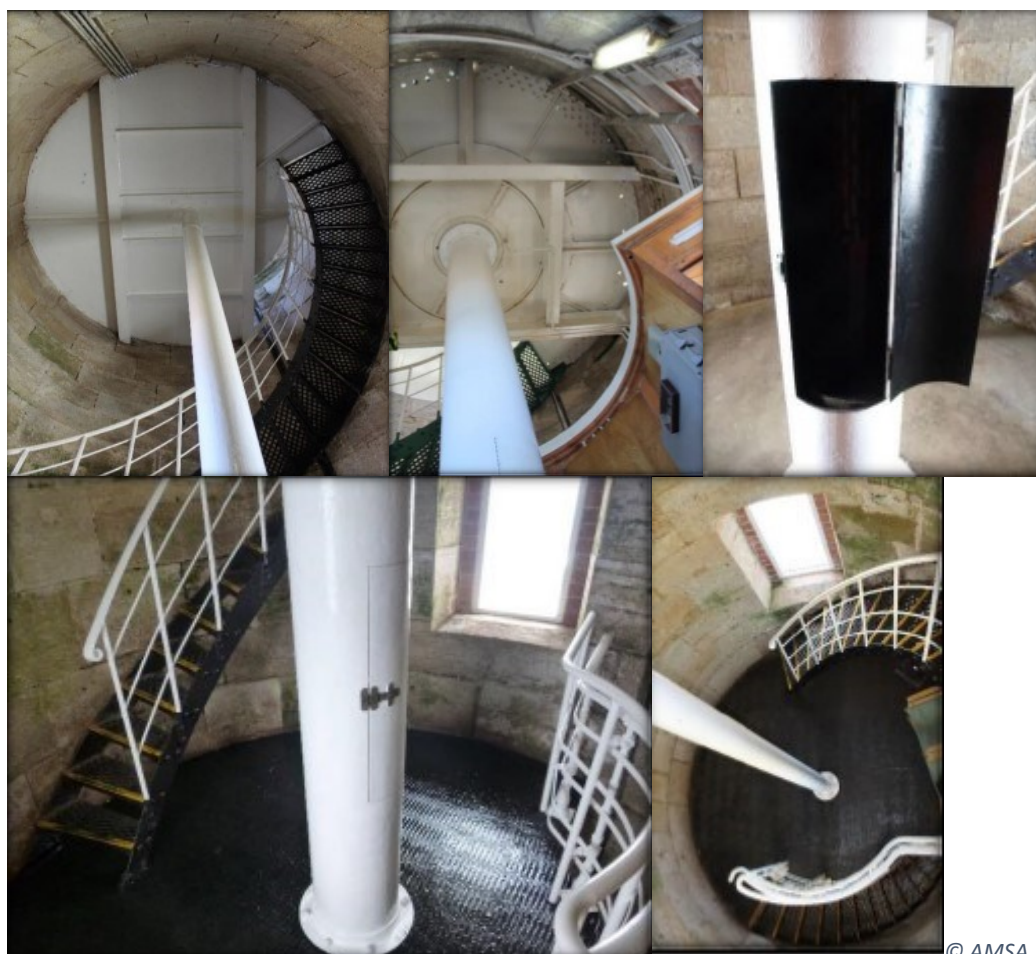
Lighthouse feature: Weight tube

Finish	Painted
Condition	intact and sound
Integrity	high
Significance	high
Maintenance	preserve prepare and repaint at normal intervals
Rectification works	none
