Cape du Couedic Lighthouse

Heritage Management Plan

2023

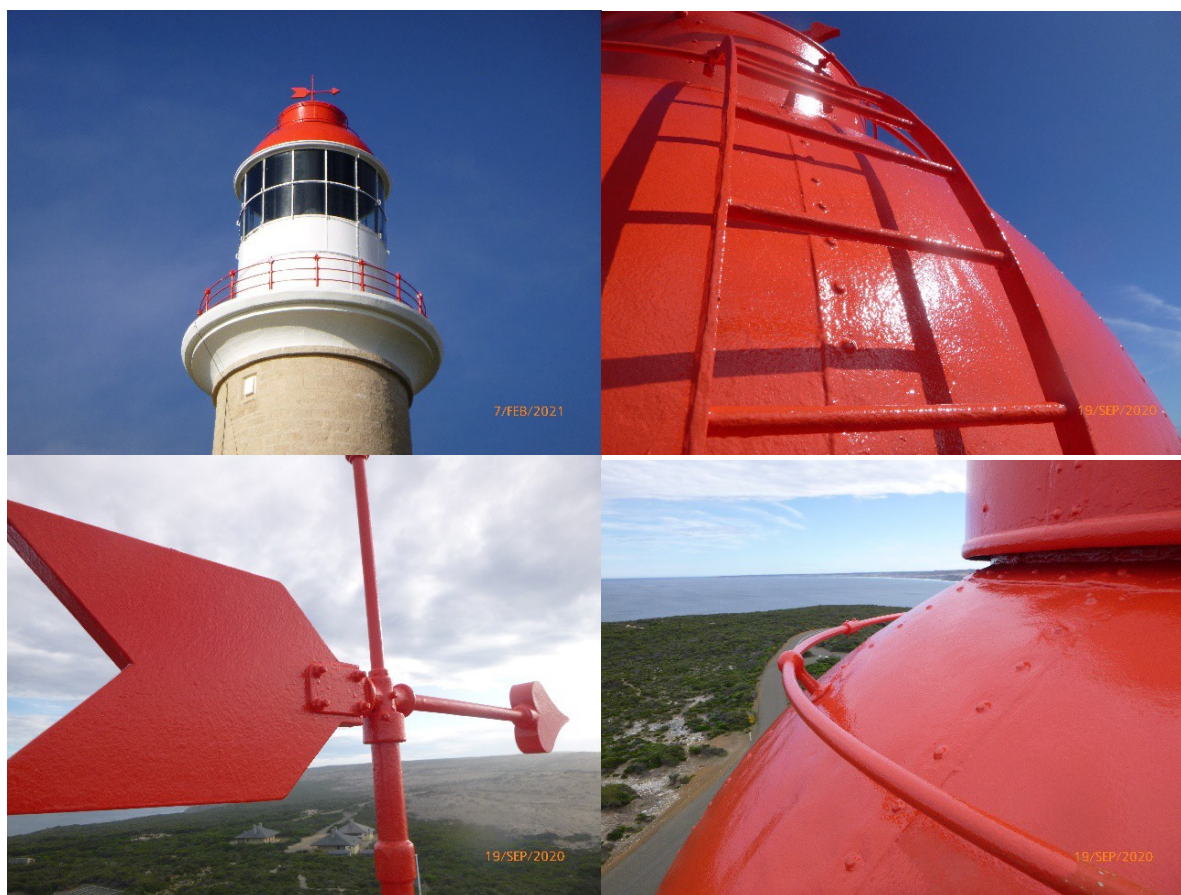
Lighthouse feature: Lantern roof

Finish:	painted
Condition:	intact and sound
Integrity:	high
Significance:	high
Maintenance:	keep in service, prepare and repaint at normal intervals
Rectification works:	none

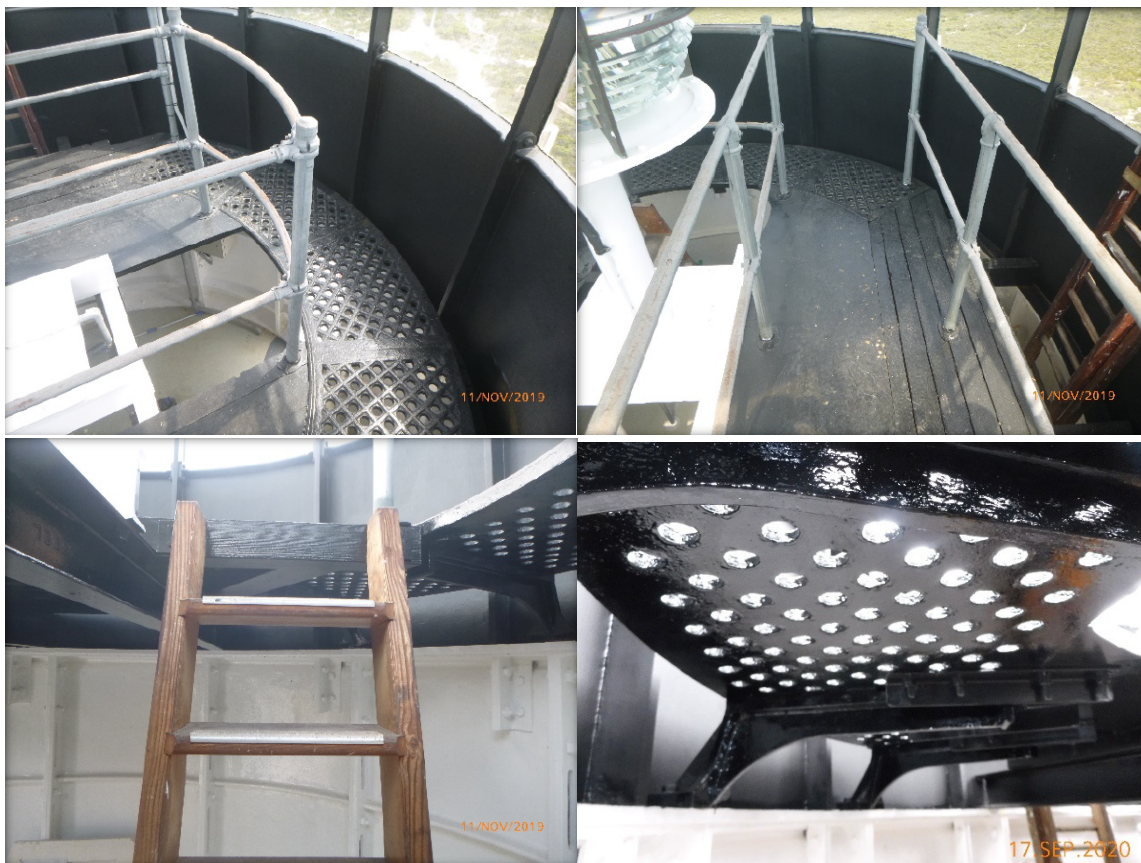
Lighthouse feature: Internal catwalk

Finish:	Painted
Condition:	Intact and sound
Integrity:	High
Significance:	High
Maintenance:	Keep in service, prepare and repaint at normal intervals
Rectification works:	None

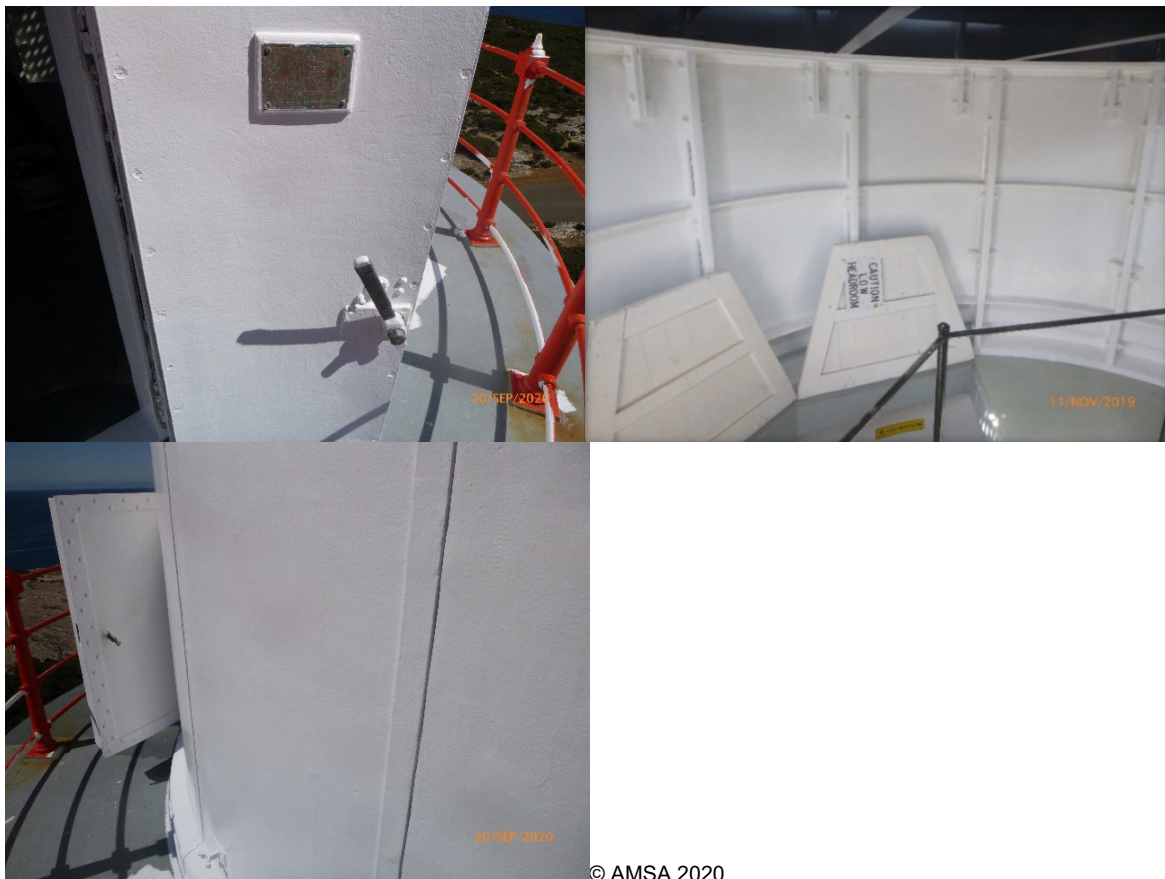
Lighthouse feature: Lantern base

Finish:	Painted
Condition:	Intact and sound
Integrity:	High
Significance:	High
Maintenance:	Keep in service, prepare and repaint at normal intervals
Rectification works:	None

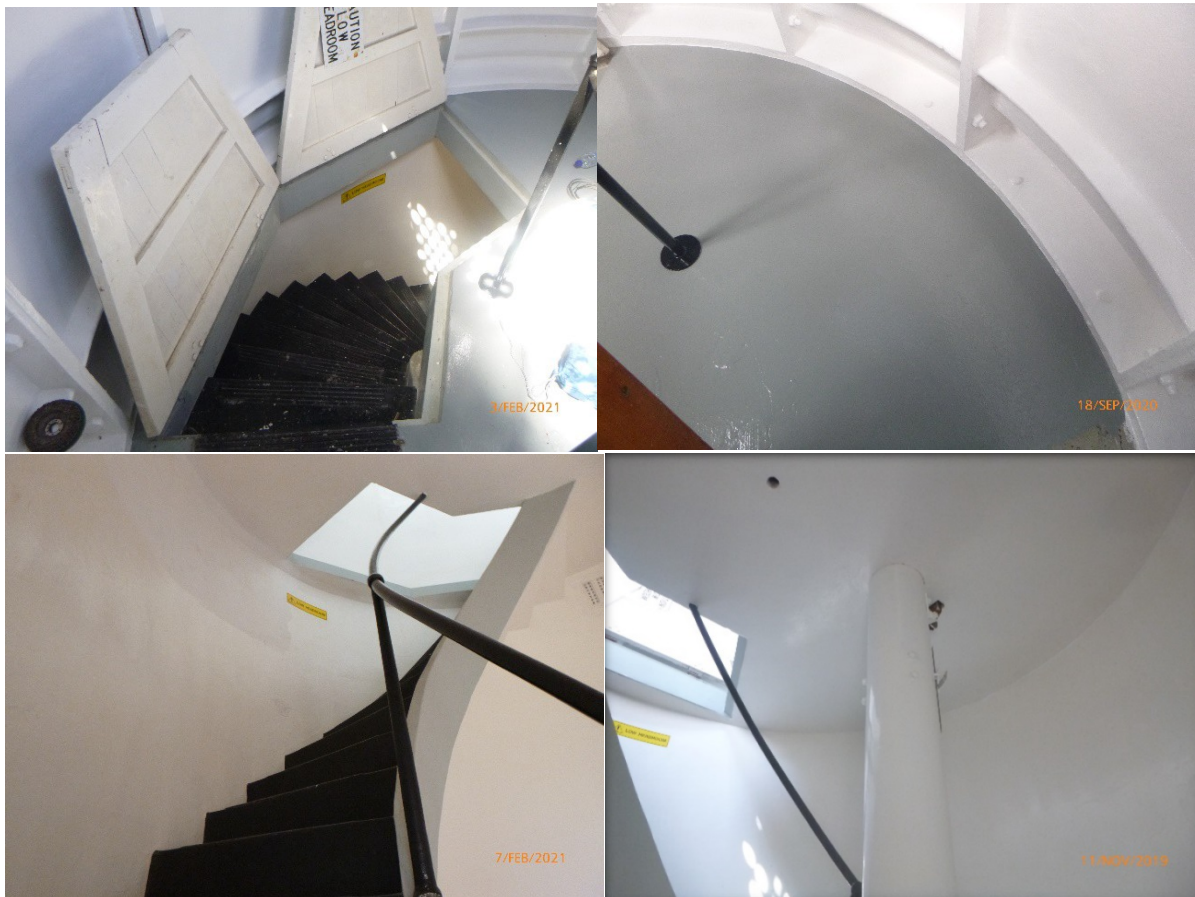
Lighthouse feature: Lantern floor

Finish:	painted
Condition:	intact and sound
Integrity:	high
Significance:	high
Maintenance:	keep in service, prepare and repaint at normal intervals
Rectification works:	none

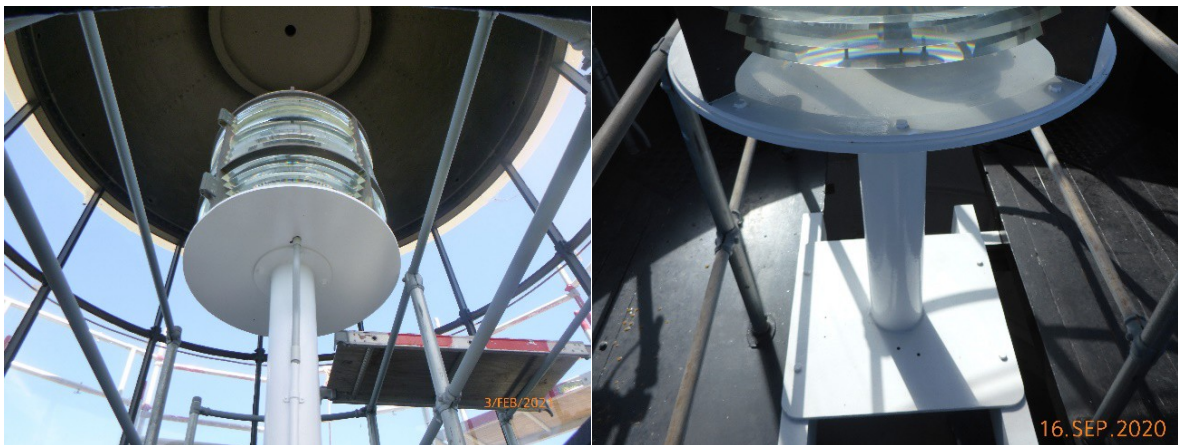
Lighthouse feature: Pedestal

Condition:	sound
Integrity:	medium
Significance:	low

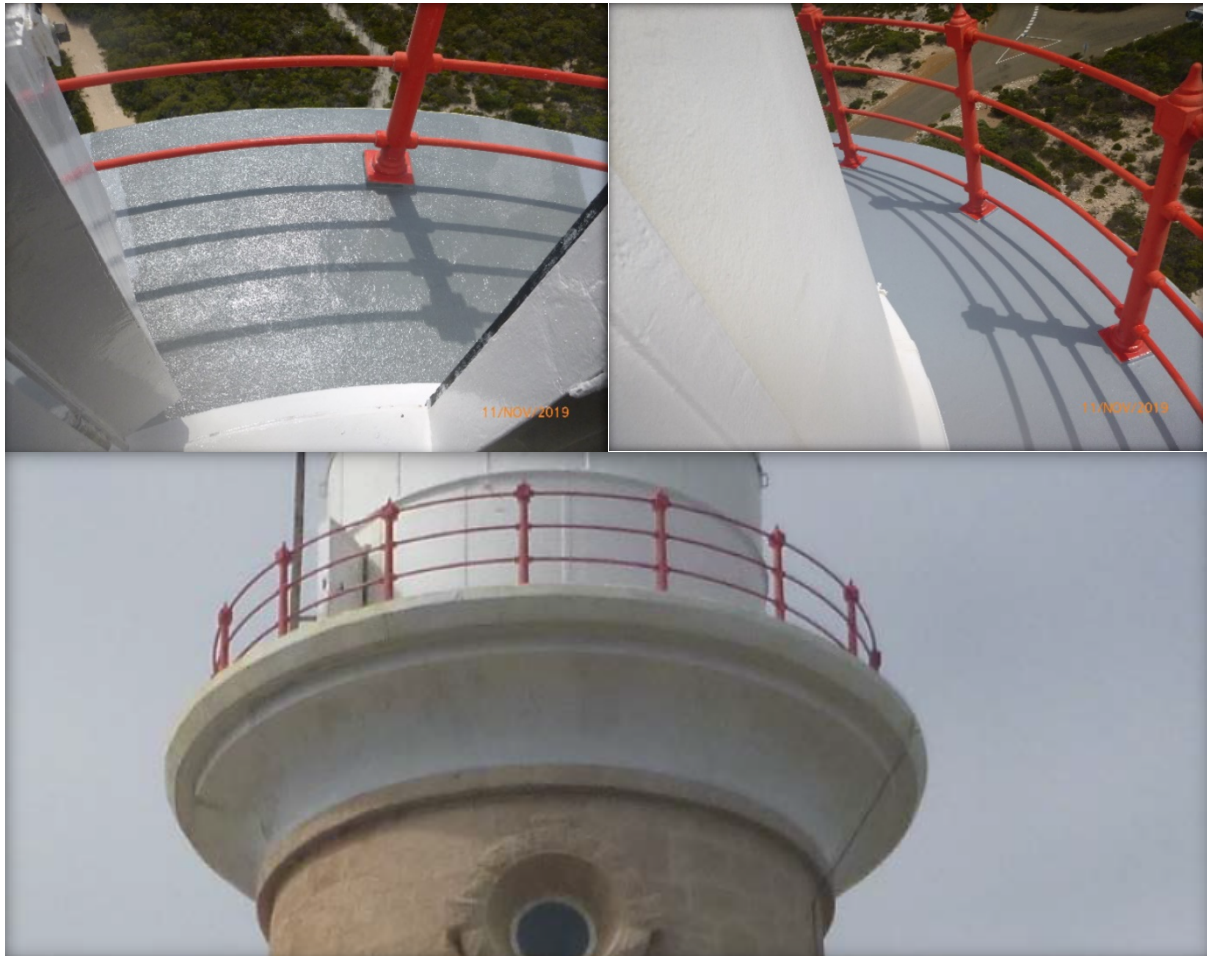
Lighthouse feature: Balcony floor

Finish:	membrane painted
Condition:	intact and sound
Integrity:	high
Significance:	high
Maintenance:	keep in service, prepare and repaint at normal intervals
Rectification works:	none

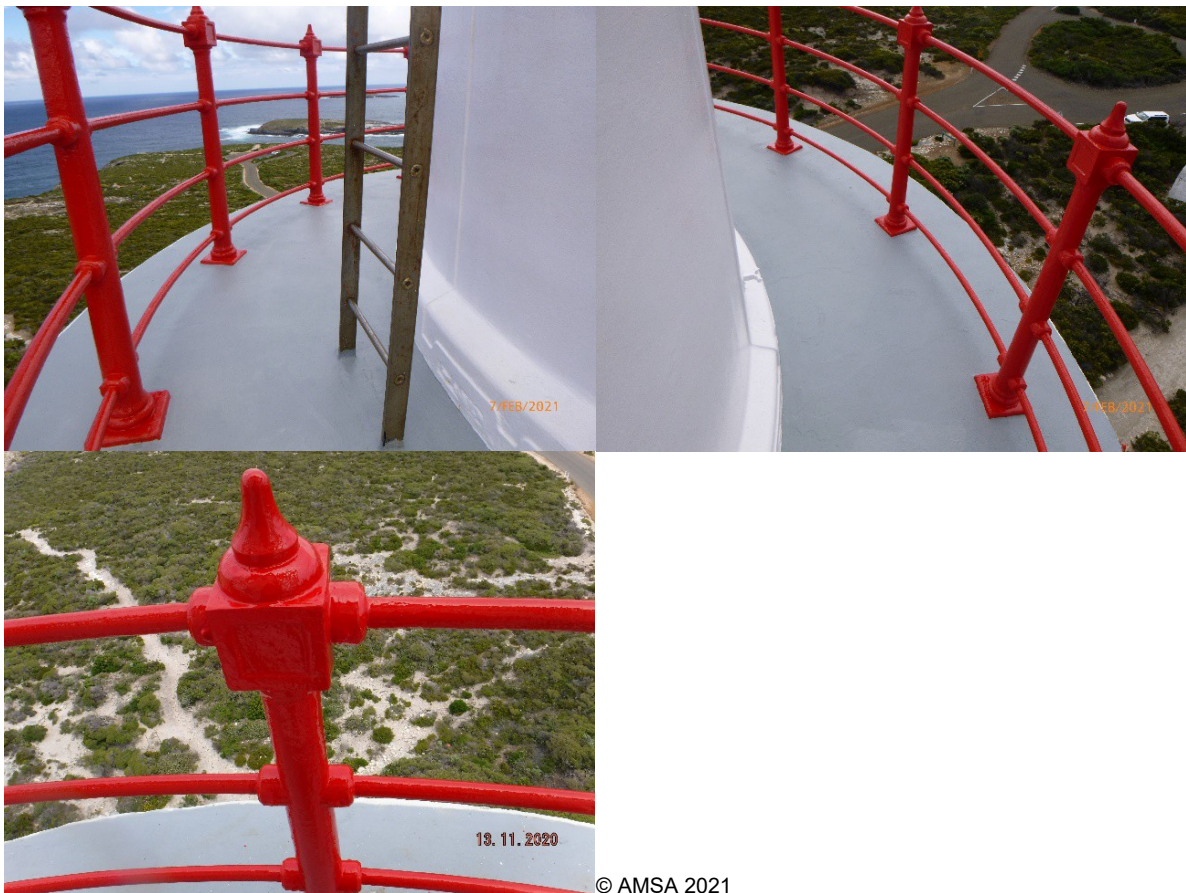
Lighthouse feature: Balcony balustrade

Finish:	painted
Condition:	intact and sound
Integrity:	high
Significance:	high
Maintenance:	keep in service, prepare and repaint at normal intervals
Rectification works:	none

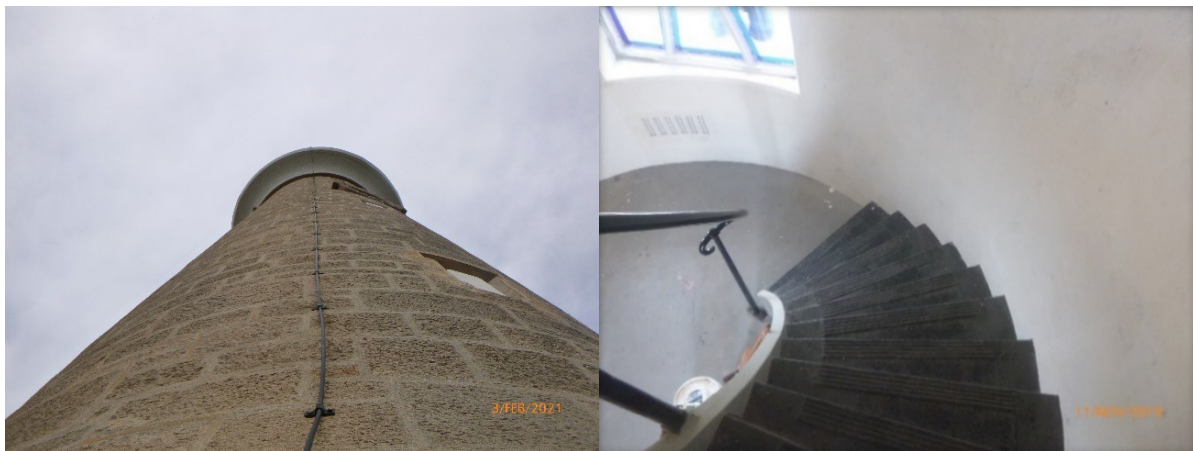
Lighthouse feature: Walls

Finish:	external walls: bare stone internal walls: painted
Condition:	intact and sound, internal paint peeling in some areas, pointing in stone dressing around circular windows needs some minor repair
Integrity:	high
Significance:	high
Maintenance:	keep in service, monitor condition of pointing and stonework, prepare and repaint at normal intervals
Rectification works:	none

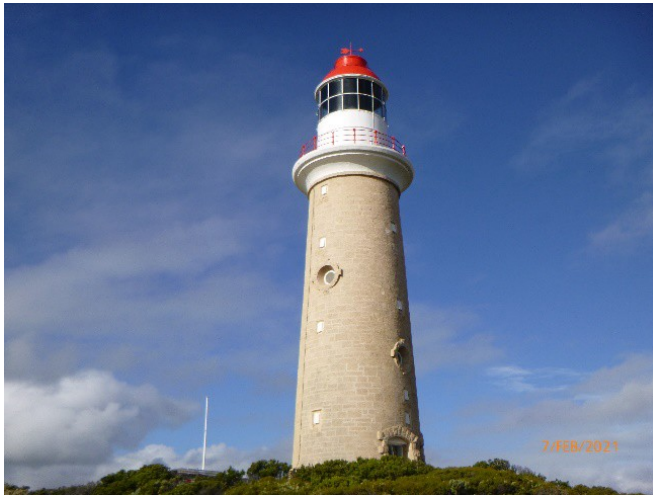
Lighthouse feature: Windows

Finish:	cast iron frames: painted glass: clear
Condition:	intact and sound
Integrity:	high
Significance:	high
Maintenance:	keep in service, prepare and repaint at normal intervals, monitor condition of repointing and stonework (window openings) and reseal as necessary
Rectification works:	none

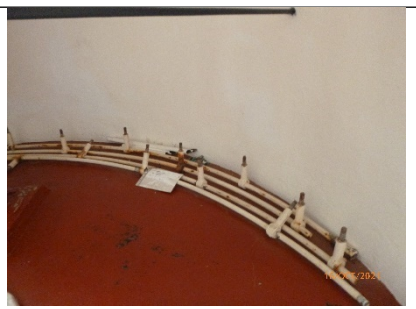
<p>Artefact description: Lantern room ladder rail – Cape du Couedic Lighthouse</p>

<p>Maximo ID: AR0992</p>	
<p>Location in lighthouse: Intermediate floor</p>	
<p>Condition: Sound, showing signs of corrosion</p>

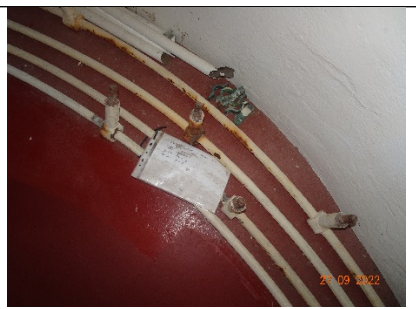
<p>Artefact description: Lantern room downpipes – Cape du Couedic Lighthouse</p>

<p>Maximo ID: AR0993</p>	
<p>Location in lighthouse: Intermediate floor</p>	
<p>Condition: Sound, showing signs of corrosion</p>
