Cape St Albans Lighthouse

Heritage Management Plan

2023

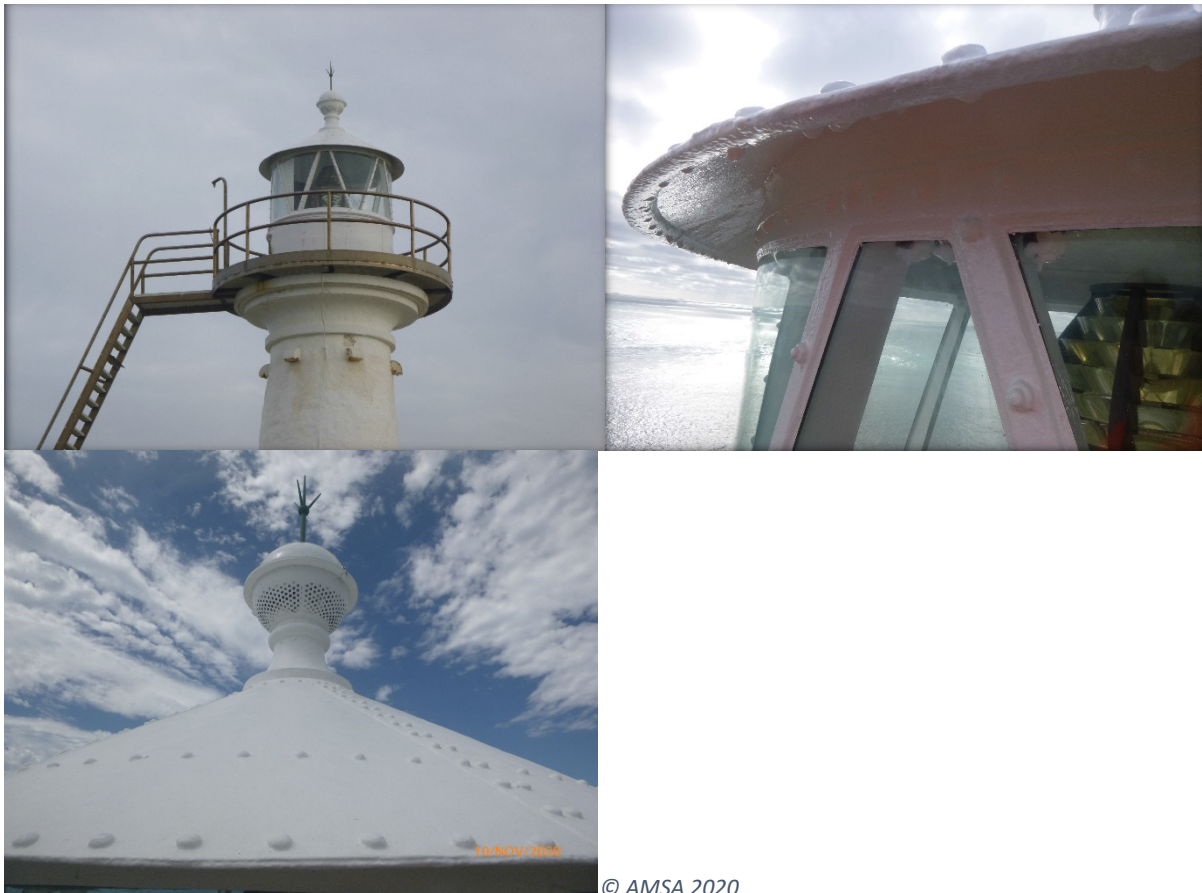
Lighthouse feature: Lantern roof

Finish	Painted
Condition	intact and sound
Significance	high
Integrity	high

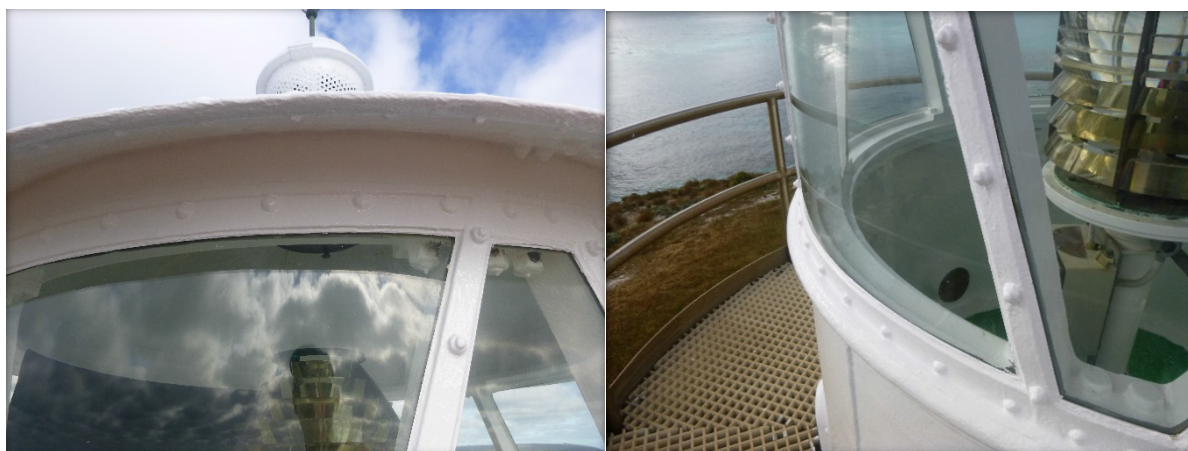
Lighthouse feature: Lantern glazing

Finish	glass: clear other parts: painted
Condition	intact and sound
Significance	high
Integrity	high
Maintenance	keep in service, reglaze as necessary, prepare and repaint at normal intervals
Rectification works	none

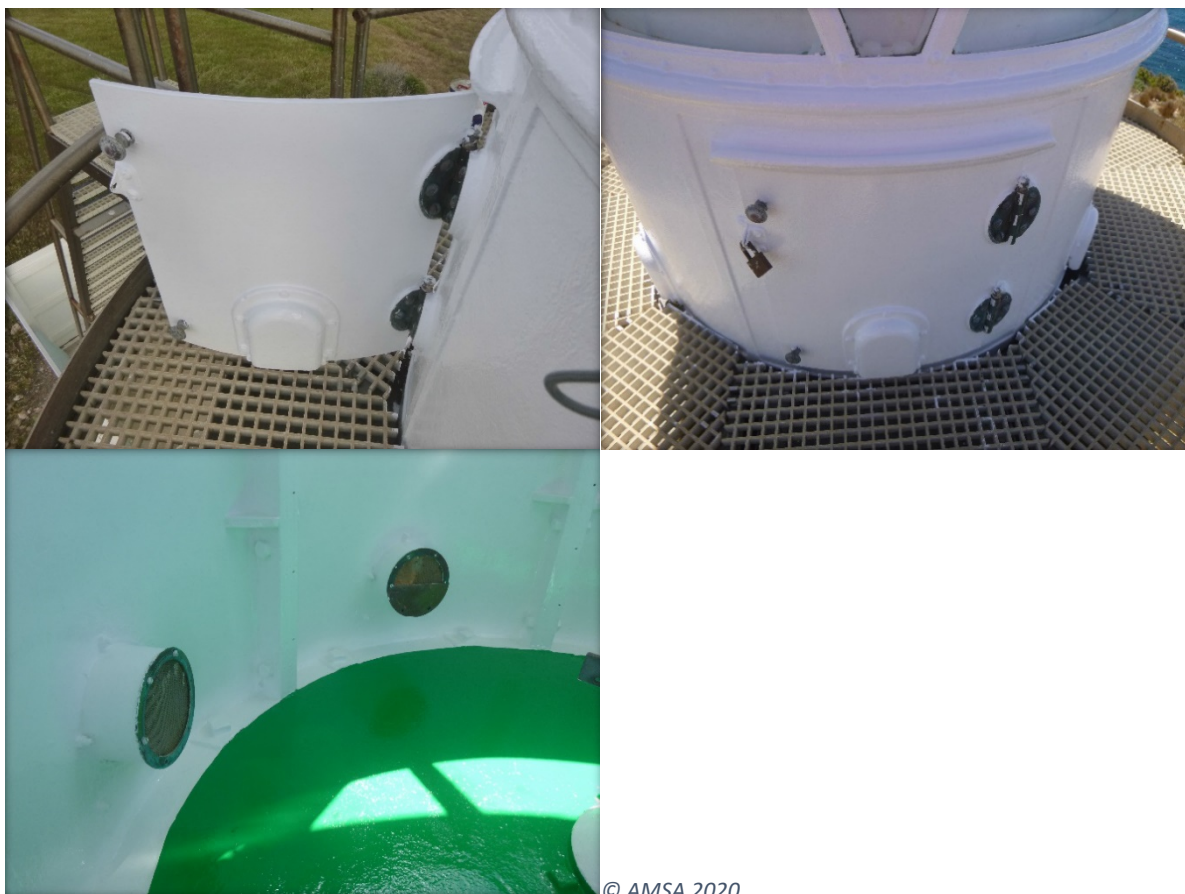
Lighthouse feature: Lantern base

Finish	Painted
Condition	Intact and sound
Significance	High
Integrity	High
Maintenance	Keep in service, prepare and repaint at normal intervals
Rectification works	None

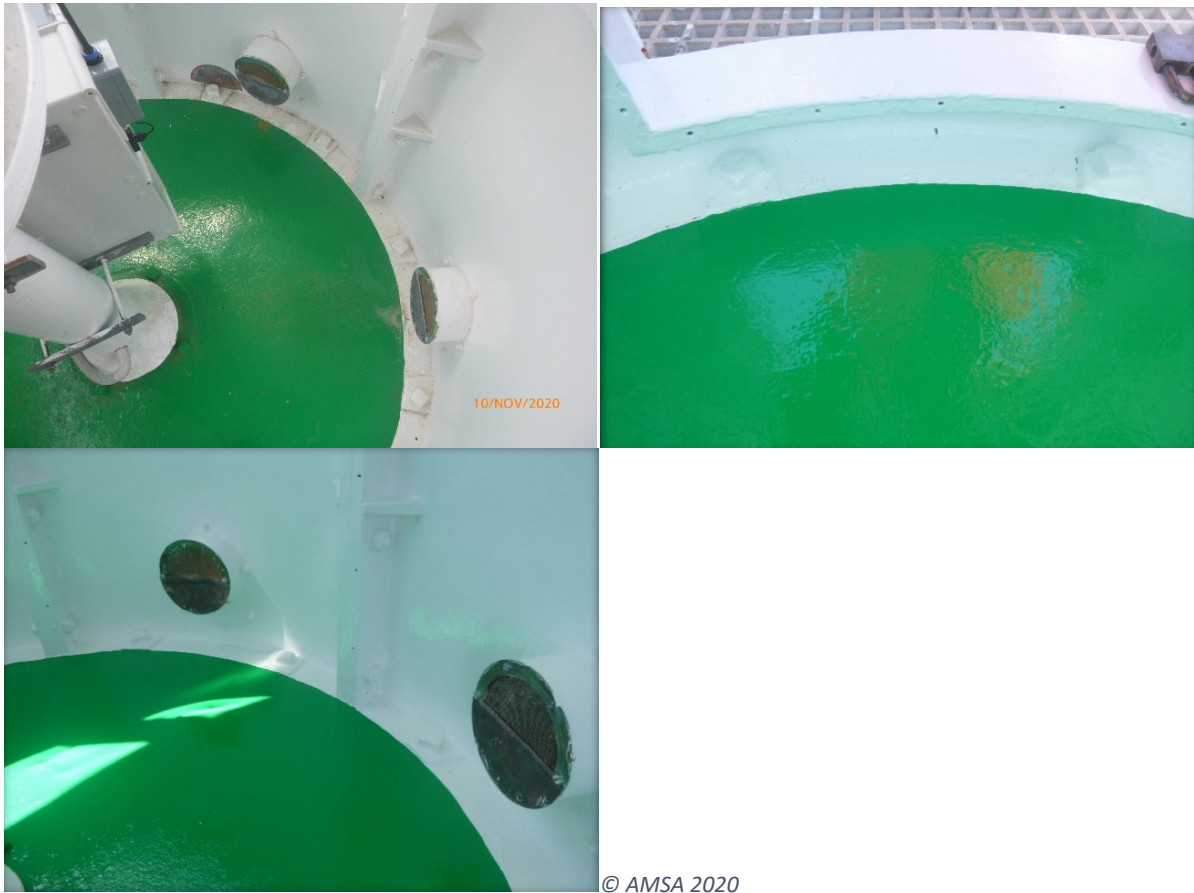
Lighthouse feature: Lantern floor

Concrete slab, continuous with balcony floor and cornice.

Finish	painted
Condition	intact and sound
Significance	high
Integrity	high
Maintenance	keep in service, prepare and repaint at normal intervals
Rectification works	none

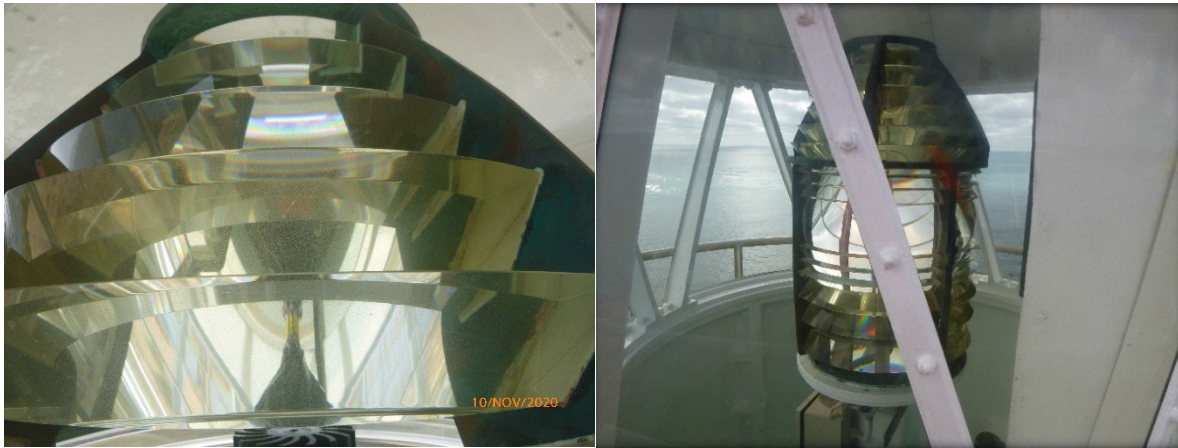
Lighthouse feature: Lens assembly

Finish	painting
Condition	intact and sound
Significance	high
Integrity	high
Maintenance	clean at regular intervals
Rectification works	none

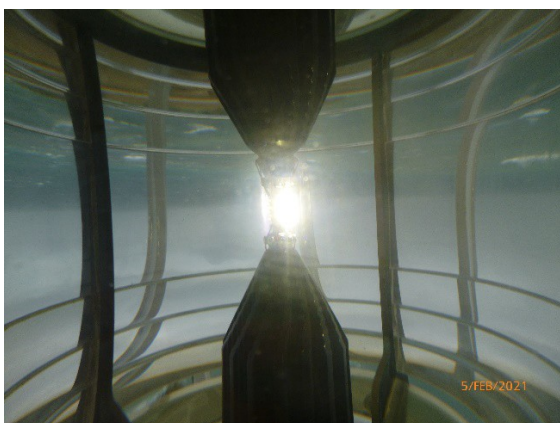
Lighthouse feature: Light source

Condition	sound
Significance	low
Integrity	high
Maintenance	keep in service
Rectification works	none

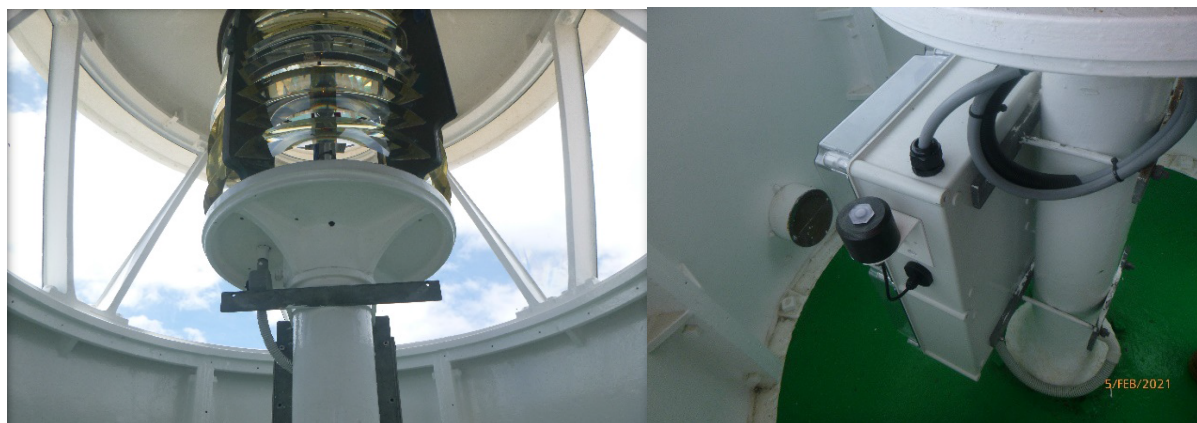
Lighthouse feature: Pedestal

Finish	painted
Condition	intact and sound
Significance	pedestal and table: high other parts: low
Integrity	high
Maintenance	keep in service, prepare and repaint at normal intervals
Rectification works	none

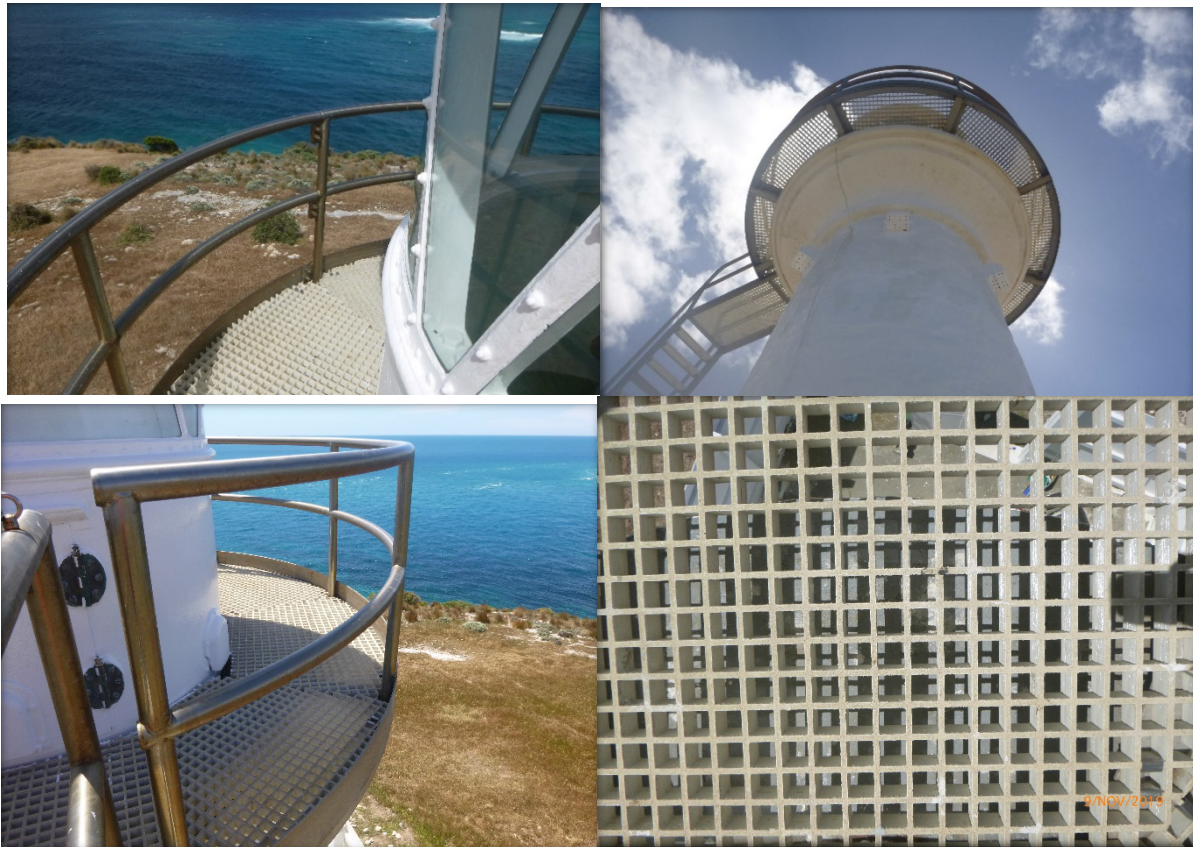
Lighthouse feature: Balcony floor

Recent stainless steel structure with FRP mesh c2006 fixed over 1908 concrete slab, which is continuous with lantern floor and coved cornice and string course.

Finish	stainless steel: bare metal, FRP coloured mesh membrane painted over concrete slab.
Condition	intact and sound
Significance	original concrete floor: high stainless steel and FRP: low
Integrity	low
Maintenance	stainless steel and FRP materials require little maintenance maintain membrane over original balcony slab
Rectification works	none

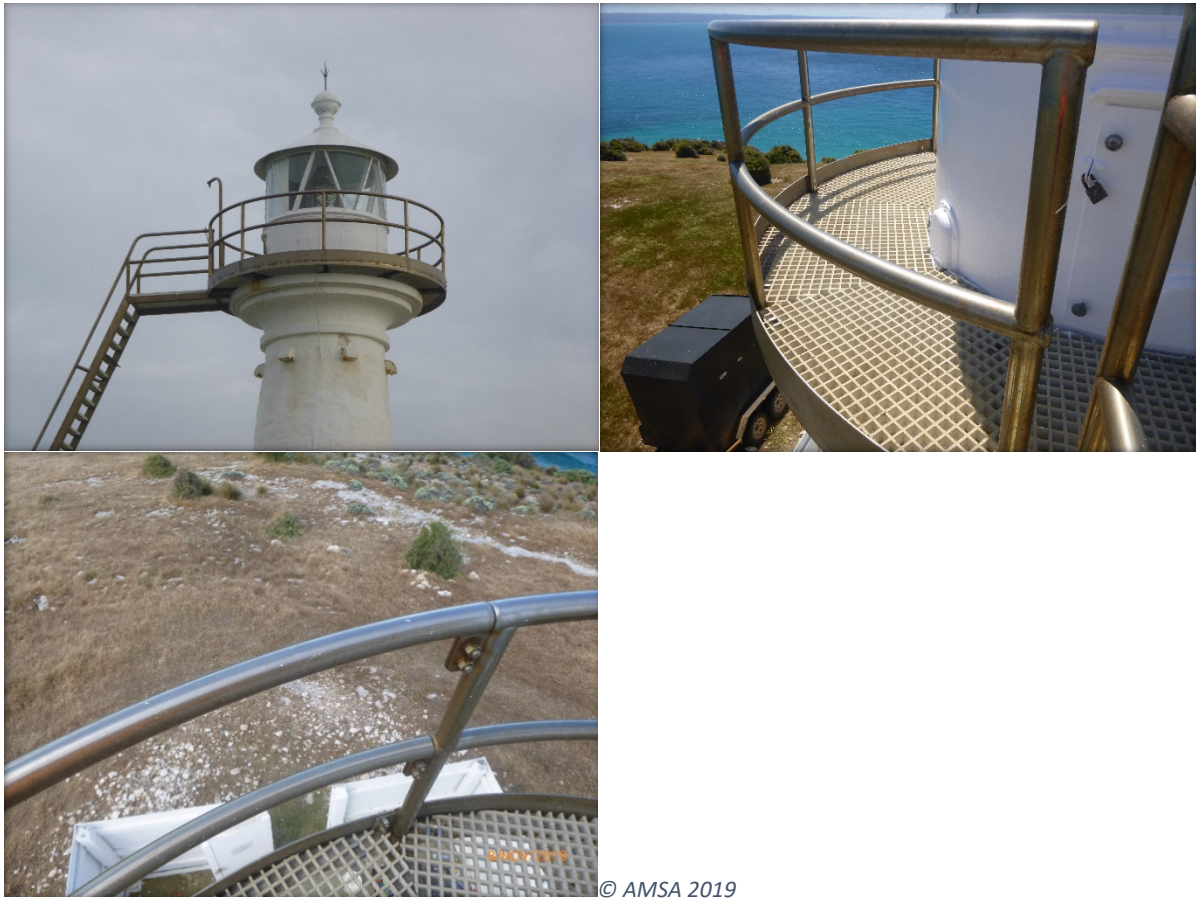
Lighthouse feature: Balcony balustrade

Stainless steel circular hollow section stanchions, handrails and knee-rails; stainless steel kick-plate.

Finish	bare metal
Condition	intact and sound
Significance	low
Integrity	low
Maintenance	keep in service, monitor condition
Rectification works	none

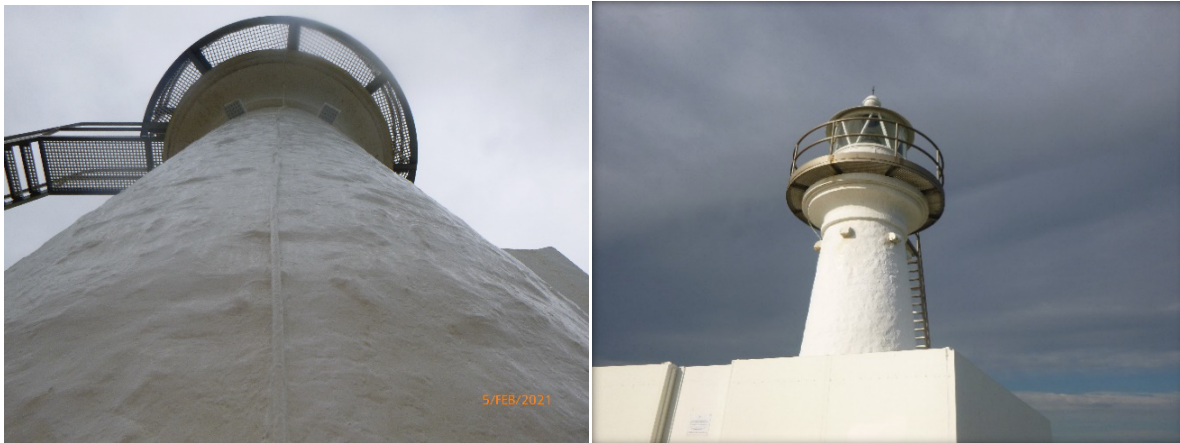
Lighthouse feature: Walls

- Vents – original vents were corroded beyond economical repair. Original covers were replaced with FRP covers, a non-corrosive substitute

Finish	Painted
Condition	Intact and sound
Significance	vent covers: low other features: high
Integrity	high
Maintenance	keep in service, prepare and repaint at normal intervals
Rectification works	none

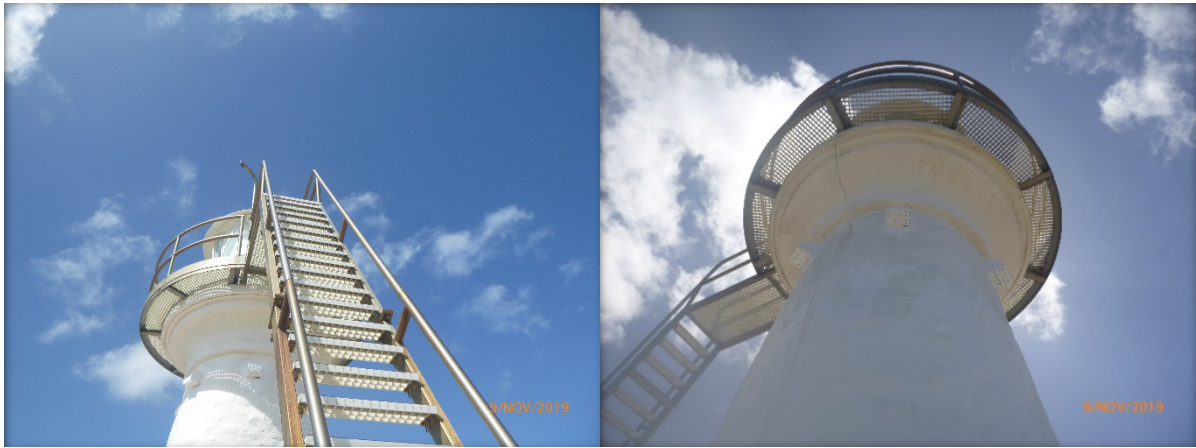
Lighthouse feature: External ladder

Fixed ladder from ground to balcony. Stainless steel stiles and FRP treads. Stainless steel brackets fixing the ladder to the ground and to the balcony. (This stainless steel ladder replaces an earlier timber ladder, which was a replacement for the original iron ladder shown on the 1908 drawings.)

Finish	bare metal
Condition	intact and sound
Significance	low
Integrity	low
Maintenance	keep in service, monitor condition
Rectification works	none

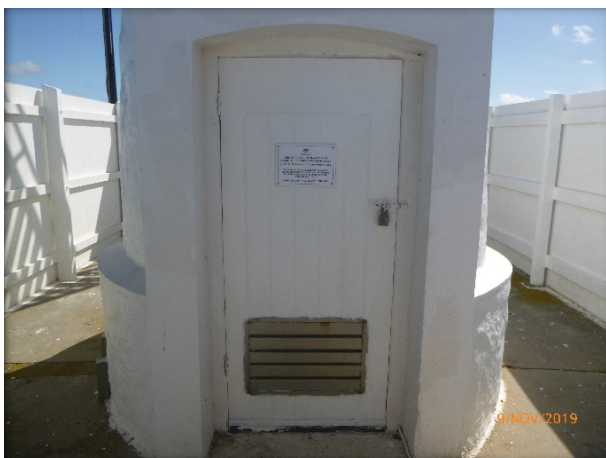
Lighthouse feature: Door

Early timber framed and sheeted door hung in timber frame on butt hinges. Recent stainless steel louvre vent panel fitted between mid-rail and bottom rail. Secured with pad bolt and CLS padlock.

Finish	louvres: bare stainless steel other parts: unpainted
Condition	intact and sound
Significance	door: high louvre: low
Integrity	high
Maintenance	keep in service, prepare and repaint at normal intervals
Rectification works	none

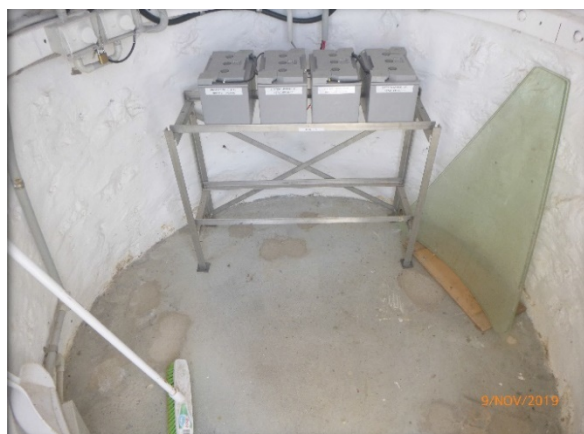
Lighthouse feature: Ground floor

Finish	painted
Condition	intact and sound
Significance	high
Integrity	high
Maintenance	prepare and repaint at normal intervals
Rectification works	none

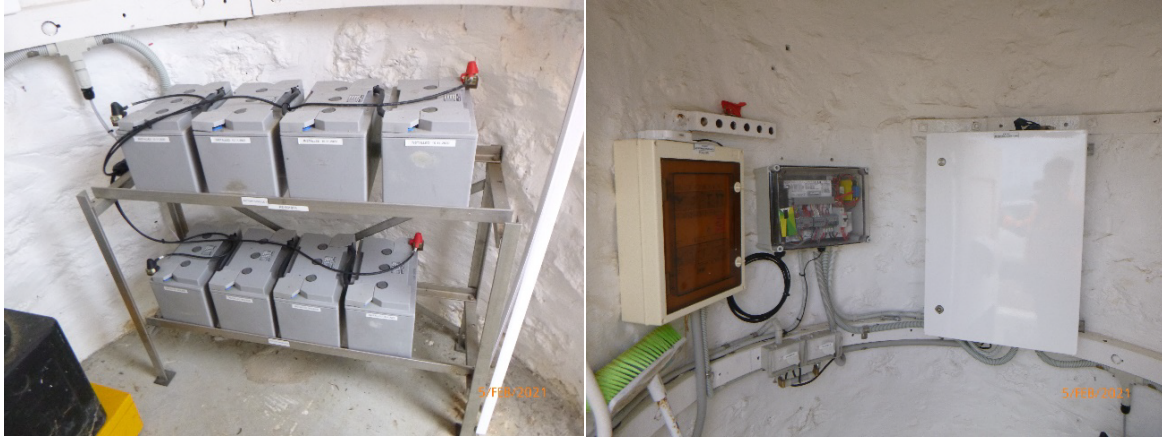
Lighthouse feature: Equipment

Condition	sound
Significance	low
Integrity	high
Maintenance	none
Rectification works	none

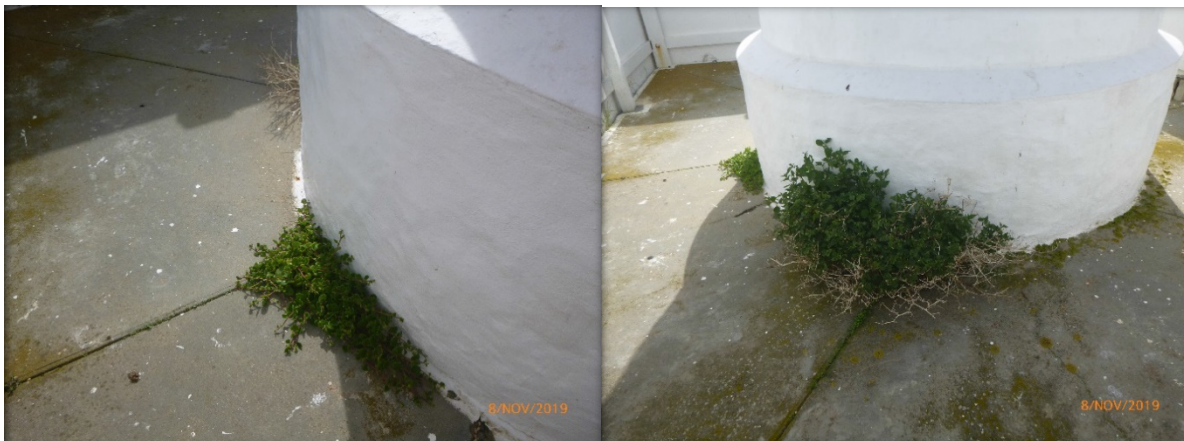
Lighthouse feature: Apron paving

Finish	bare concrete
Condition	intact and sound
Significance	moderate
Integrity	high
Maintenance	keep in service, carry out minor repairs as required
Rectification works	none

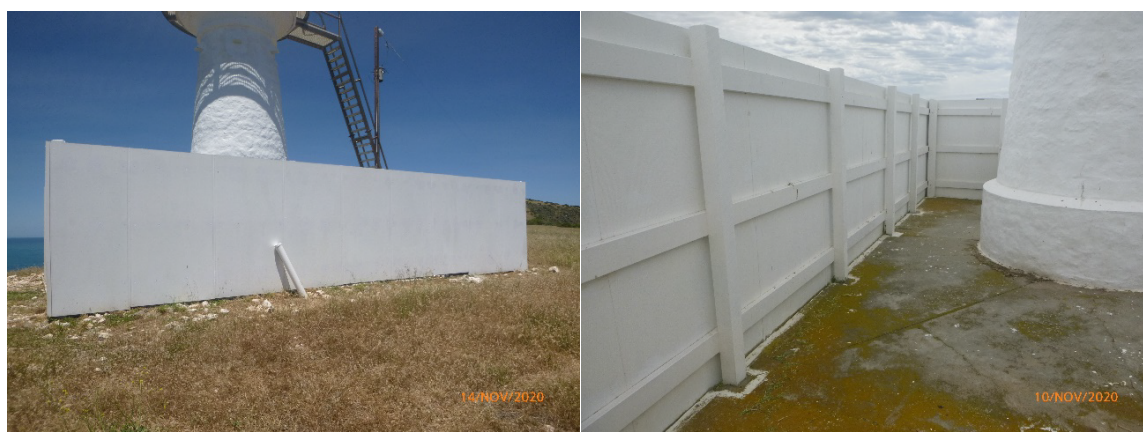
Lighthouse feature: Fence

1908 timber framed fence, extensively rebuilt. Several original posts remain, with evidence of the original arris-cut rails housed into the posts. Most of the posts and all of the rails, are later replacements. The original corrugated iron sheeting was replaced with a 'super six' corrugated asbestos-cement. The corrugated asbestos-cement sheet has recently been replaced with a fibre-cement flat sheeting. Timber-framed gate, sheeted with fibre-cement sheet. Storm damaged section of fence on north western side completely replaced in 2016.

Finish	painted
Condition	intact and sound
Significance	moderate
Integrity	low
Maintenance	keep in service, prepare and repaint at normal intervals
Rectification works	none
