Goose Island Lighthouse

Heritage Management Plan

Heritage Management
Plan
2023

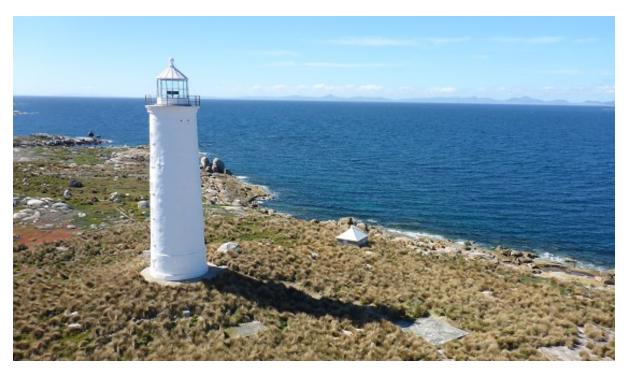
Apart from the lighthouse tower, oil storeroom and helipad, the Island bears no other structure – with exception to some structural remains of the demolished lightkeepers' cottages, tramway and small lighthouse graveyard.

- Figure 5. View of Goose Island Lighthouse and surrounds (Source: AMSA, 2018)
- Figure 6. Goose Island Lightstation 2018 Map of Lease (Goose Island Lightstation Map of Lease (Esri, DigitalGlobe, GeoEye, Earthstar Geographics, CNES/Airbus DS, USDA, USGS, AeroGRID, IGN, and the GIS User Community)

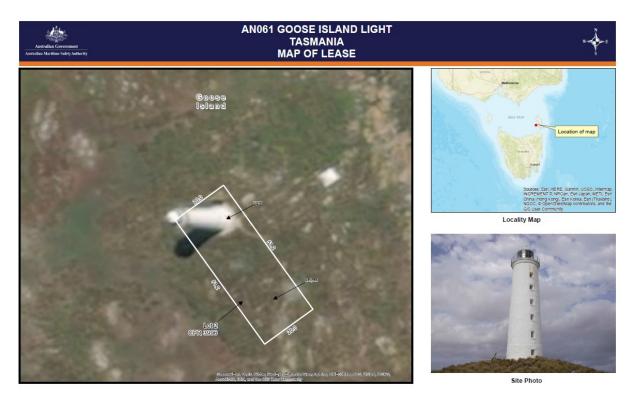
Figure 6. Goose Island Lightstation 2018 Map of Lease (Esri, DigitalGlobe, GeoEye, Earthstar Geographics, CNES/Airbus DS, USDA, USGS, AeroGRID, IGN, and the GIS User Community)

Goose Island Lighthouse and its accompanying store shed are the only remaining structure from the original lightstation. The land surrounding AMSA's lease is managed by the Minister administering the *National Parks and Wildlife Act 1970 (TAS)*.

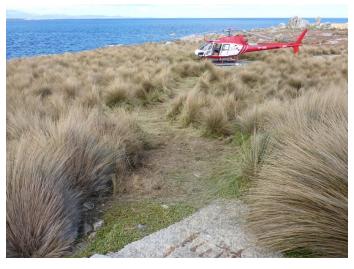
Figure 7. View of path from lighthouse tower to helipad (Source: AMSA, 2018)

Goose Island can be accessed by helicopter and boat – boat landing is enabled on the sandy beaches of its north eastern coastline. Visitors are required to walk the distance to the lighthouse (minimal path visibility). Access inside the lighthouse is restricted to authorised personnel only.

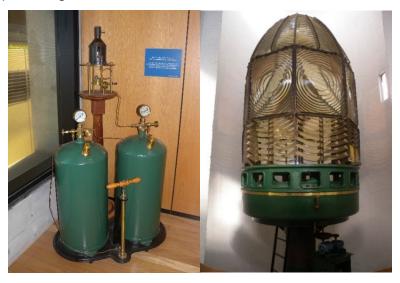
Figure 8. Incandescent oil vapour lamp by Chance Brothers (Source: AMSA)

Figure 9. Dioptric lens on display at Narooma (Source: AMSA)

In 1900, incandescent burners were introduced. This saw the burning of fuel inside an incandescent mantle, which produced a brighter light with less fuel within a smaller volume. Light keepers were required to maintain pressure to the burner by manually pumping a handle as can be seen in Figure 8.

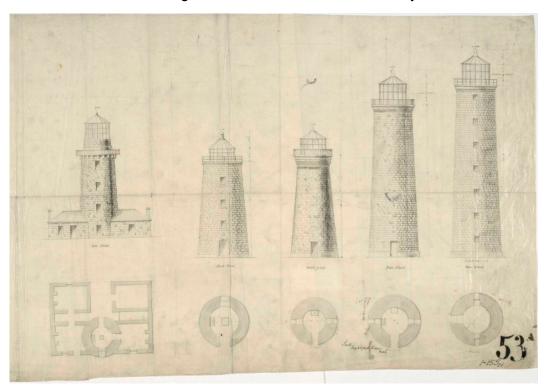
Figure 11. Drawings and floor plans of five Tasmanian lighthouses built in 1840s. From left to right: Low Head, South Bruny, Deal Island, Swan Island, and Goose Island (1848). Courtesy of the National Archives of Australia. (© Commonwealth of Australia, National Archives of Australia)¹⁶

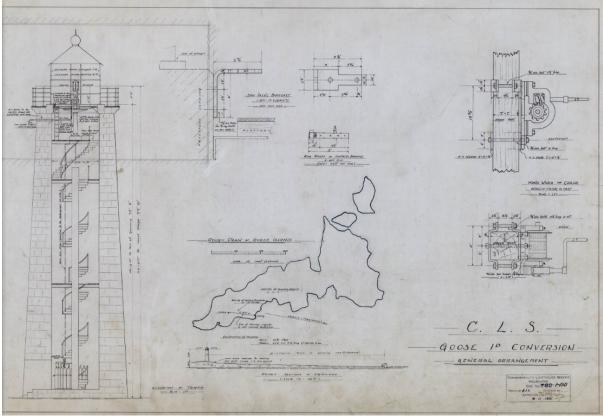
Figure 14. Blueprints for conversion of Goose Island to Acetylene operation, 1931. Image courtesy of the National Archives of Australia: A10182, CN 01 130 (© Commonwealth of Australia, National Archives of Australia)

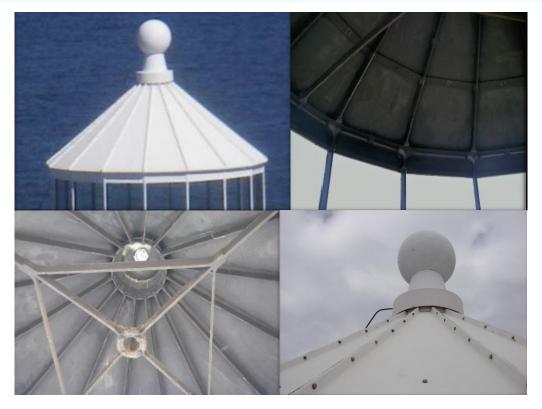
Lighthouse feature: Lantern roof

Finish:	painted
Condition:	intact and sound
Integrity:	high
Significance:	original fabric: high
	other parts: low
Maintenance:	keep in service
	prepare and repaint at normal intervals
Rectification works:	none

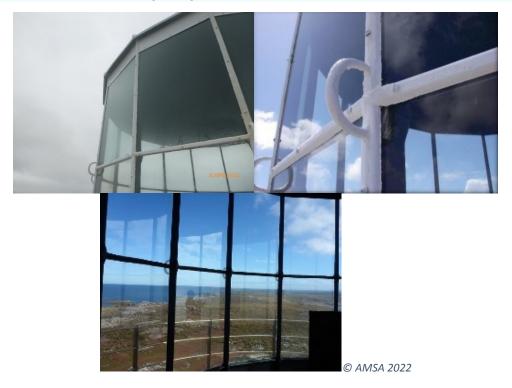
Lighthouse feature: Lantern glazing

Polygonal in form, with 16 sides. The vertical astragals extend from a base ring at lantern floor level up to the lantern roof – there is no separate lantern base.

Finish:	bottom tier: blanking panels
	astragals and glazing strips: painted
Condition:	intact and sound
Integrity:	high
Significance:	high
Maintenance:	keep in service, reglaze as necessary
	prepare and repaint at normal intervals
Rectification works:	none

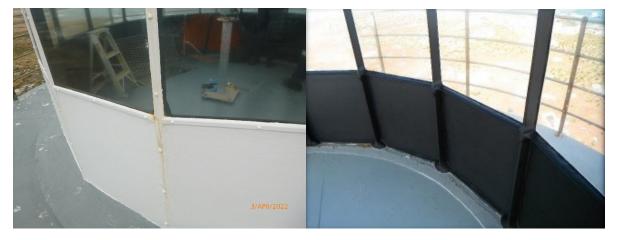
Lighthouse feature: Lantern base

Finish:	painted
Condition:	intact and sound
Integrity:	high
Significance:	blank panels and vents: low
	other parts: high

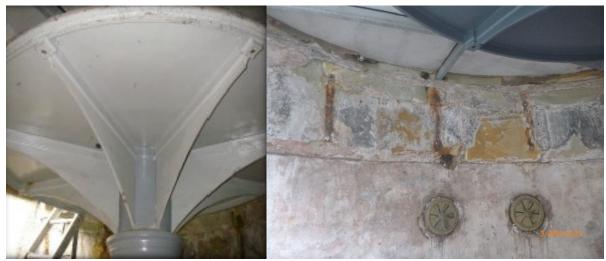
Lighthouse fabric: 1846 Lantern base

Finish:	masonry wall: bare render
	pedestal: painted
Condition:	There is fretting of the top course of sandstone masonry on the
	internal face, otherwise sound.
Integrity:	medium
Significance:	high
Maintenance:	keep in service
	prepare and repaint at normal intervals
Rectification works:	none

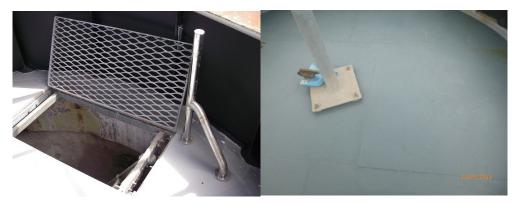
Lighthouse feature: Lantern floor

Finish:	painted
Condition:	intact and sound
Integrity:	high
Significance:	high
Maintenance:	keep in service
	prepare and repaint at normal intervals
Rectification works:	none

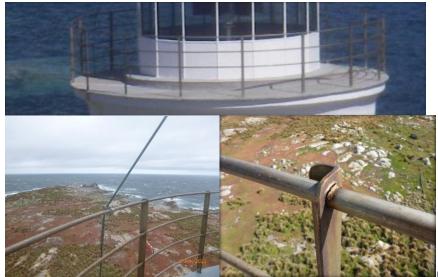
Lighthouse feature: Balcony balustrade

Recent balustrade of welded stainless steel, with angle section stanchions bolted to the balcony floor at the bottom, with four round tubular rails.

Finish:	bare metal
Condition:	intact and sound
Integrity:	high
Significance:	low
Maintenance:	keep in service
Rectification works:	none

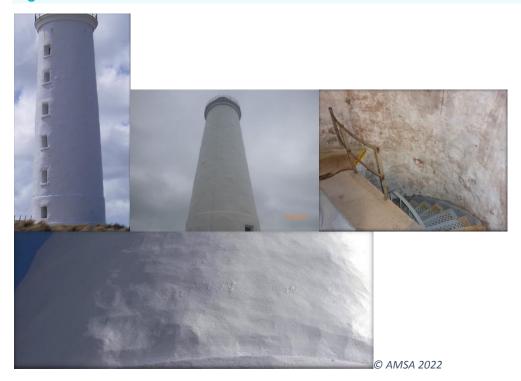
Lighthouse feature: Walls

1846 stone walls, probably originally with exposed rock faced stone in courses with finely dressed freestone cornice courses at the top. It has render and stucco coatings inside and out, probably a later modification. Internal projecting ledges indicate probable earlier locations of intermediate floors, since removed.

Finish:	painted
Condition:	intact and sound
Integrity:	high
Significance:	high
Maintenance:	keep in service
	prepare and paint at normal intervals
	monitor condition of pointing and stonework

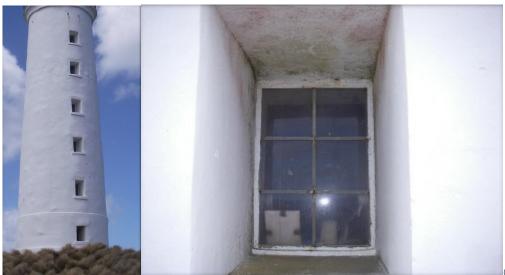
Lighthouse feature: Windows

Six original window openings with fixed glazing in stainless steel sashes and frames.

Finish:	frames and sashes: bare metal
	glass: clear
Condition:	intact and sound
Integrity:	high
Significance:	window openings: high
_	glazing, sashes and frames: low
Maintenance:	keep in service
	replace broken panes as required
Rectification works:	none

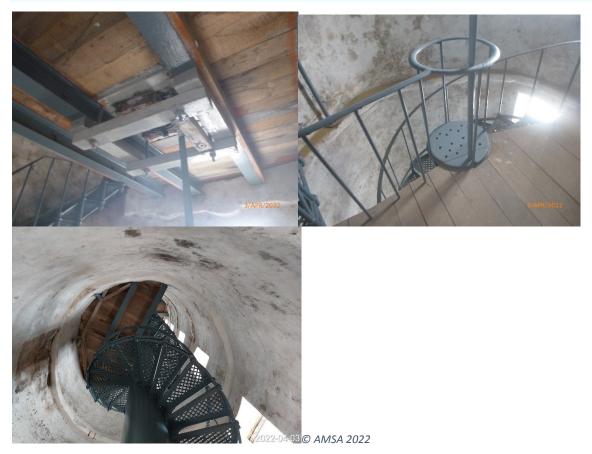
Lighthouse feature: Intermediate floors

Three intermediate landings, of timber boards on rolled iron beams built into the tower walls. (Original intermediate floors at lower levels have been removed when the cast iron stair was installed, but their positions are marked by projecting ledges inside the tower walls).

Finish:	painted
Condition:	corrosion on beam ends
	otherwise intact and sound
Integrity:	medium
Significance:	high
Maintenance:	keep in service
	treat corrosion
	prepare and repaint at normal intervals
Rectification works:	none

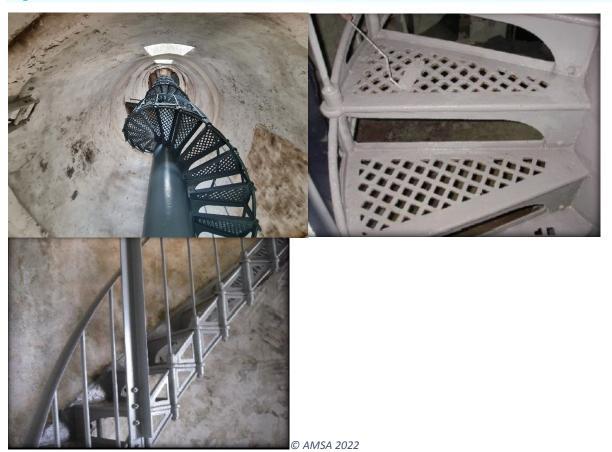
Lighthouse feature: Stairs

Cast iron spiral stair integrated with central weight tube/column, rising from the ground floor to a floor two storeys below the lantern floor. The stair structure is free-standing, independent of the stone tower. Cast iron treads/riser units with lattice treads are bolted to one another and to the weight tube, the connecting bolts extend vertically as balusters supporting a wrought iron handrail on the outside of the flight. A separate flight of stairs, with a wrought iron outer string, leads from the lower intermediate floor to the one below the lantern floor.

Finish:	painted
Condition:	intact and sound
Integrity:	high
Significance:	high
Maintenance:	keep in service
	prepare and repaint at normal intervals
Rectification works:	none

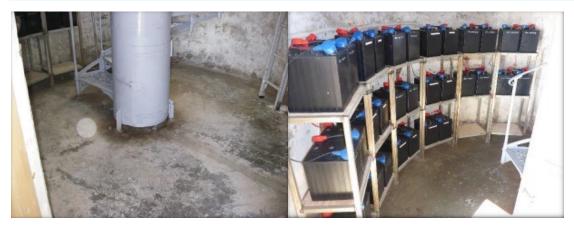
Lighthouse feature: Ground floor

Finish:	bare
Condition:	intact and sound
Integrity:	high
Significance:	high
Maintenance:	keep in service
	clean at normal intervals
Rectification works:	none

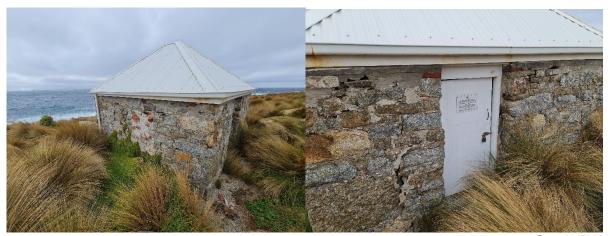
Lighthouse feature: Store shed

Early free standing building with rubble stone walls and hipped roof clad with recent (2012) corrugated stainless steel roofing sheet.

Stainless steel guttering and downpipe.

Condition:	Sound. Some movement is showing by the cracks in the uncoursed rubble stonework. This movement in the wall has been visible for a length of time and the walls are in a stable condition. The red clay bricks used to in-fill the old window and door are eroding and a few of the clay bricks in the window have fallen out of place. The door frame has also moved causing the door to not fit properly.
Integrity:	medium
Significance:	high
Maintenance:	monitor condition prepare and repaint parts as required
Rectification works:	none

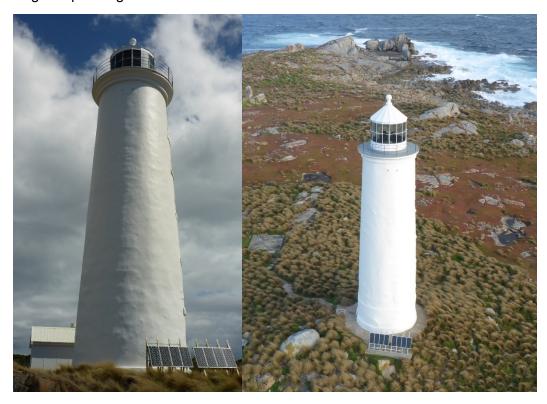
Figure 15. Swan Island Lighthouse, TAS. First lit 1845 (Source: AMSA, 2021)

Figure 16. Goose Island Lighthouse, TAS. First lit 1846 (Source: AMSA, 2020)

Exhibiting similar stylistic features, both the Swan Island Lighthouse, first lit 1845, and Goose Island Lighthouse were built by ex-convict Charles Watson and his team of prisoners. Both masonry towers were constructed of cement rendered rubble stone and fitted with a catadioptric lens with silvered mirrors. In 1872, Swan Island's mirrors were removed and fitted in the Goose Island lantern room. Located on isolated islands, the two towers are situated approximately 54.5 km apart in Bass Strait and are considered to be the two major coastal lights operating north-east of Tasmania.
