Australian Maritime Safety Authority

# Cape Byron Lighthouse Heritage Management Plan

2020

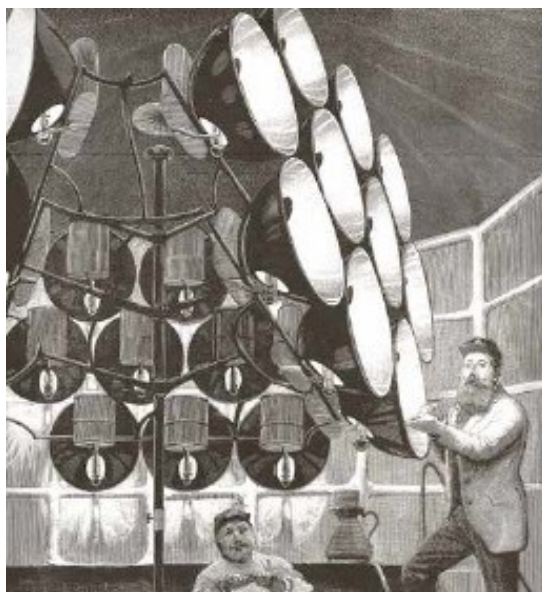
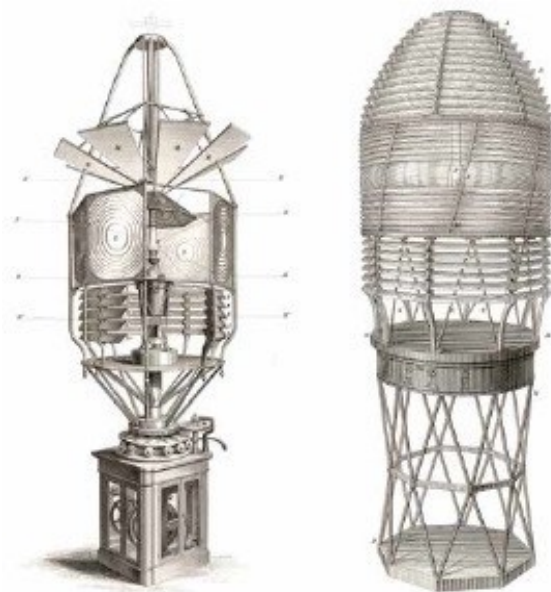
Figure 10. Early technology used in lighthouses <sup>2</sup>

<sup>1</sup> Figure 10 – The Lantern room of the 1834 Belle Tout lighthouse, south west England. ‘The apparatus here employed is that of the “catoptric” system, in which a revolving frame has a number of large concave reflectors, with an Argand fountain lamp in each, fitted to each side of the frame. The shape and position of the reflectors are precisely calculated to throw the rays of light, in a combined flood of light, upon certain parts of the surface of the sea, and to prevent their being wasted in the sky.’ (Parts of a wood engraving and article published in the *Illustrated London News*, 5th January, 1884.); Figure [10] right – Early example of a rotating catadioptric apparatus, made for the 1844 lighthouse at Skerryvore, Western Scotland (Steel engraving from *Tomlinson’s Cyclopaedia of Useful Arts*, 1854)

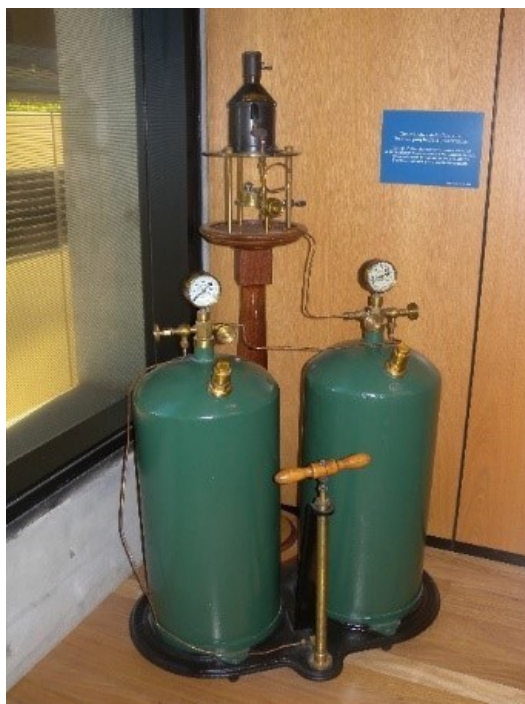
Figure 11. Incandescent oil vapour lamp by Chance Brothers

In 1900, incandescent burners were introduced. This saw the burning of fuel inside an incandescent mantle which produced a brighter light with less fuel within a smaller volume. Light keepers were required to maintain pressure to the burner by manually pumping a handle as can be seen in Figure 11.

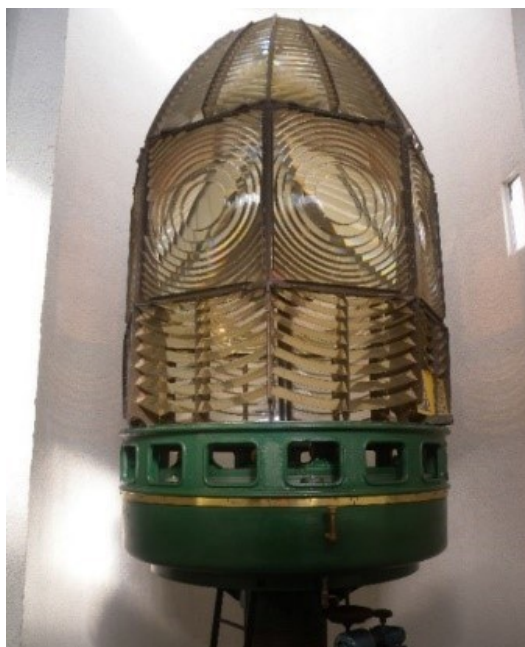
Figure 12. Dioptric lens on display at Narooma

Large dioptric lenses, such as that shown in Figure 12, gradually decreased in popularity due to cost and the move towards unmanned automatic lighthouses. By the early 1900s, Australia had stopped ordering these lenses with the last installed at Eclipse Island in Western Australia in 1927. Smaller Fresnel lenses continued to be produced and installed until the 1970s when plastic lanterns, still utilising Fresnel's technology, were favoured instead. Acetylene remained in use until it was finally phased out in the 1990s.

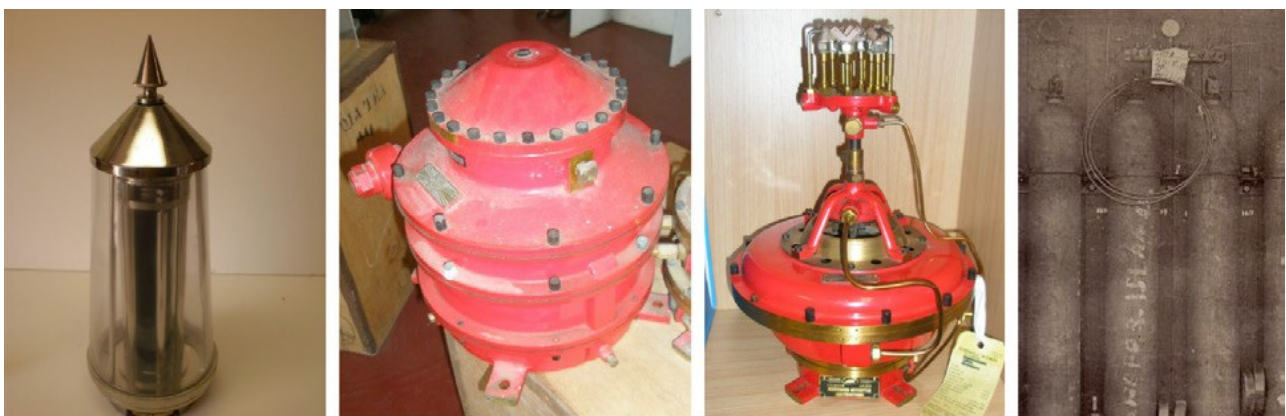
Figure 13. Dalén's system – sunvalve, mixer, flasher and cylinder

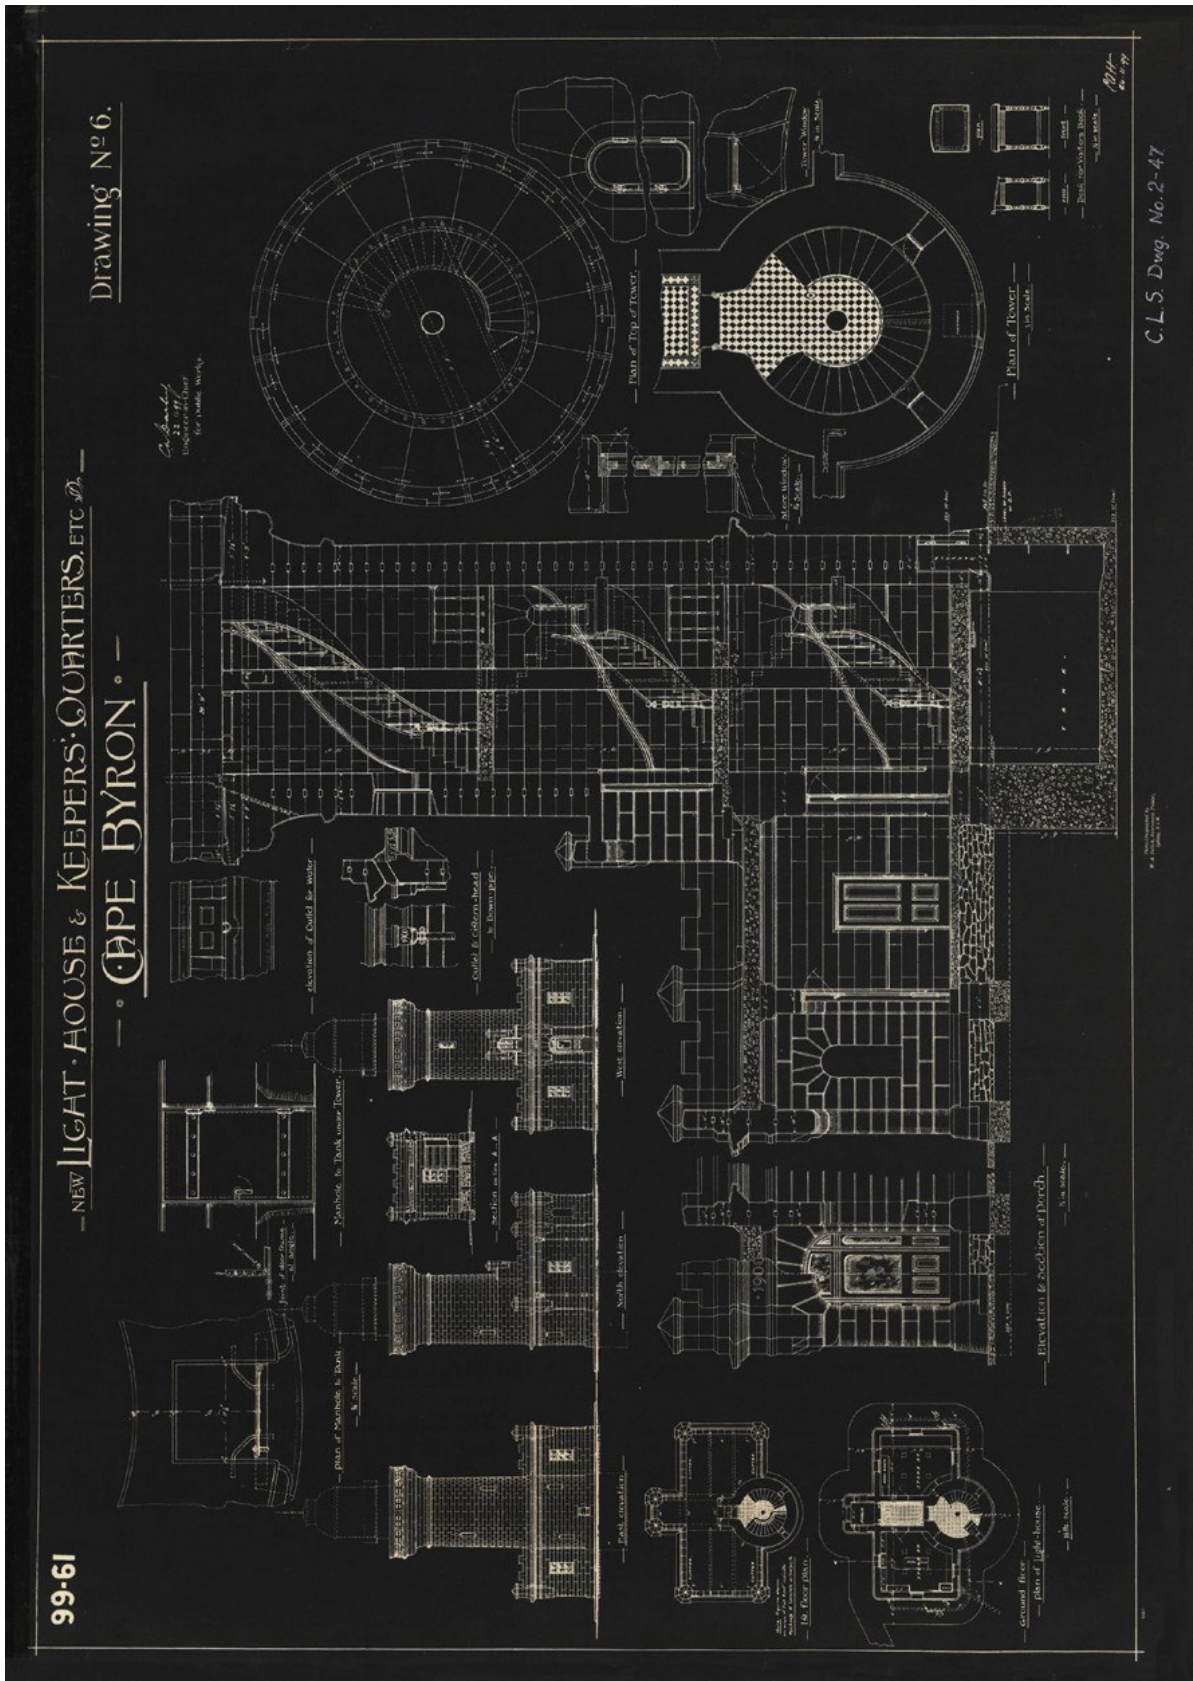
Figure 15. Blueprints for Cape Byron Lighthouse tower and attached pavilions (c. 1899)

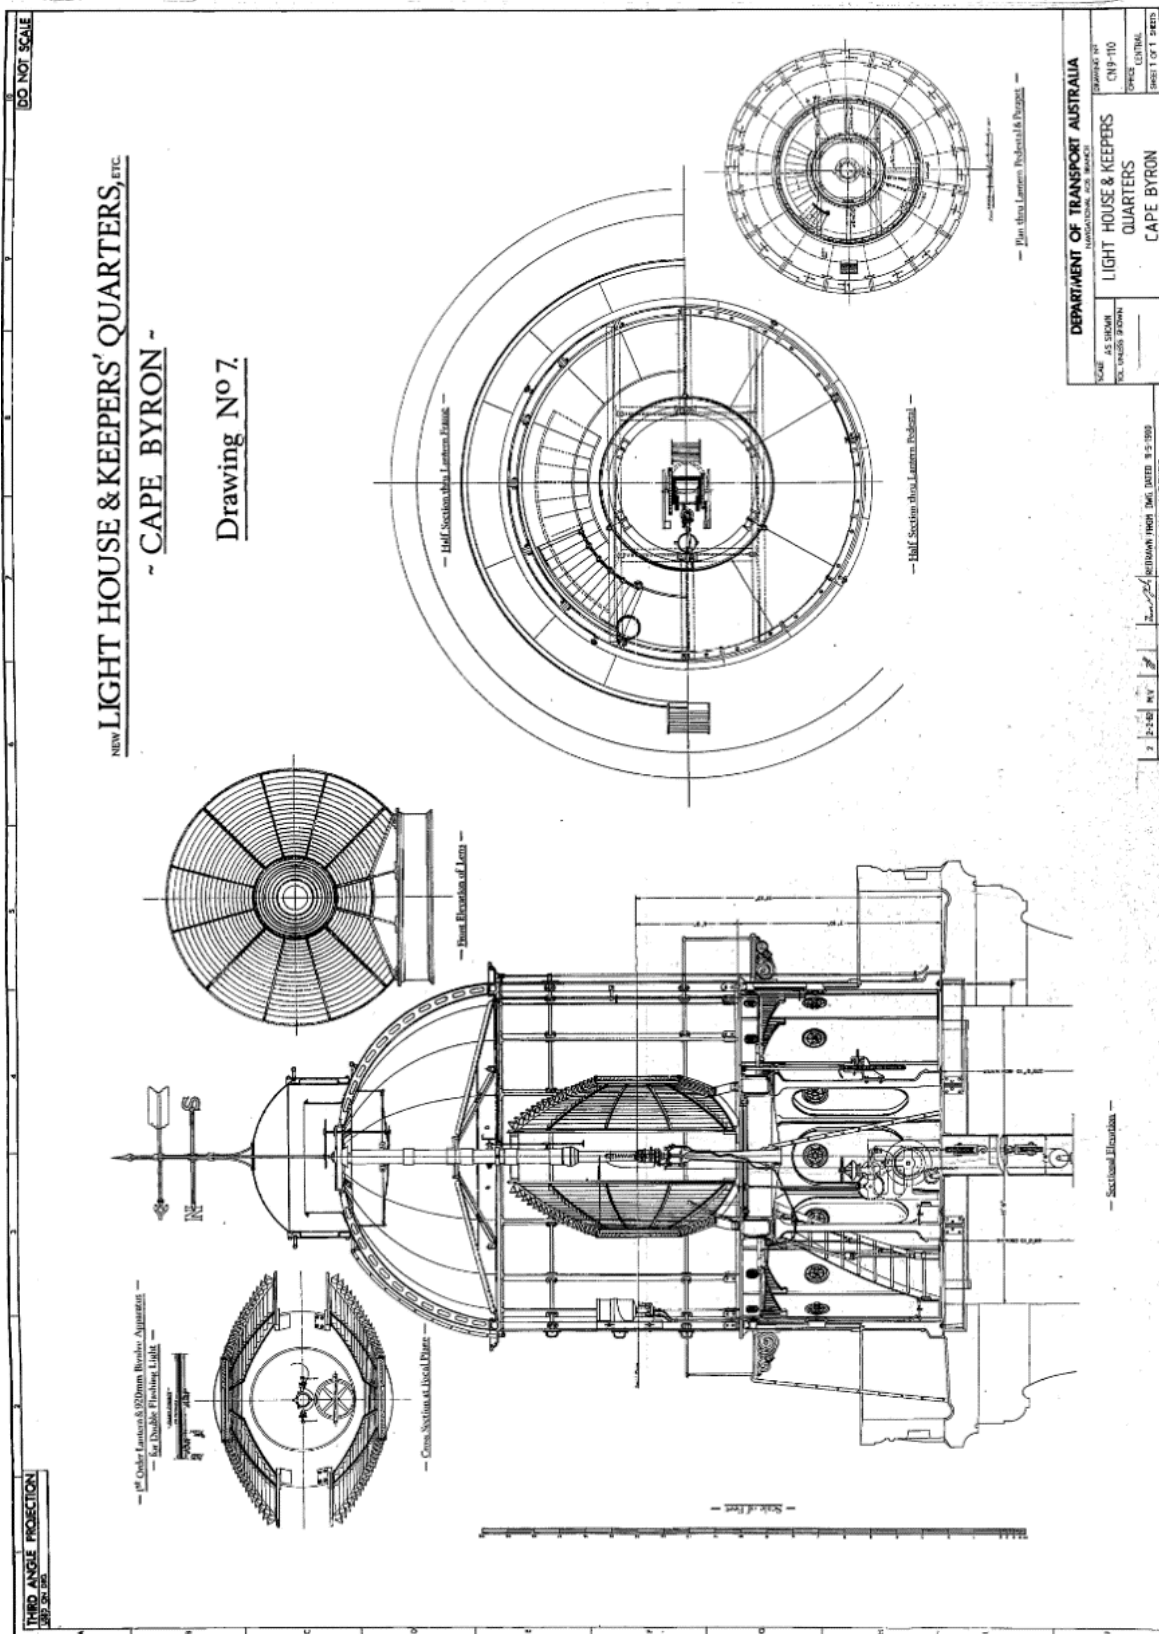
Figure 16. Design plan of Cape Byron's lens and lantern room (1982)

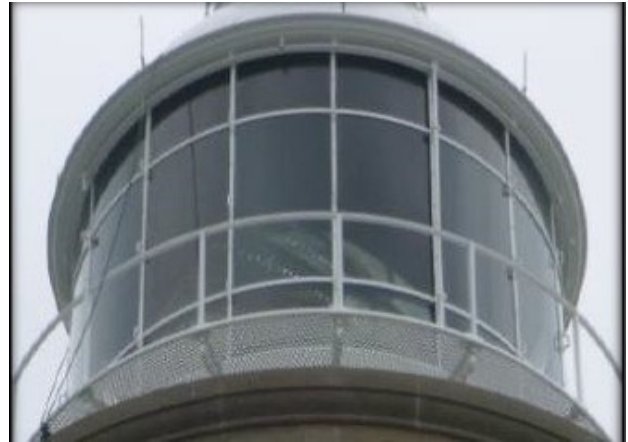
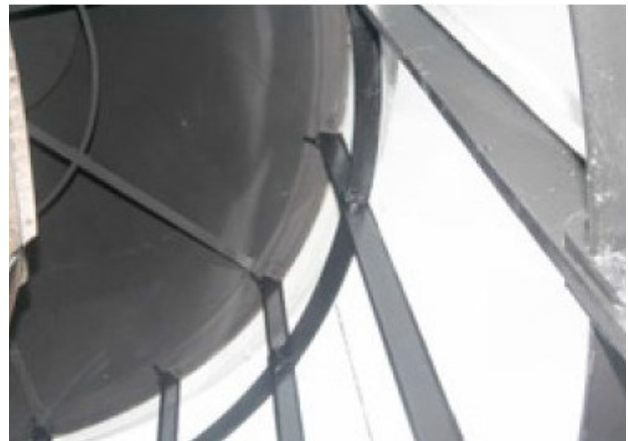
**Lighthouse feature: Internal catwalk**

<b>Finish</b>	painted
<b>Condition</b>	intact and sound
<b>Integrity</b>	high
<b>Significance</b>	high
<b>Maintenance</b>	keep in service, prepare and repaint at normal intervals
<b>Rectification works</b>	none

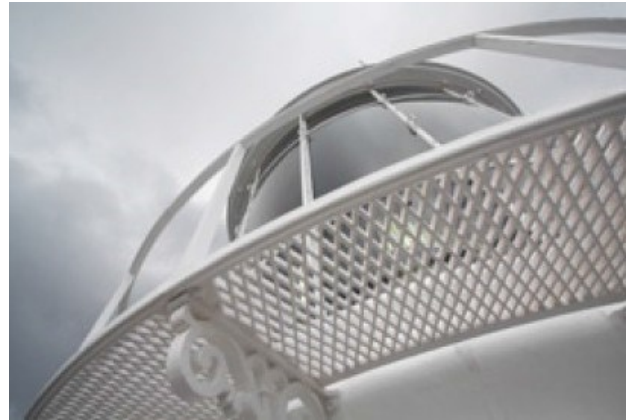
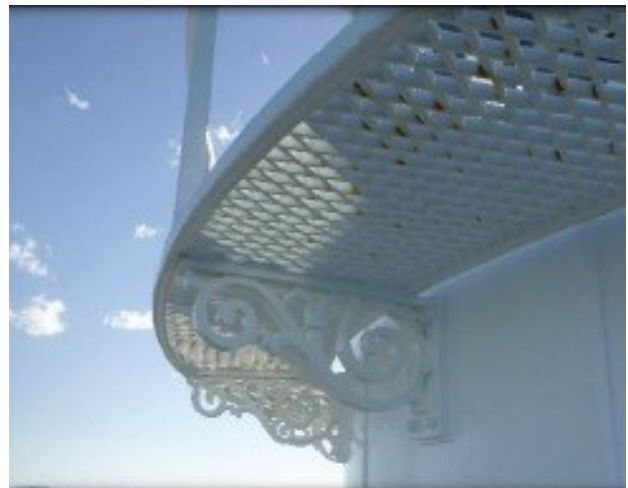
## Lighthouse feature: Lantern base

<b>Finish</b>	painted
<b>Condition</b>	intact and sound
<b>Integrity</b>	medium – high
<b>Significance</b>	high
<b>Maintenance</b>	keep in service, prepare and repaint at normal intervals
<b>Rectification works</b>	none

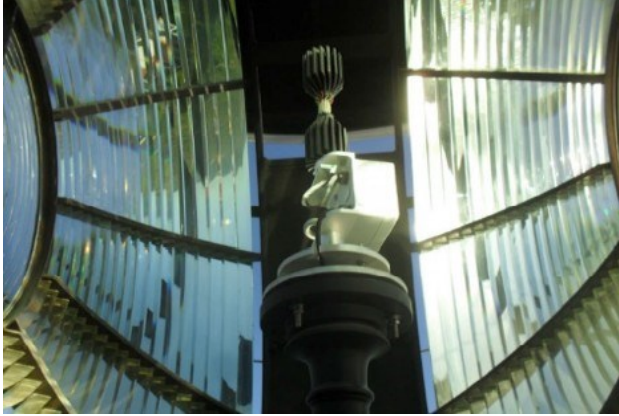
**Lighthouse feature: Light source**

Sealite SL-LED-324-W; 12 sided – 36 Light-emitting diode (LED) light source mounted on original cast iron pillar.

<b>Condition</b>	intact and sound
<b>Integrity</b>	high
<b>Significance</b>	original pillar – high other parts – low
<b>Maintenance</b>	keep in service, prepare and repaint pillar at normal intervals.
<b>Rectification works</b>	none

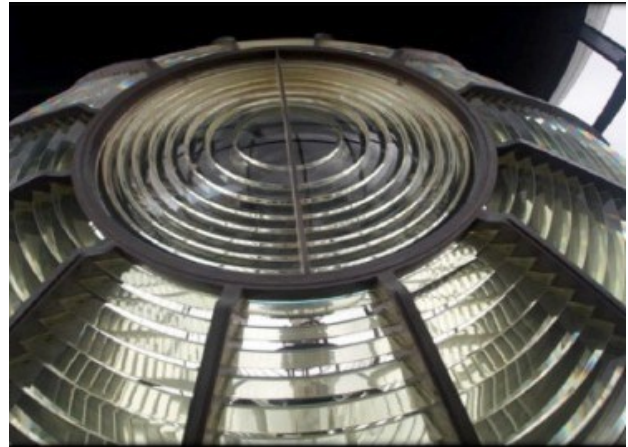
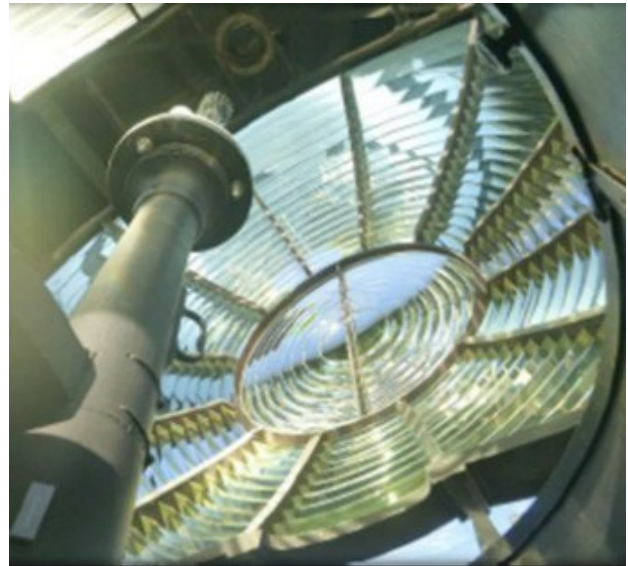
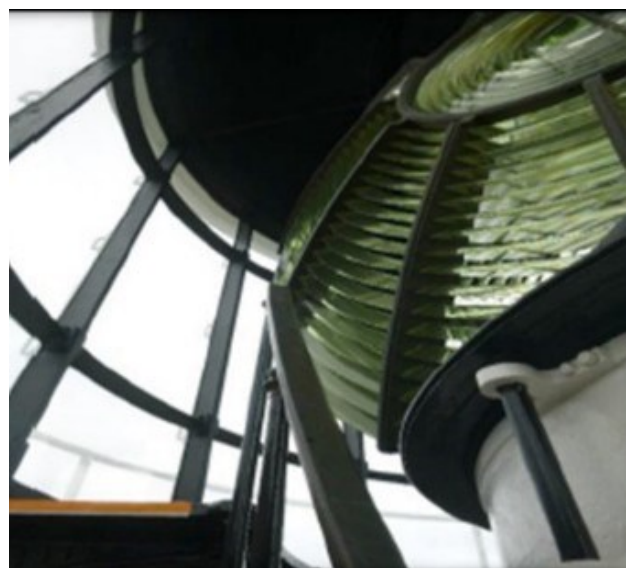
The lighthouse's Henry-Lepaute lens is the only example within Australia (criterion b; criterion f).

The lens assembly contributes to the aesthetic value of the lighthouse (criterion e).

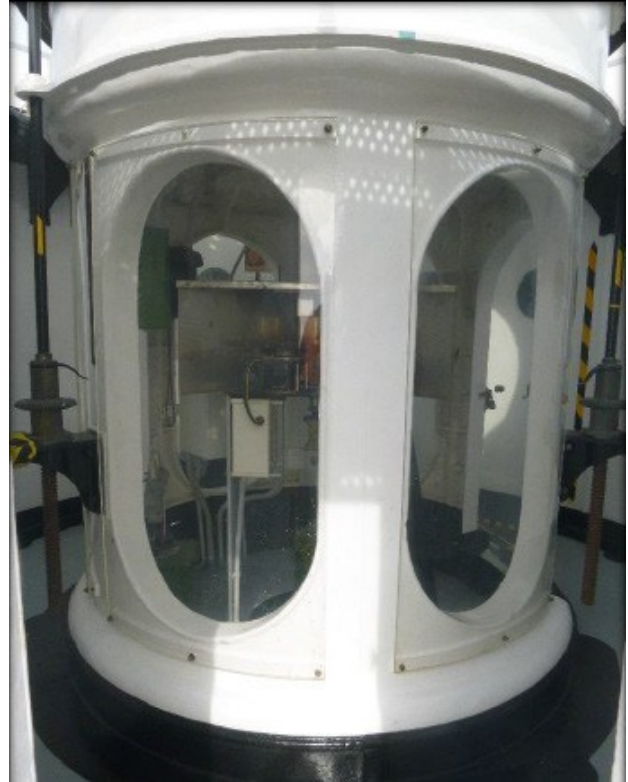
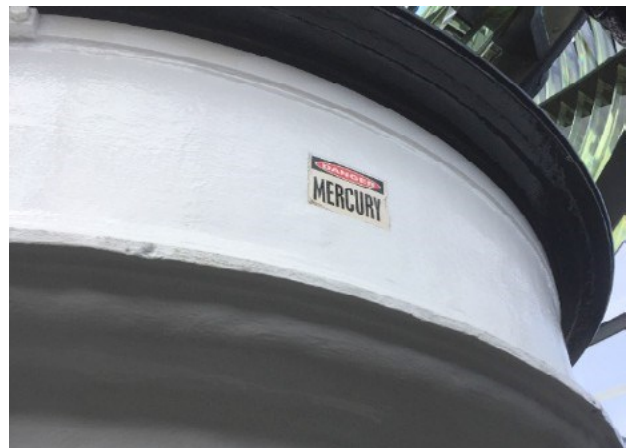
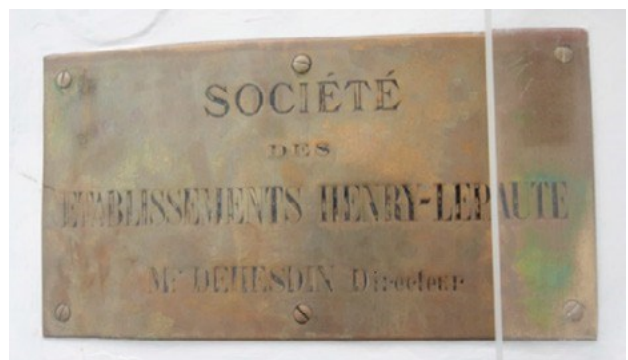
## Lighthouse feature: Pedestal

<b>Condition</b>	intact and sound
<b>Integrity</b>	high
<b>Significance</b>	high
<b>Maintenance</b>	keep in service, prepare and repaint at normal intervals
<b>Rectification works</b>	none

The pedestal is an original and essential part of a lighthouse associated with the development of marine aids to navigation along the NSW coast (criterion a).

The pedestal's first order mercury float mechanism is only one of six (6) found in Australian lighthouses (criterion b; criterion f).

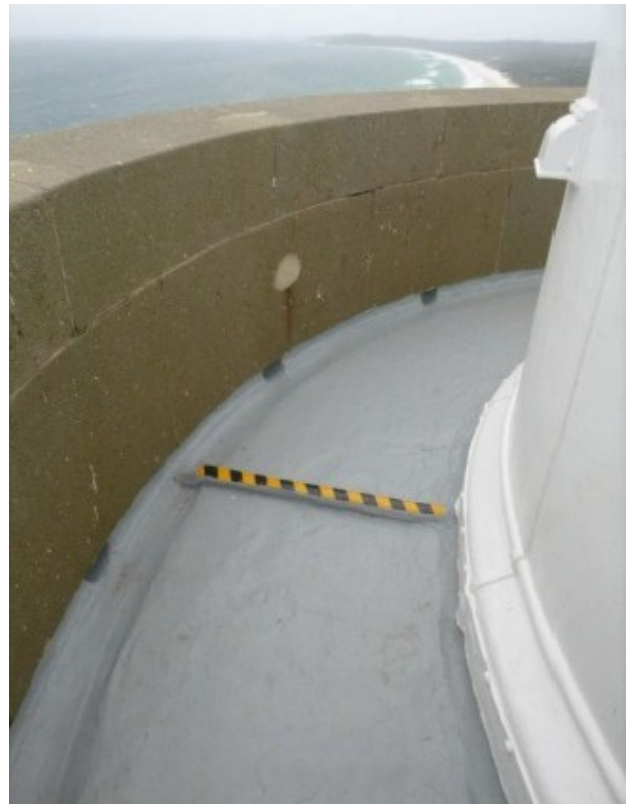
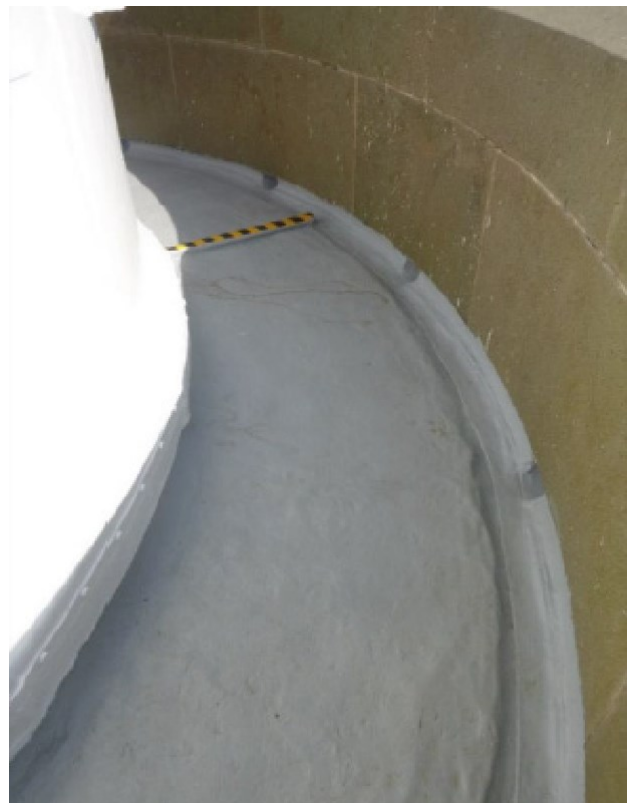
## Lighthouse feature: Balcony floor

<b>Finish</b>	membrane painted; other visible surfaces are bare stone
<b>Condition</b>	intact and sound
<b>Integrity</b>	medium
<b>Significance</b>	high
<b>Maintenance</b>	keep in service, maintain paint coating and monitor for failure of membrane, replace membrane as necessary. Monitor pointing integrity in spitters
<b>Rectification works</b>	none

The balcony floor is an original and essential part of a lighthouse associated with the development of marine aids to navigation along the NSW coast (criterion a).

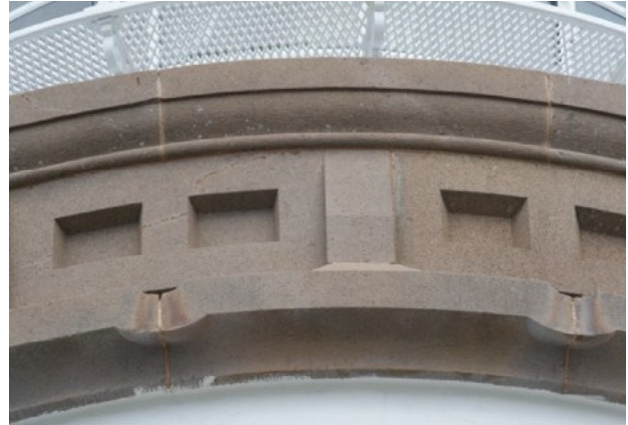
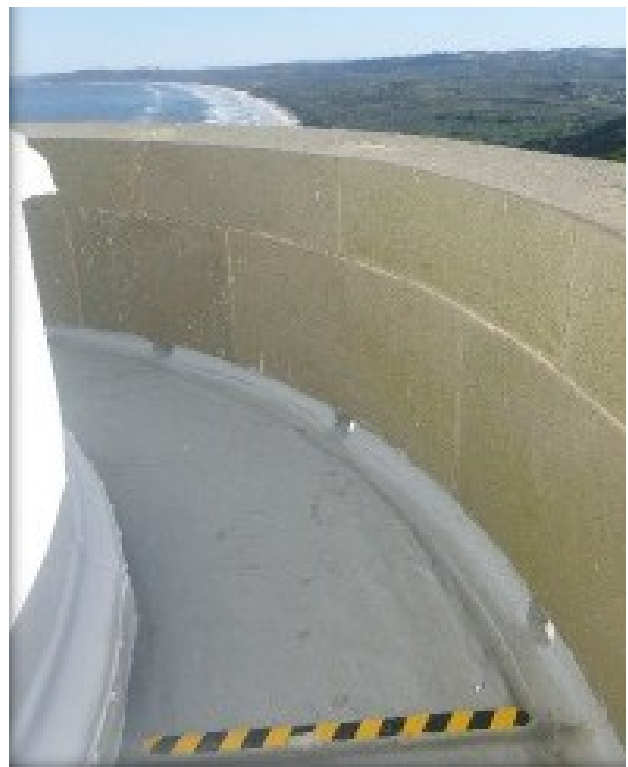
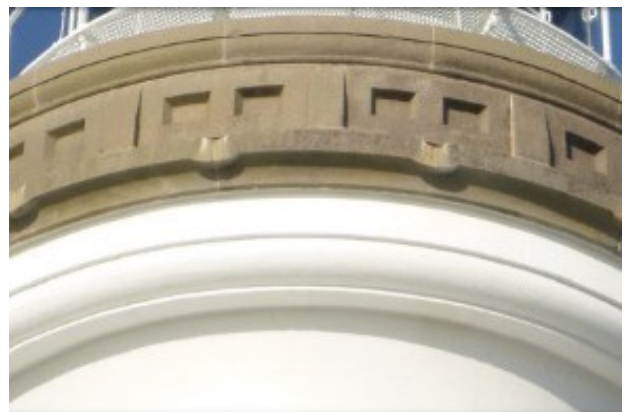
## Lighthouse feature: Balcony balustrade

<b>Condition</b>	intact and sound. Re-pointed in 2008
<b>Integrity</b>	high
<b>Significance</b>	high
<b>Maintenance</b>	keep in service; monitor for failure of pointing; repoint as necessary
<b>Rectification works</b>	none

The balcony balustrade is an original and essential part of a lighthouse associated with the development of marine aids to navigation along the NSW coast (criterion a).

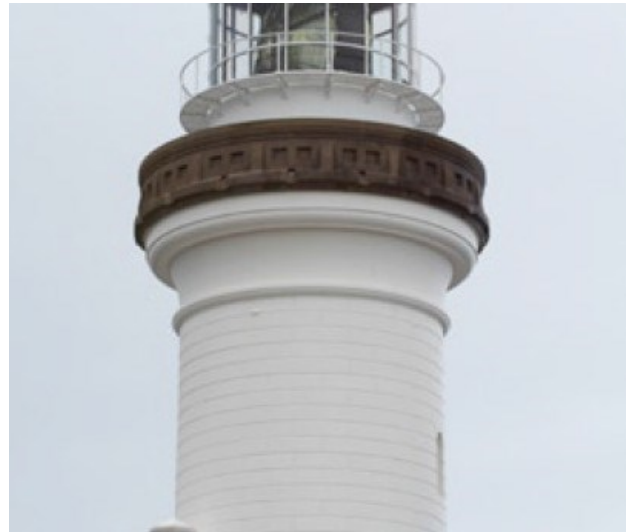
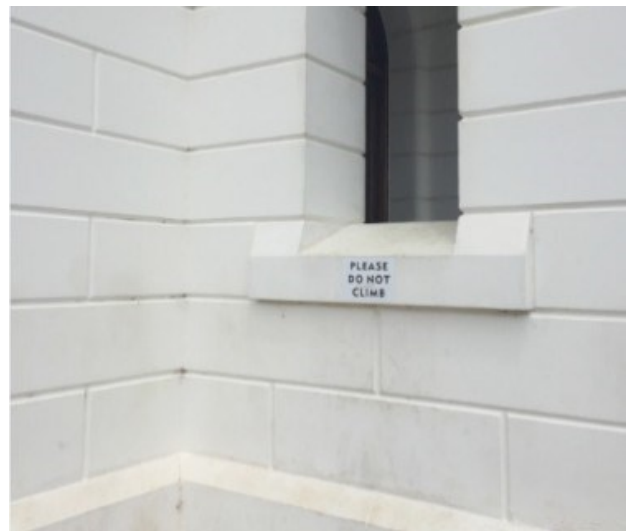
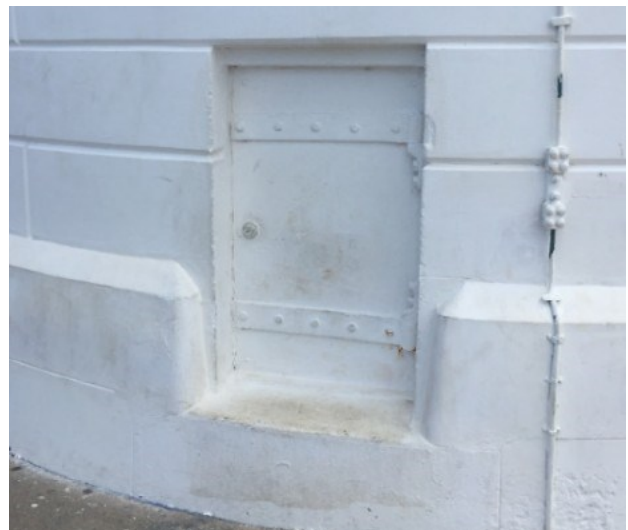
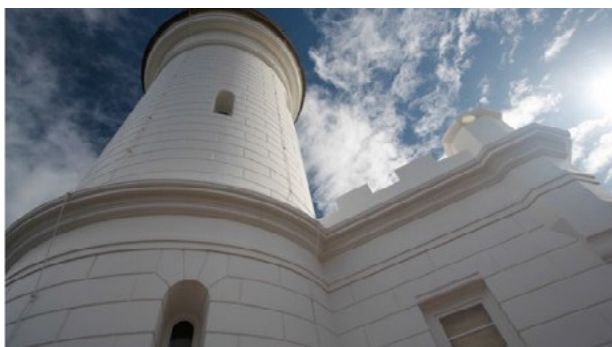
## Lighthouse feature: Walls

<b>Finish</b>	painted
<b>Condition</b>	intact and sound, some cracking showing in concrete walls just below lantern floor
<b>Integrity</b>	medium
<b>Significance</b>	high
<b>Maintenance</b>	keep in service, prepare and repaint at normal intervals – monitor cracks below lantern floor for movement and ingress of water
<b>Rectification works</b>	none

The walls are an early example of concrete block construction in Australian lighthouses (criterion f).

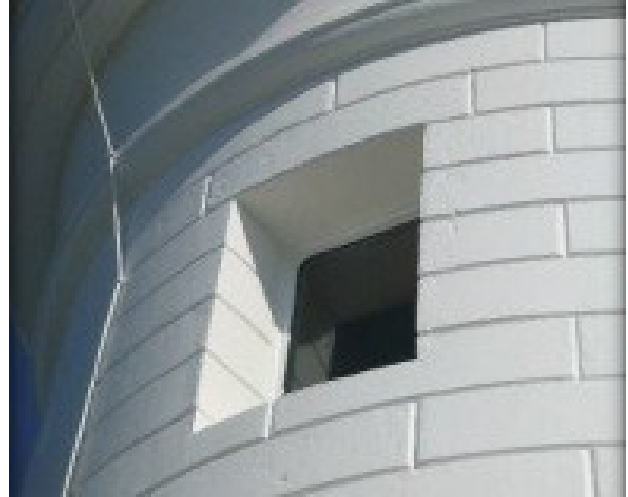
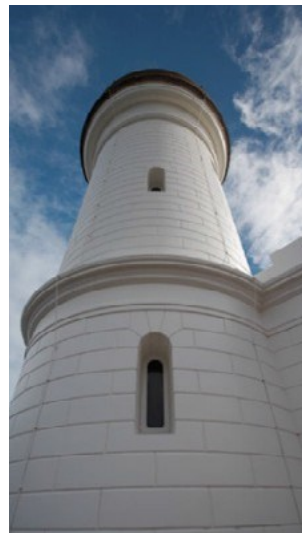
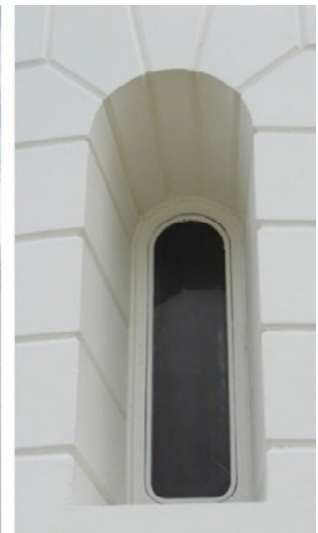
## Lighthouse feature: Windows

<b>Finish</b>	Painted, except for inside of sashes
<b>Condition</b>	intact and sound
<b>Integrity</b>	high
<b>Significance</b>	high
<b>Maintenance</b>	keep in service, prepare and repaint at normal intervals
<b>Rectification works</b>	none

The window openings are original and essential parts of a lighthouse associated with the development of marine aids to navigation along the NSW coast (criterion a).

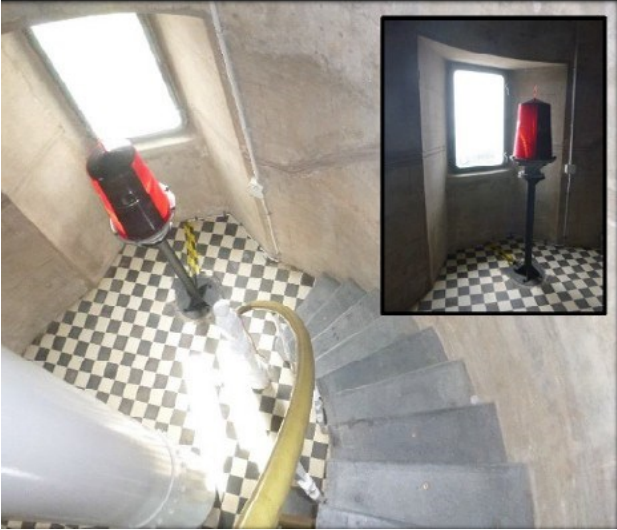
**Lighthouse feature: Auxiliary light**

- Beacon – Tideland ML-300 self-contained fixed beacon with red lens, on a fabricated steel post.

<b>Condition</b>	sound and intact
<b>Integrity</b>	high
<b>Significance</b>	window – high beacon – low
<b>Maintenance</b>	keep in service, prepare and repaint at normal intervals
<b>Rectification works</b>	none

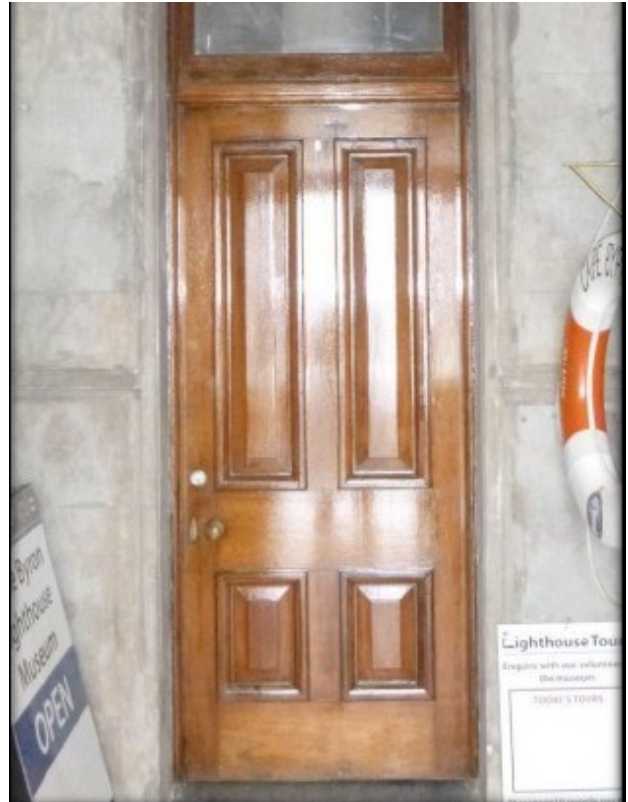
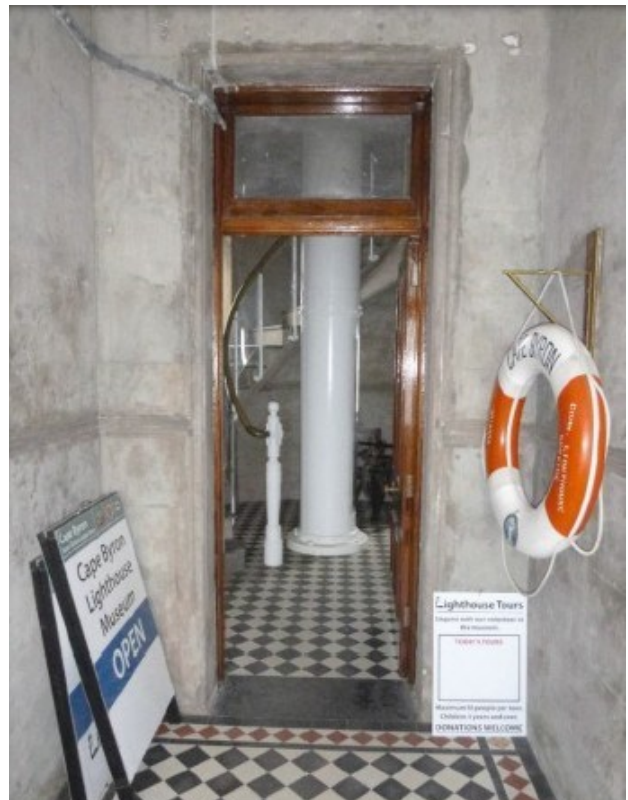
<b>Finish</b>	polished
<b>Condition</b>	intact and sound
<b>Integrity</b>	high
<b>Significance</b>	high
<b>Maintenance</b>	keep in service, prepare and maintain polish at normal intervals
<b>Rectification works</b>	none

The door is an original and essential part of a lighthouse associated with the development of marine aids to navigation along the NSW coast (criterion a).

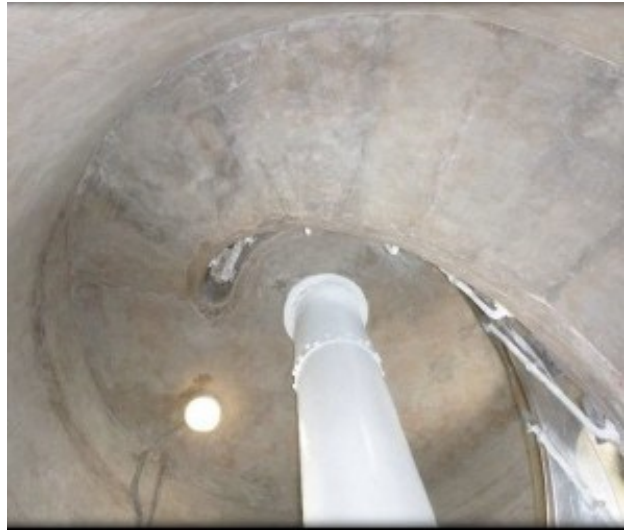
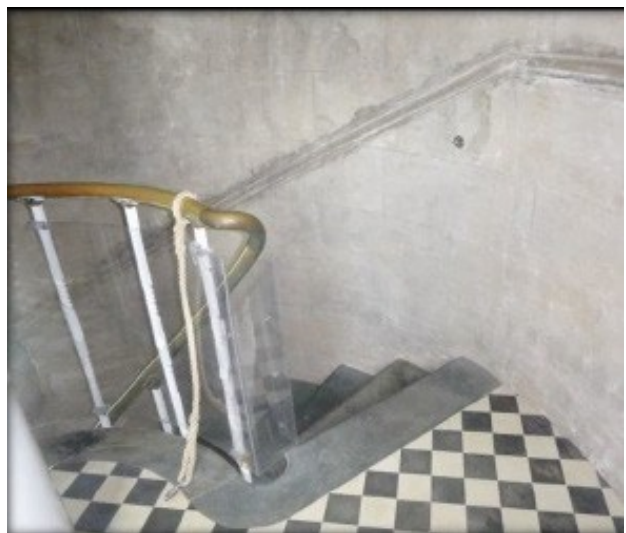
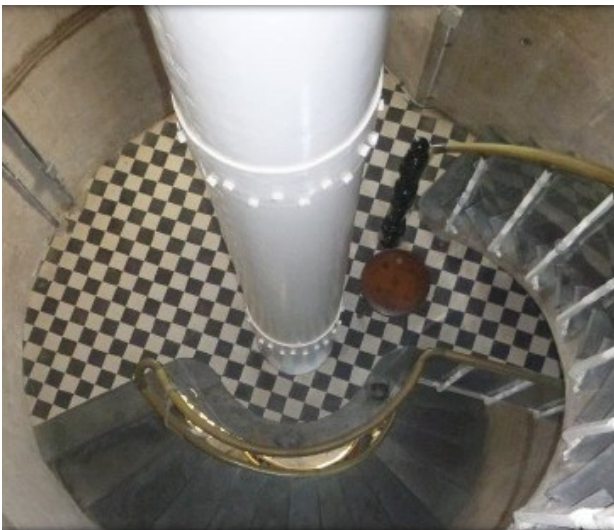
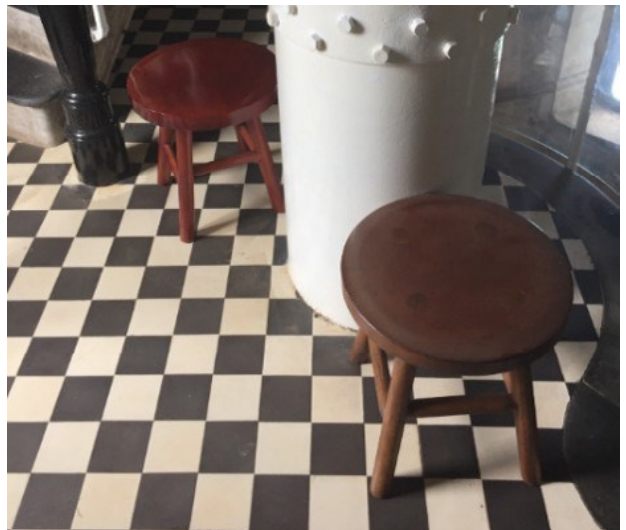
## Lighthouse feature: Intermediate floors

<b>Finish</b>	render bare
<b>Condition</b>	intact and sound
<b>Integrity</b>	high
<b>Significance</b>	high
<b>Maintenance</b>	keep in service
<b>Rectification works</b>	none

The intermediate floors are an original and essential part of a lighthouse associated with the development of marine aids to navigation along the NSW coast (criterion a).

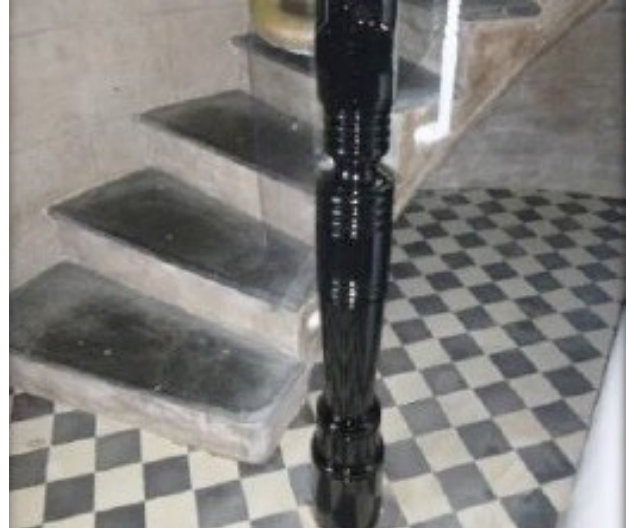
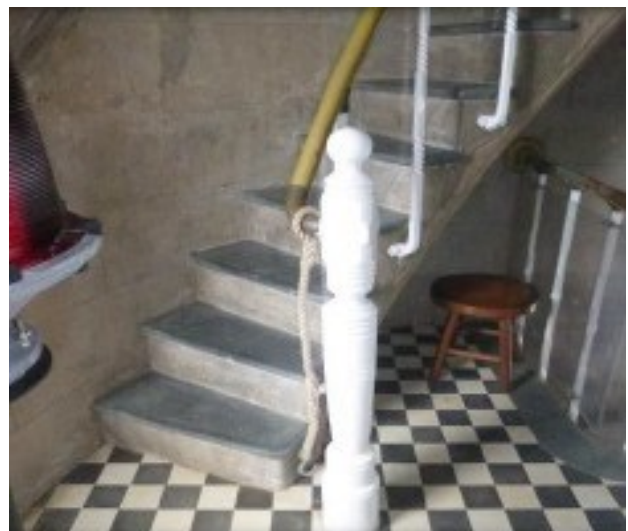
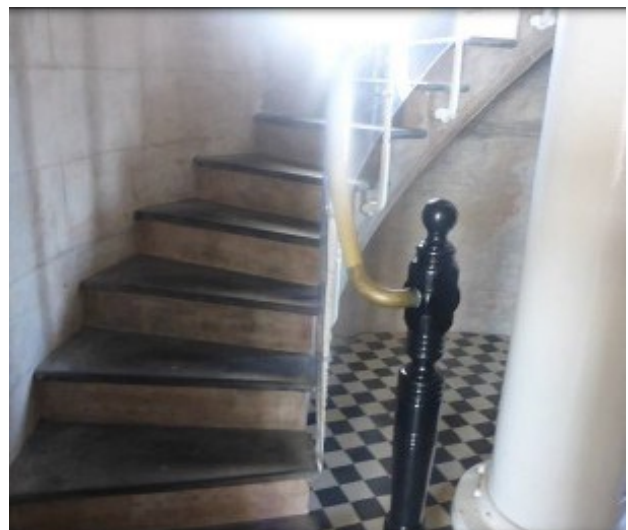
## Lighthouse feature: Stairs

<b>Finish</b>	Render – Bare Balusters – Painted Slate treads – Bare
<b>Condition</b>	intact and sound
<b>Integrity</b>	high
<b>Significance</b>	high
<b>Maintenance</b>	keep in service, prepare and repaint balusters at normal intervals
<b>Rectification works</b>	none

The stairs are an original and essential part of a lighthouse associated with the development of marine aids to navigation along the NSW coast (criterion a).

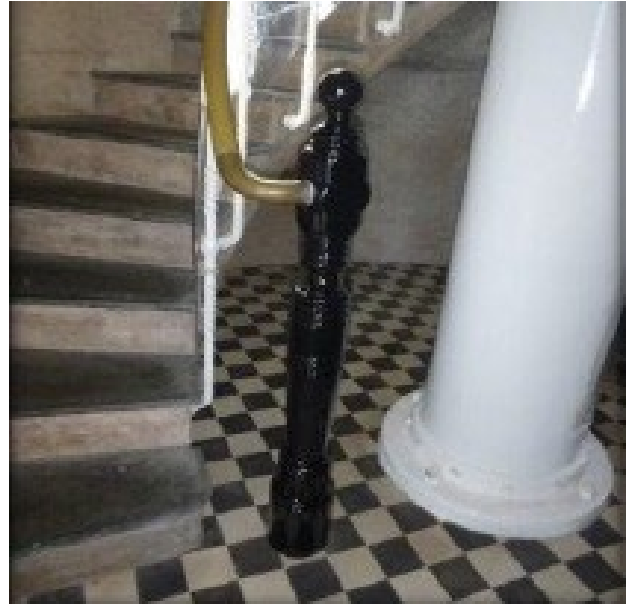
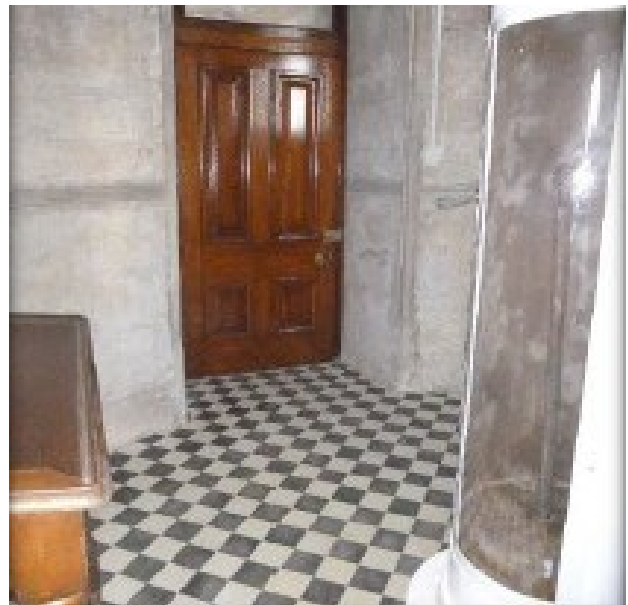
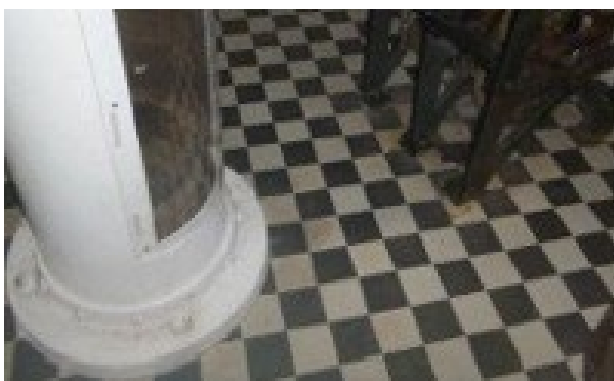
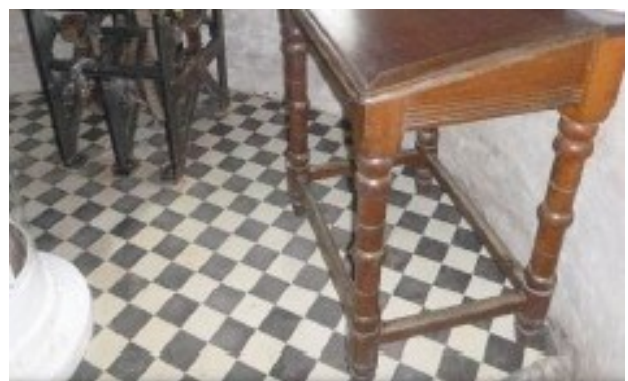
## Lighthouse feature: Ground floor

<b>Finish</b>	ceramic tiles
<b>Condition</b>	intact and sound
<b>Integrity</b>	high
<b>Significance</b>	high
<b>Maintenance</b>	keep in service, clean at normal intervals
<b>Rectification works</b>	none

The ground floor is an original and essential part of a lighthouse associated with the development of marine aids to navigation along the NSW coast (criterion a).

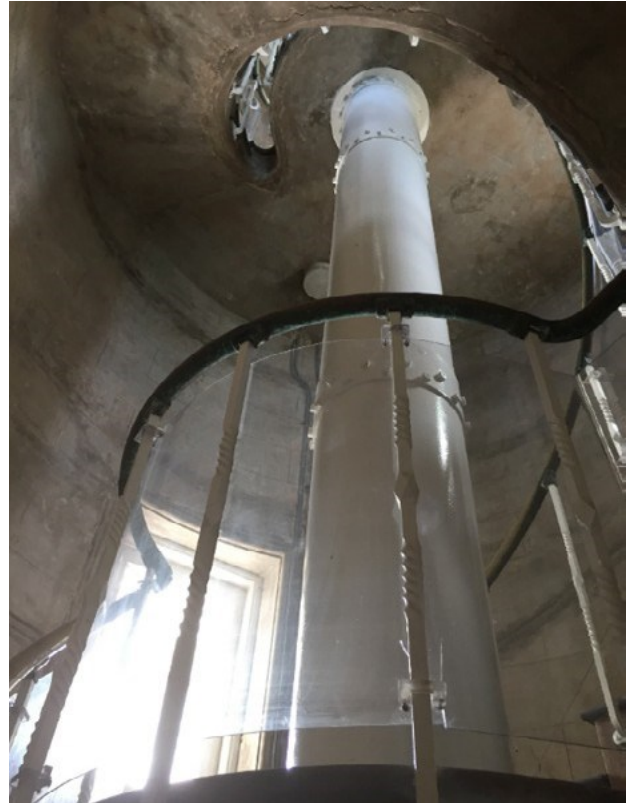
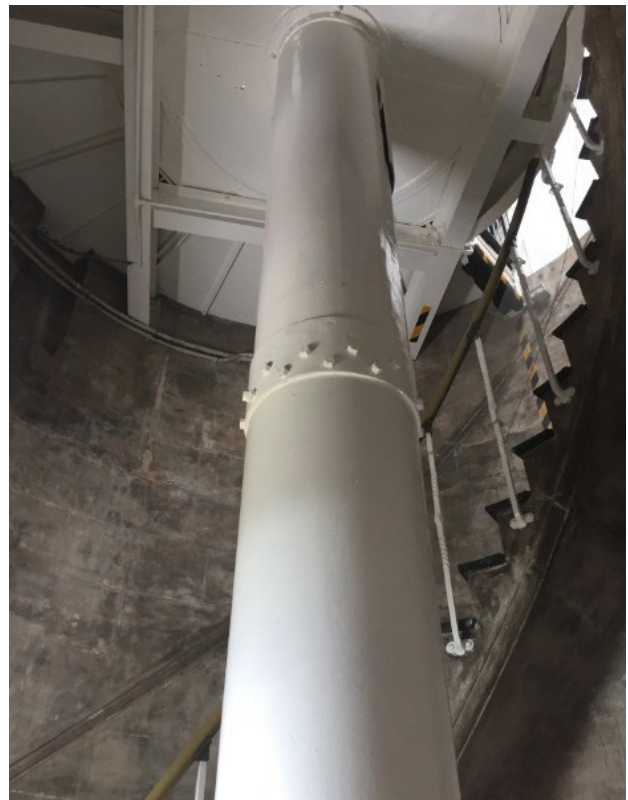
## Lighthouse feature: Weight tube

<b>Finish</b>	painted
<b>Condition</b>	intact and sound
<b>Integrity</b>	high
<b>Significance</b>	high
<b>Maintenance</b>	keep in service, maintain and repaint at normal intervals
<b>Rectification works</b>	none

The weight tube is a historic and essential part of a lighthouse associated with the development of marine aids to navigation along the NSW coast (criterion a).

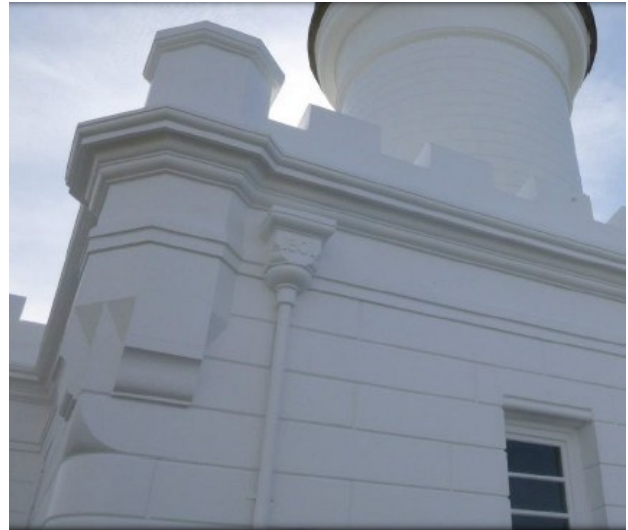
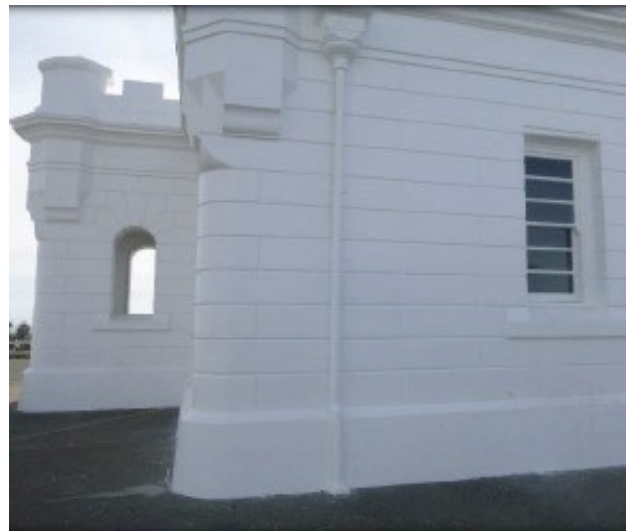
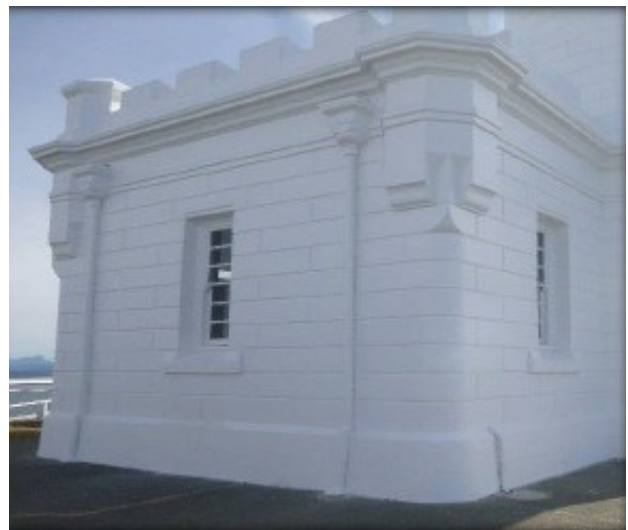
## Lighthouse feature: Pavilion room walls

<b>Finish</b>	Painted externally, bare internally
<b>Condition</b>	intact and sound
<b>Integrity</b>	high
<b>Significance</b>	high
<b>Maintenance</b>	keep in service, prepare and repaint external face at normal intervals
<b>Rectification works</b>	none

The pavilion room walls are an original and essential part of a lighthouse associated with the development of marine aids to navigation along the NSW coast (criterion a).
