Australian Maritime Safety Authority

# Cape Byron Lighthouse Heritage Management Plan

2020

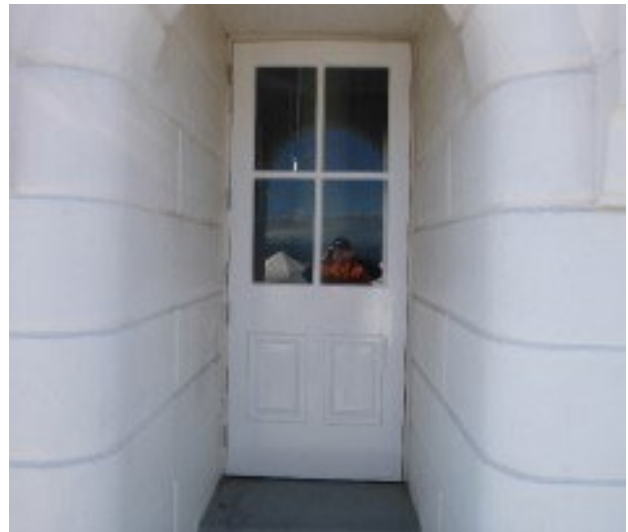
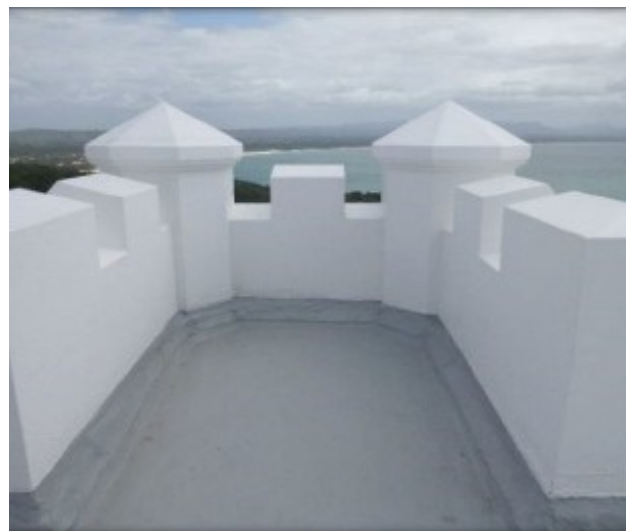
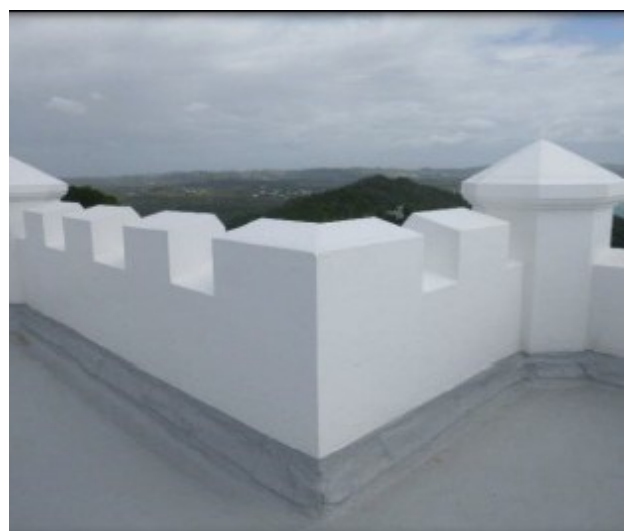
## Lighthouse feature: Pavilion roof

<b>Finish</b>	membrane
<b>Condition</b>	intact and sound
<b>Integrity</b>	high
<b>Significance</b>	roof and parapets: high roof door: low
<b>Maintenance</b>	keep in service, monitor membrane; prepare and re-apply at normal intervals
<b>Rectification works</b>	none

The pavilion roof is an essential part of a lighthouse associated with the development of marine aids to navigation along the NSW coast (criterion a).

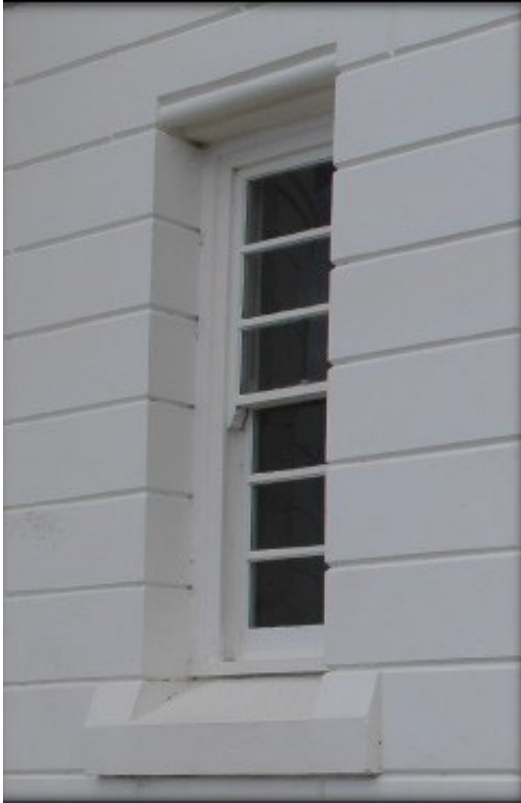
**Lighthouse feature: Pavilion windows**

Early timber double hung sashes in timber frames.

<b>Finish</b>	painted
<b>Condition</b>	Intact and sound. Repairs and replacement of parts during the period 2009–2015. Sash cords in museum room windows reinstated in 2017
<b>Integrity</b>	high
<b>Significance</b>	high
<b>Maintenance</b>	keep in service, prepare, re-seal and repaint at normal intervals
<b>Rectification works</b>	none

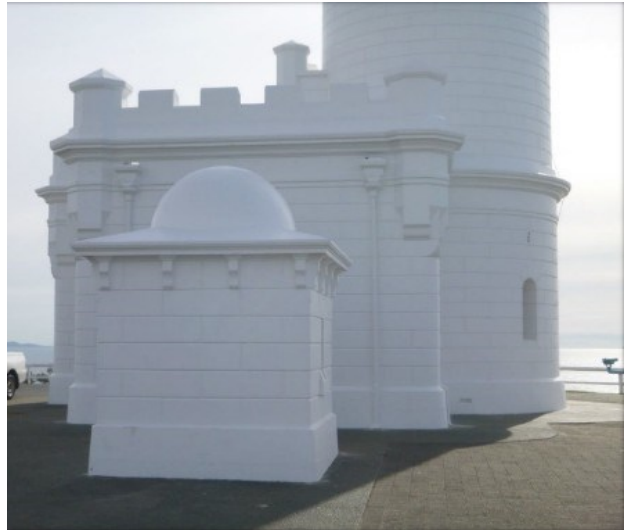
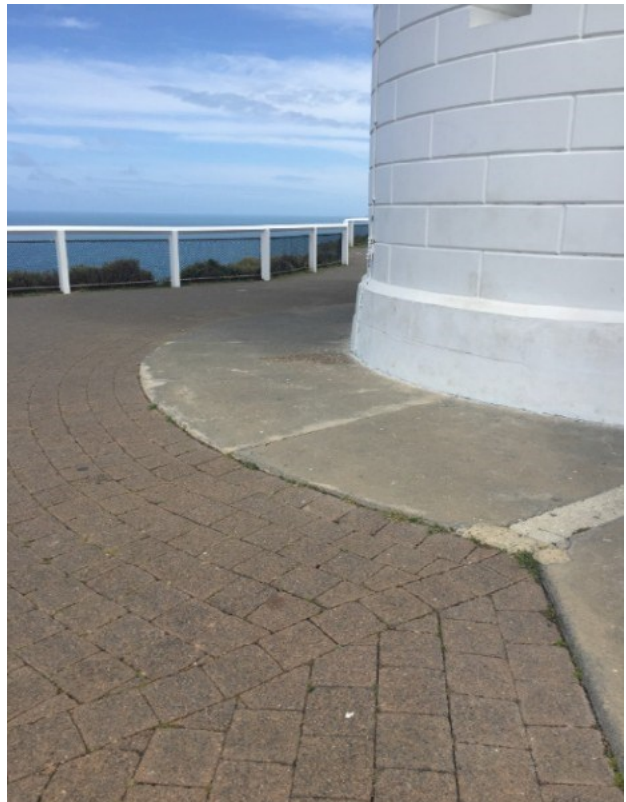
**Lighthouse feature: Apron paving**

<b>Finish</b>	trowelled bare concrete
<b>Condition</b>	intact and sound with minor cracks visible
<b>Integrity</b>	high
<b>Significance</b>	high
<b>Maintenance</b>	keep in service, carry out minor repairs as required
<b>Rectification works</b>	none

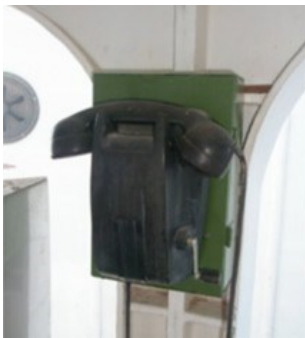
### Phone in Lantern Room

Good condition.

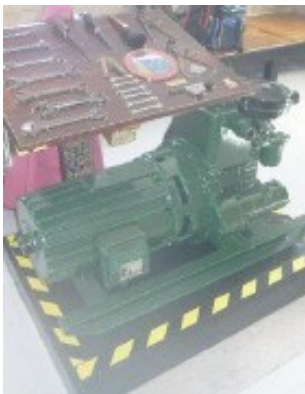
### Diesel lister SR3 generator set Ex Cape Byron

Good, decommissioned – set up at ground floor of lighthouse for tourist viewing.

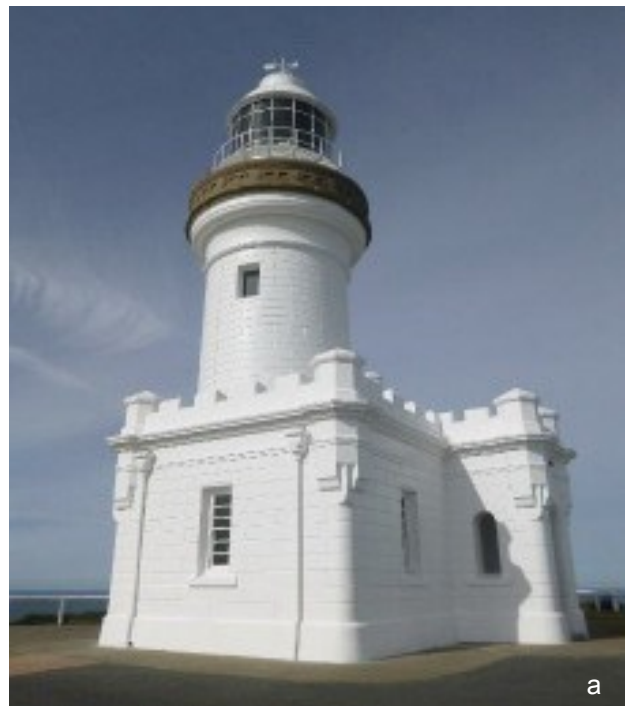
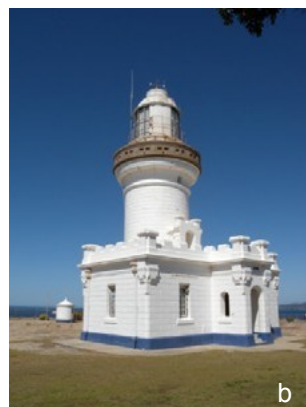
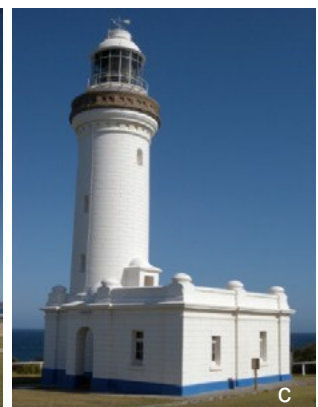
In terms of design, the Cape Byron Lighthouse closely resembles that of Point Perpendicular Light (first lit 1899) diverging only in lens and lantern manufacture. Cape Byron's unique Henry-Lepaute lens differed from Point Perpendicular's 1st Order Fresnel lens. Cape Byron's mercury bath mechanism allowed the lens to revolve at a faster rate (once every 10 seconds as opposed to Pt. Perpendicular's rate of once every 90 seconds).

Figure 17. a) Cape Byron Lighthouse (lit 1901)  
 b) Point Perpendicular Lighthouse (lit 1899)  
 c) Norah Head Lighthouse (lit 1903).

Cape Byron Lighthouse also shares design similarities with Norah Head Light (first lit 1903).

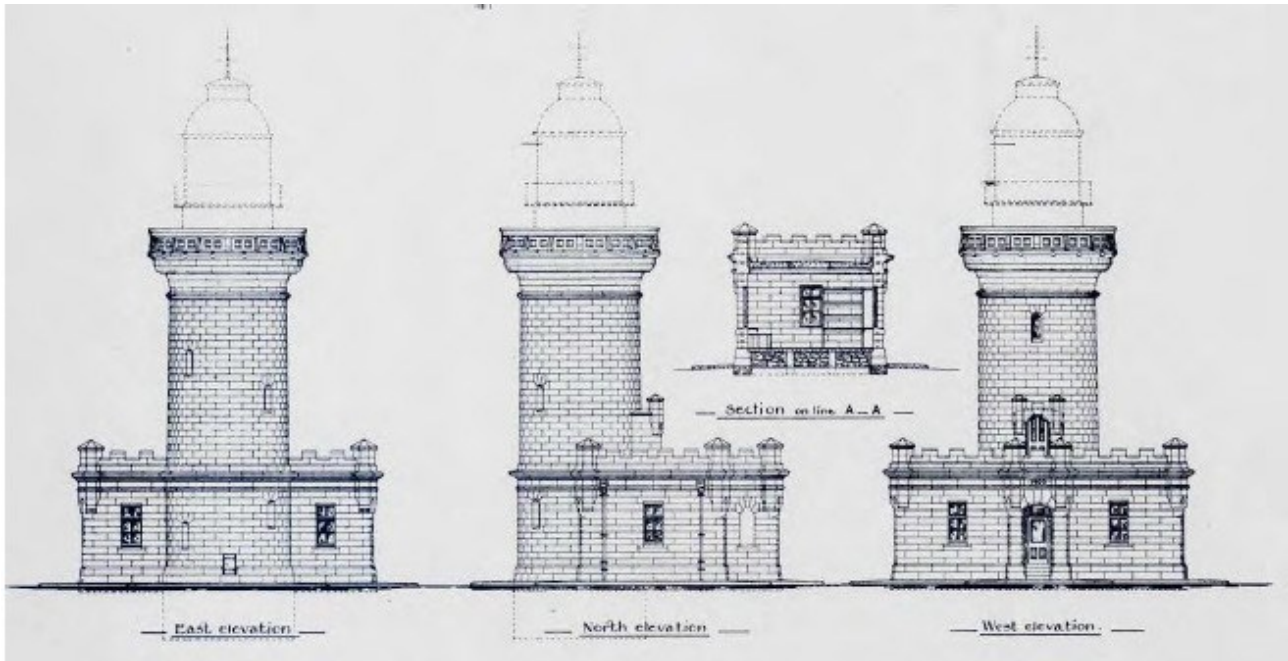
Figure 18. Cape Byron elevation blueprint (1899)
